Office of Transport Safety Investigations

RAIL SAFETY INVESTIGATION REPORT

NEAR MISS WITH TRACK CLEANING CONTRACTORS BANKSTOWN

29 OCTOBER 2010

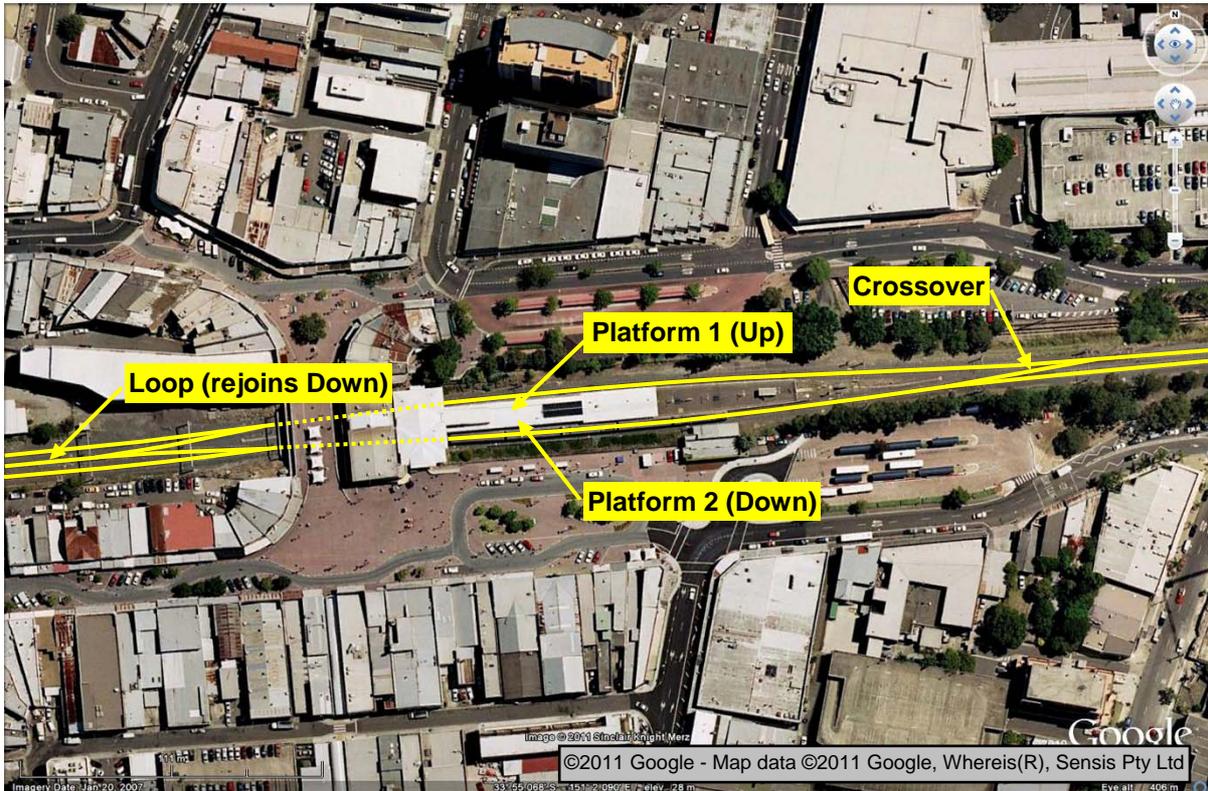
Photograph 1: Bankstown Railway Station

- 1.7 Bankstown Station has an island platform serving both lines. The lines are joined at the city end of the station by a crossover, and at the country end through a loop. The station layout is shown in *Photograph 1*.
- 1.8 The Up line is in a wide corridor in the area adjacent to Platform 1, providing an easily accessible Safe Place for workers on the track.
- 1.9 RailCorp is responsible for track maintenance, signalling and train control functions in this corridor. Train movements in the region either side of Bankstown are controlled under Network Rule NSY 500 *Rail Vehicle Detection System* with signalling and points remotely operated from Sydenham. The control of signal and points operation is divided into panels, each operated by
