RAIL SAFETY INVESTIGATION REPORT

UNCONTROLLED MOVEMENT OF EL ZORRO GRAIN SERVICE 3996

UNANDERRA

7 FEBRUARY 2011

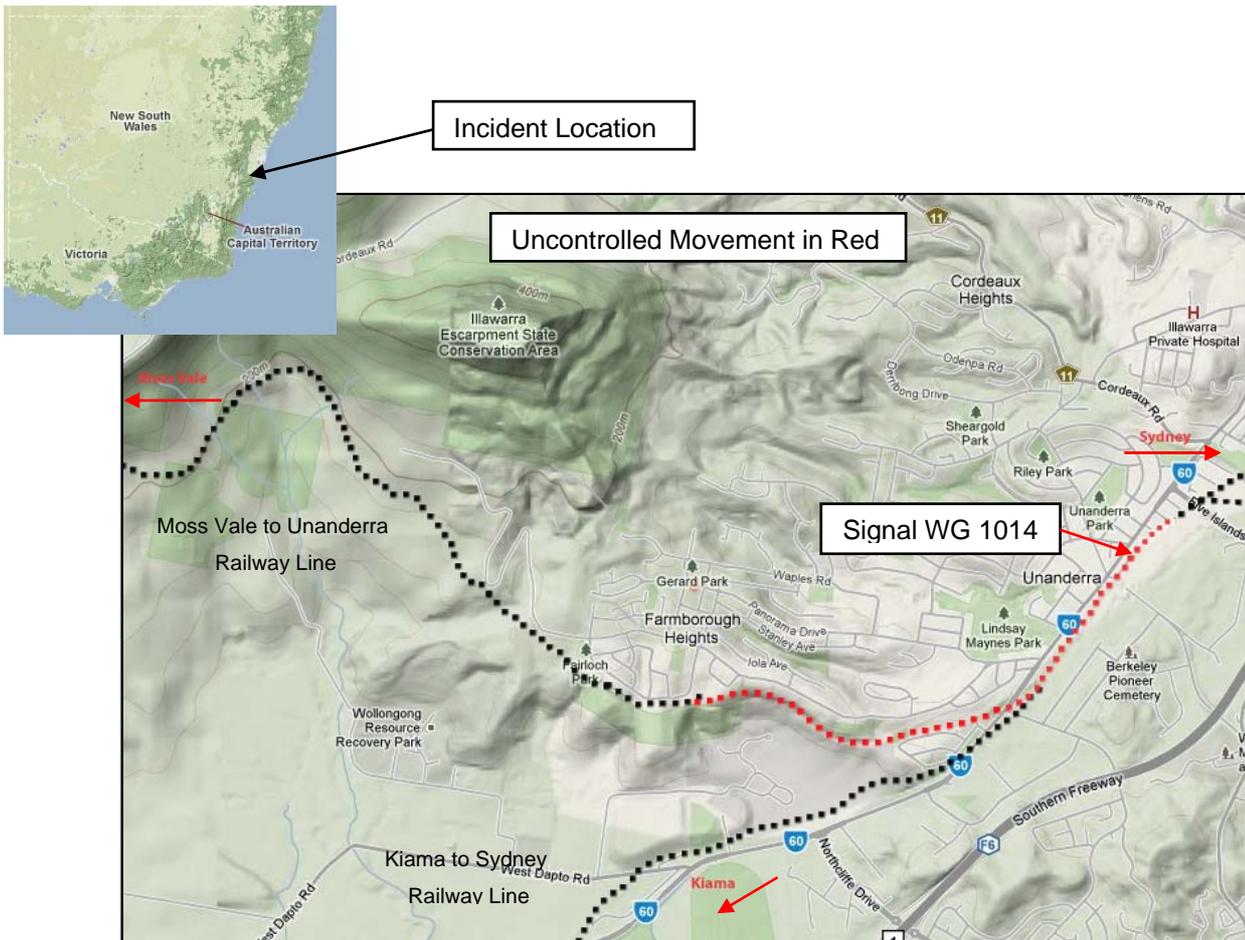
Figure 1: Illawarra and incident locations

- 1.1 At approximately 6.38am on 7 February 2011, loaded El Zorro grain service 3996, en route from West Wyalong to Port Kembla, passed signal WG 1014 at danger before coming to a stand 527 metres beyond the signal which is located on the Northern side of Unanderra Station (see *Figure 1*). The driver had not been able to control the speed of the train towards the end of its descent of the steeply sloping Illawarra Mountain. No injuries or damage resulted from the incident.

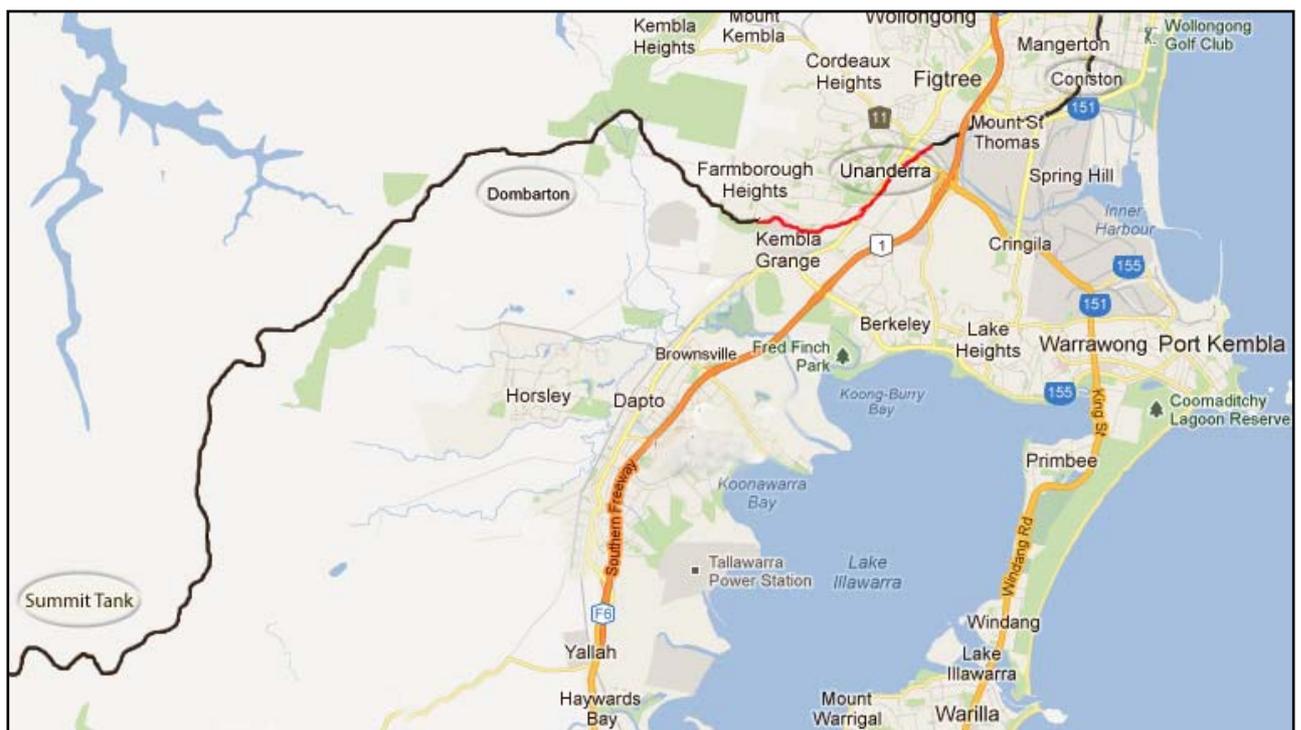
Figure 3: Key locations from Summit Tank to Coniston

- 1.4 The track from Moss Vale to Unanderra supports the movement of intermodal² freight, bulk commodities such as coal and grain, and passenger services. Train movements on the single line between Moss Vale and Dombarton and the double line from Dombarton to kilometrage 91.080 are controlled from the Australian Rail Track Corporation's (ARTC) Network Control Centre South at Junee (NCCS) under Network Rule ANSY 500 *Rail Vehicle Detection* system. From kilometrage 91.080, approximately 2.8 km West of Unanderra, train movements are controlled by RailCorp under Network Rule NSY 500 *Rail Vehicle Detection* system. In the 'Up' direction,³ the last signal controlled from NCCS is signal WG 1052 just prior to Dombarton. From Dombarton onwards the signals are controlled from the RailCorp Signal Box at Wollongong (see *Figure 3*).

- 2.16 The train's brake pipe pressure was set at 480 kPa from when the train left West Wyalong rather than the standard setting for freight trains of 500 kPa. The driver did not test his air brakes at any stage after leaving Moss Vale despite this being common practice (but not a requirement of either operators or infrastructure managers). Between Summit Tank and the point at which 3996 came to a stand, the driver made a number of brake applications. Only on two of the earlier of these occasions did the brake pipe air pressure return to the set pressure of 480 kPa. Also, successive brake applications were generally greater than the preceding application, indicating the driver was having trouble controlling the train as it increased speed (see *Figure 3*).
