## RAIL SAFETY INVESTIGATION REPORT

# DERAILMENT OF FREIGHT AUSTRALIA LIMITED CEMENT SERVICE 4VM9 BETHUNGRA

22 DECEMBER 2004

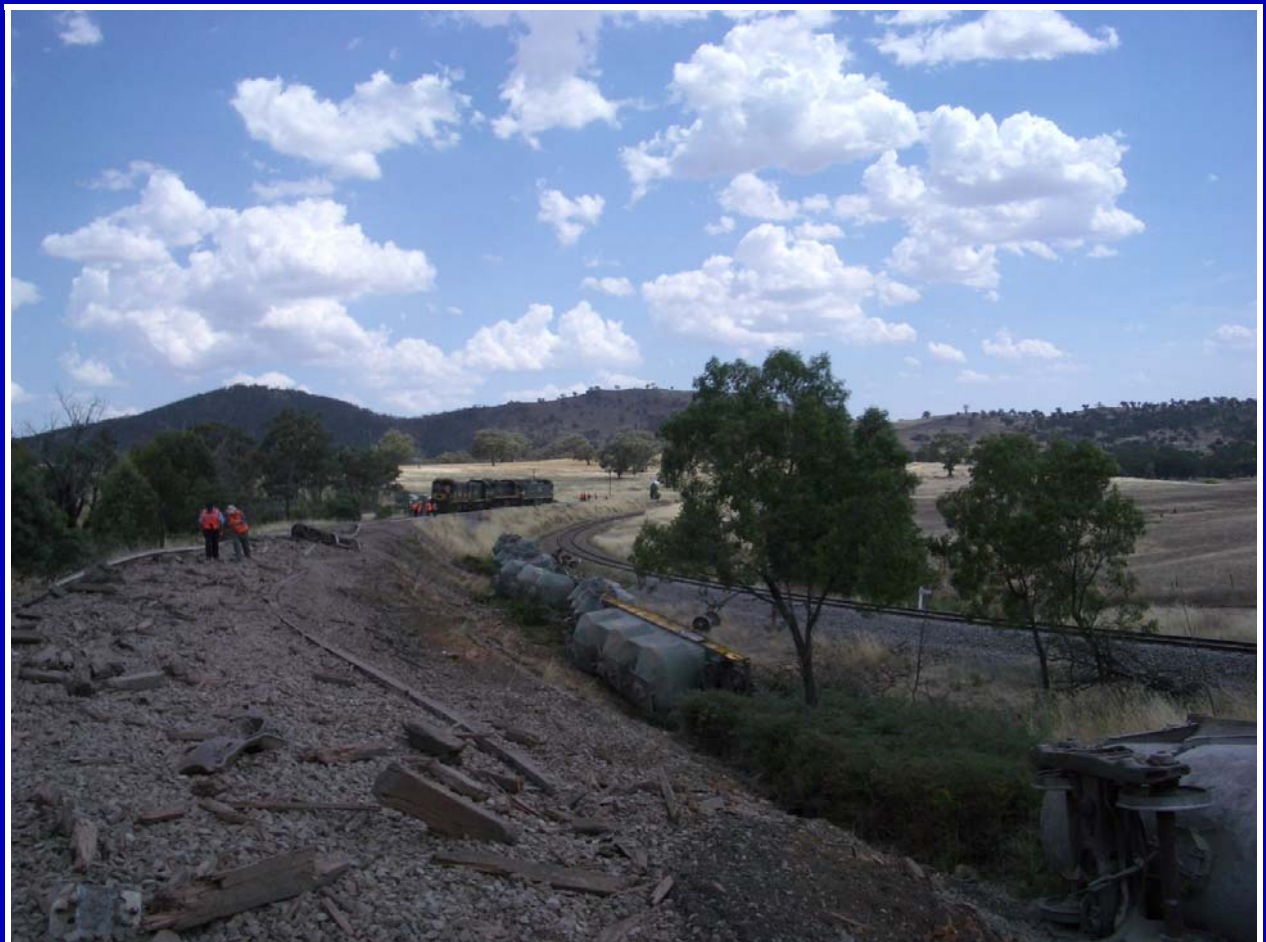
Cover	The position at which 4VM9 came to rest after the derailment.	
Photo 1	Looking towards the derailment site from the probable point at which the driver applied the emergency brakes.	6
Photo 2	Incident site indicating proximity of derailed wagons and debris to the Up line.	6
Photo 3	Position of front automatic coupler indicating the extent of lateral forces.	10
Photo 4	Impact marks on leading bogie of T388 indicating degree of bogie/body movement.	10
Photo 5	Impact marks on leading bogie and damage to piping of air brake system of T409.	10
Photo 6	Incident site looking towards Sydney showing extent of track damage.	15
Photo 7	Indications of rail creep at 453.490kms.	16
Photo 8	Apex point of misalignment found after the incident.	17
