RAIL SAFETY INVESTIGATION REPORT

FATAL LEVEL CROSSING COLLISION GRAWLIN PLAINS

31 MAY 2005

OTSI File Ref: 04085

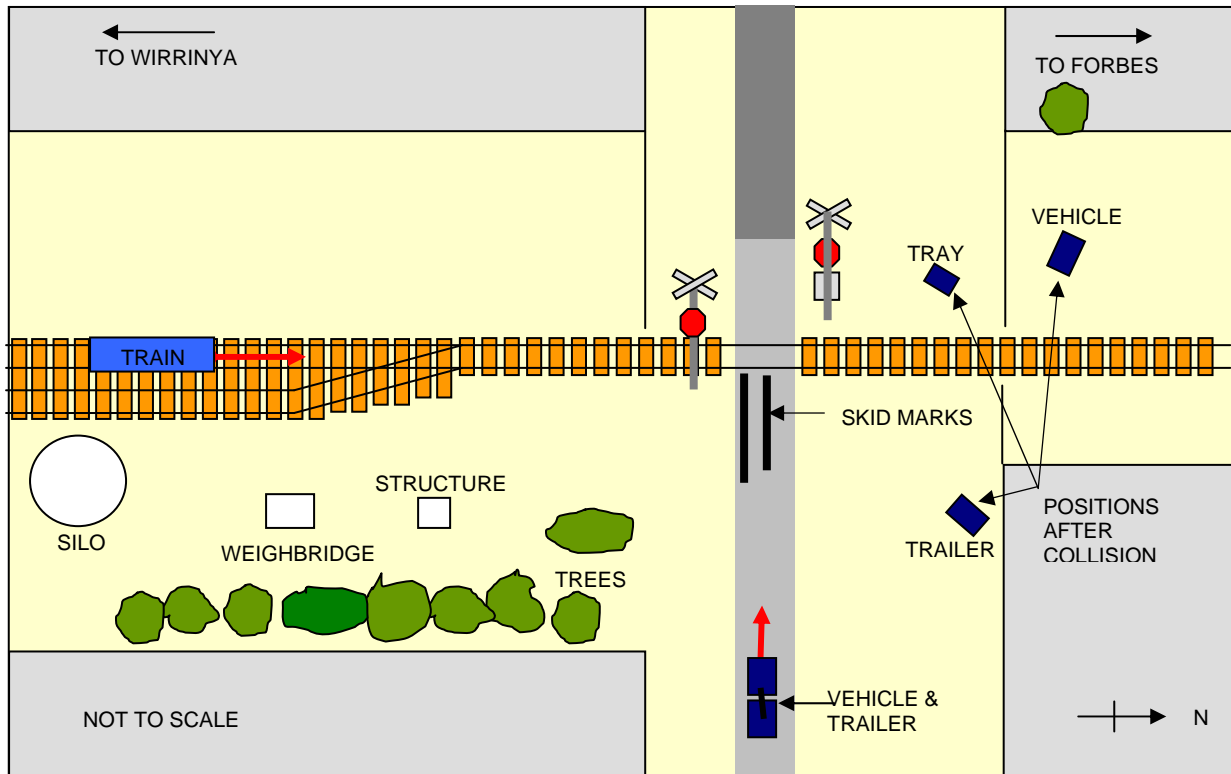
Figure 2: Site Diagram of Grawlin Plains

- 2.9 On approaching the level crossing, the assistant driver sounded the horn in accordance with network rules and procedures. Whilst sounding the horn, the assistant driver saw a motor vehicle travelling from the East towards the crossing, as depicted in *Figure 2*, and he continued sounding the horn to alert the driver of the motor vehicle. He said he recalled that the motor vehicle appeared to slow as if to stop, but then recalled seeing smoke coming from the vehicle's tyres as it continued towards the crossing. The Locomotive driver, seated on the opposite side of the cabin, could not see the approaching motor vehicle but applied the emergency brakes in reaction to the continual sounding of the horn by his assistant.

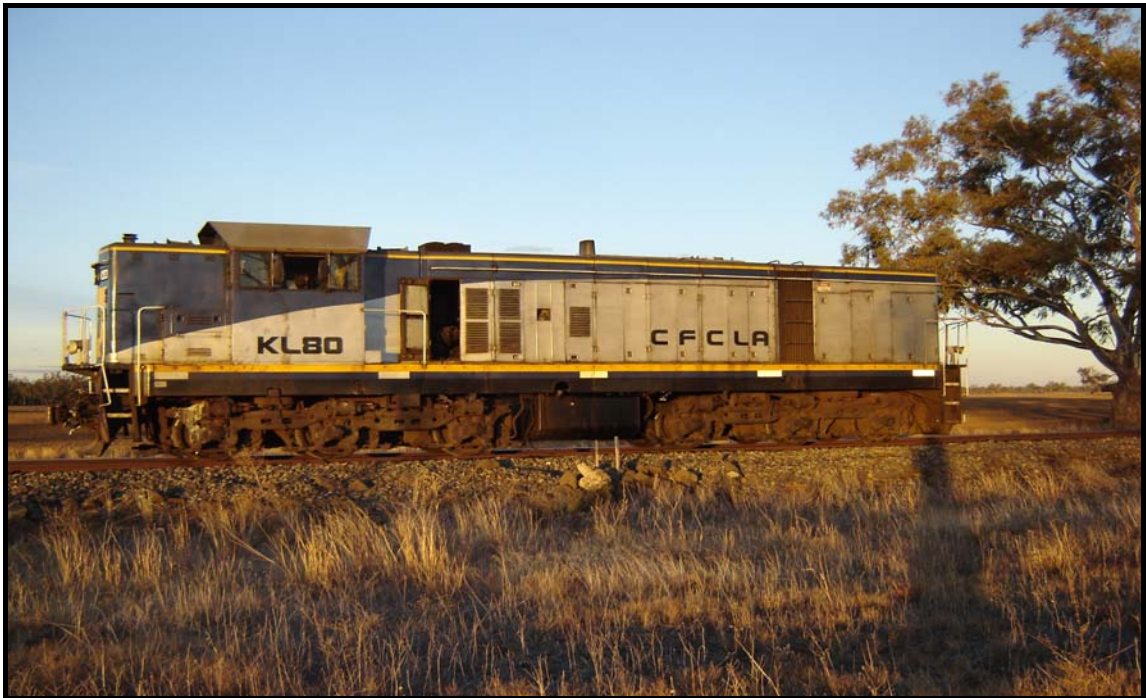
Photo 2: Locomotive KL80 (designated as Train D386)

- 2.18 Train D386 consisted of a single ex-49 Class branch line locomotive with the identification number KL80, which had been leased from Chicago Freight Car Leasing Australia Pty Ltd (CFCLA) by ARG on 31 May 2005. The locomotive is a six-axle, diesel-electric manufactured at Clyde Engineering, Granville, NSW and came into service in 1960. The locomotive measures 15.4m in length and has a mass of 81 tonnes.
- 2.19 The locomotive was painted in CFCLA livery: blue and silver with gold stripes and white reflective patches spaced at regular intervals along each side at eye level, as shown in *Photo 2*. Locomotive warning devices included an air-operated horn mounted on top of the locomotive body, with standard headlight

and marker light configurations. The reflective markings and the warning devices met the relevant operating and safety standards.

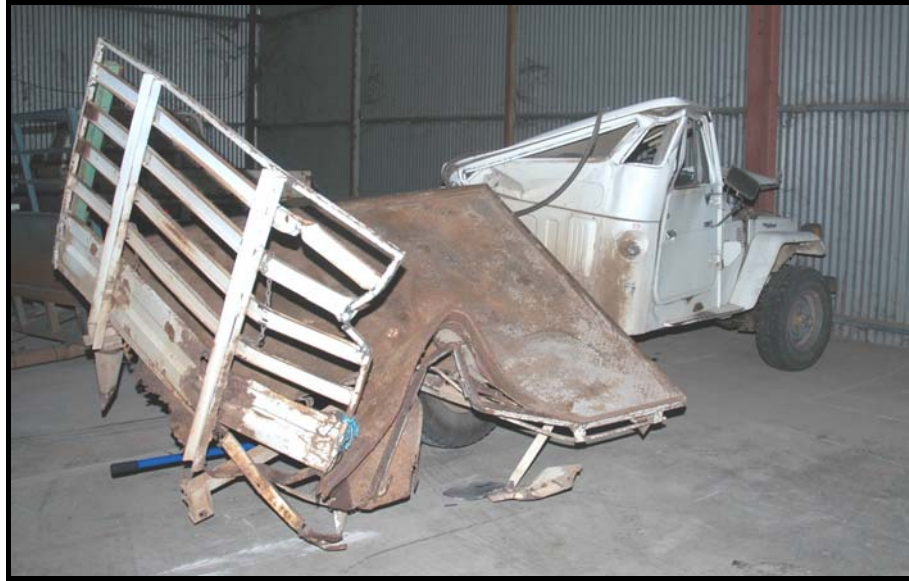
Photo 4: Toyota Landcruiser and Tray

- 2.25 The motor vehicle involved in the collision was a white 1983 Toyota Landcruiser (HJ 47 series, NSW registration URL-171) with a cab and chassis configuration. A flat, steel tray was attached to the chassis. The vehicle was registered until 3 November 2005 and it had 348,002 km showing on its odometer. A photo of the motor vehicle after the collision can be seen in *Photo 4*. However, it should be noted however that the tray, as depicted, is in reverse of its normal position, i.e., the tray barrier would normally be immediately behind the cabin.

- 2.26 The Landcruiser had an overall length of 4.7m, a wheel base of 2.9 m and a gross vehicle mass of 3.7 tonnes. The engine was a 4-litre, 6-cylinder diesel with vacuum assisted, dual circuit hydraulic disc brakes at the front and drum brakes at the rear.
- 2.27 The Australian-made steel trailer, as shown in *Photo 5*, was manufactured in April 1998 and measured 5.1m in length and 2.1m in width. The trailer's identification plate indicated a mass of 2.0 tonnes. Both the vehicle and trailer were only carrying a few light farming items and some small containers of fuel.

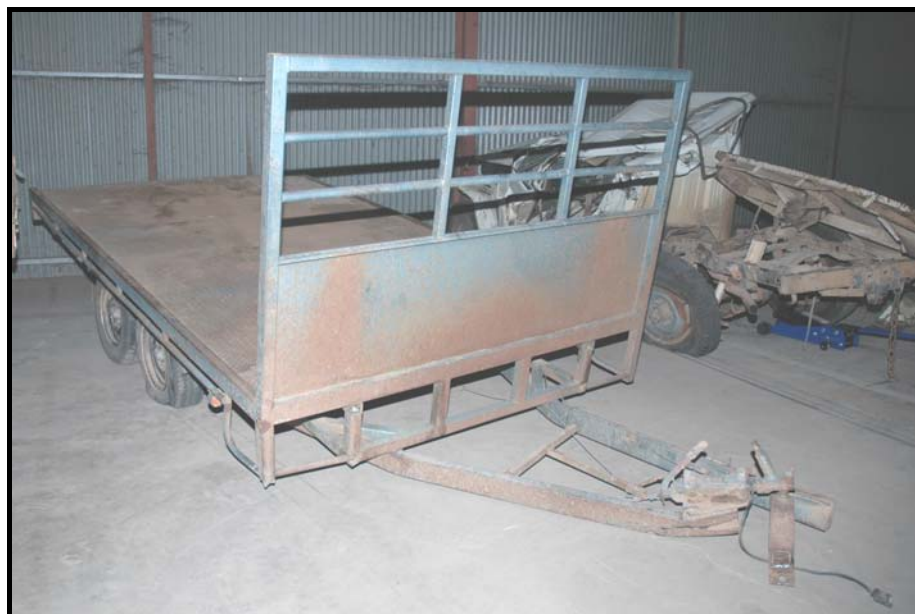
Photo 5: Trailer

- 3.2 The Landcruiser was of a type and model typically operated by many farmers in NSW. It was in a serviceable condition and had functioning brakes. The tyres on both the Landcruiser and the trailer were within standards and all had adequate tread depth. However, braking would not have been assisted by the trailer's brakes which were not properly adjusted.
