RAIL SAFETY INVESTIGATION REPORT

FATAL LEVEL CROSSING COLLISION GRAWLIN PLAINS

31 MAY 2005

OTSI File Ref: 04085

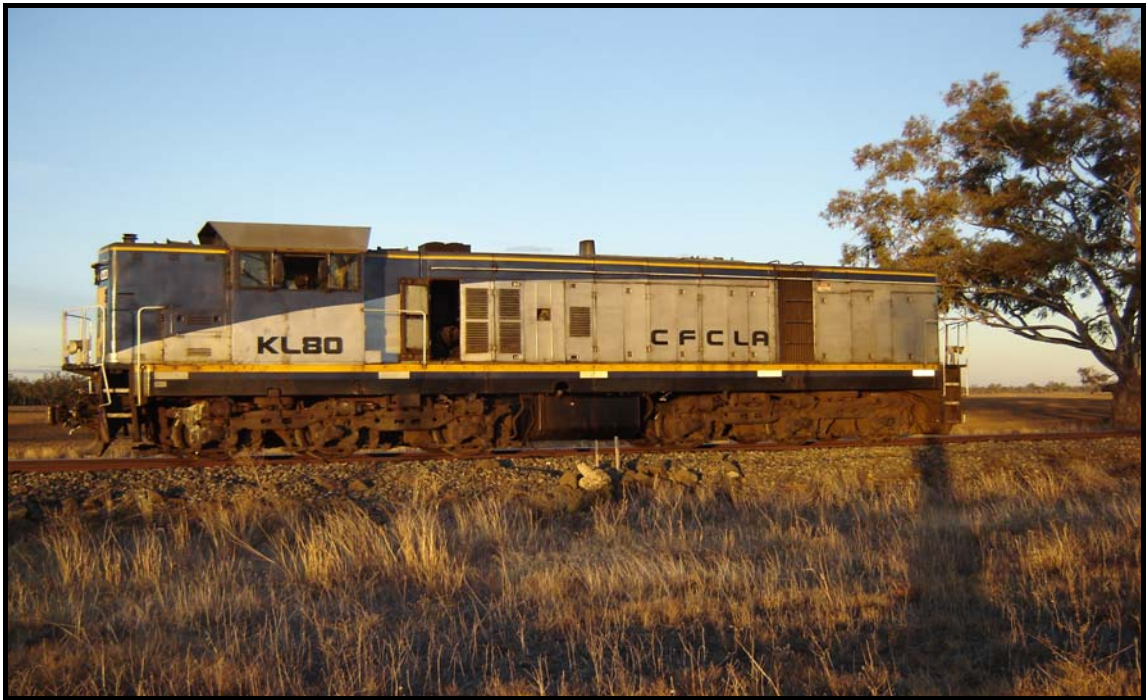
Photo 2: Locomotive KL80 (designated as Train D386)

- 2.18 Train D386 consisted of a single ex-49 Class branch line locomotive with the identification number KL80, which had been leased from Chicago Freight Car Leasing Australia Pty Ltd (CFCLA) by ARG on 31 May 2005. The locomotive is a six-axle, diesel-electric manufactured at Clyde Engineering, Granville, NSW and came into service in 1960. The locomotive measures 15.4m in length and has a mass of 81 tonnes.
- 2.19 The locomotive was painted in CFCLA livery: blue and silver with gold stripes and white reflective patches spaced at regular intervals along each side at eye level, as shown in *Photo 2*. Locomotive warning devices included an air-operated horn mounted on top of the locomotive body, with standard headlight

and marker light configurations. The reflective markings and the warning devices met the relevant operating and safety standards.

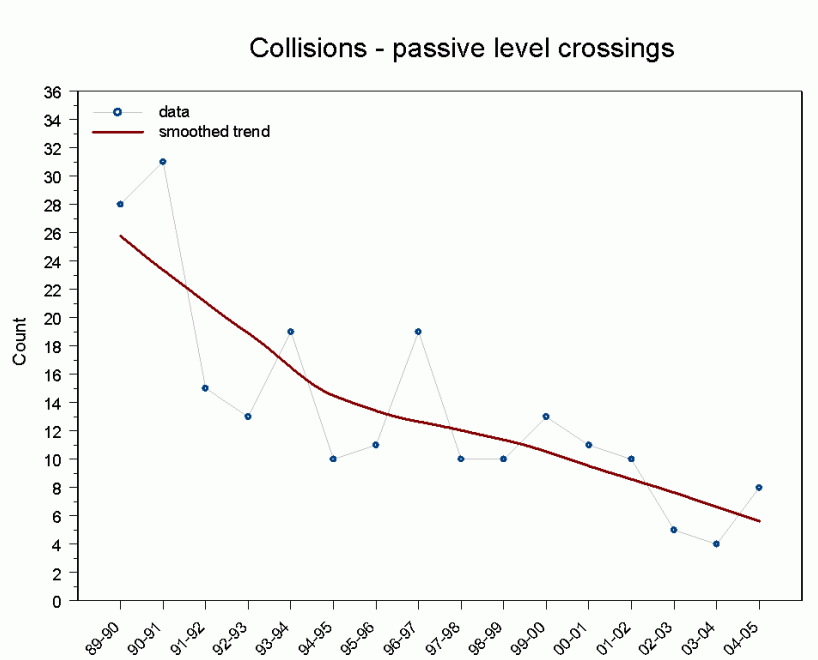
Figure 3: Statistics from NSW Level Crossing Strategy Council

- 3.16 OTSI also reviewed information obtained from the NSW Level Crossing Strategy Council and noted that between 1997 and 2002 though there was an average of 100 level crossing collisions, resulting in an average of 37 fatalities, per year throughout Australia. However, the trend in NSW is downwards, as indicated in *Figure 3*.
