Office of Transport Safety Investigations

RAIL SAFETY INVESTIGATION REPORT

DERAILMENT OF 4BM7 LIDCOMBE

4 NOVEMBER 2005

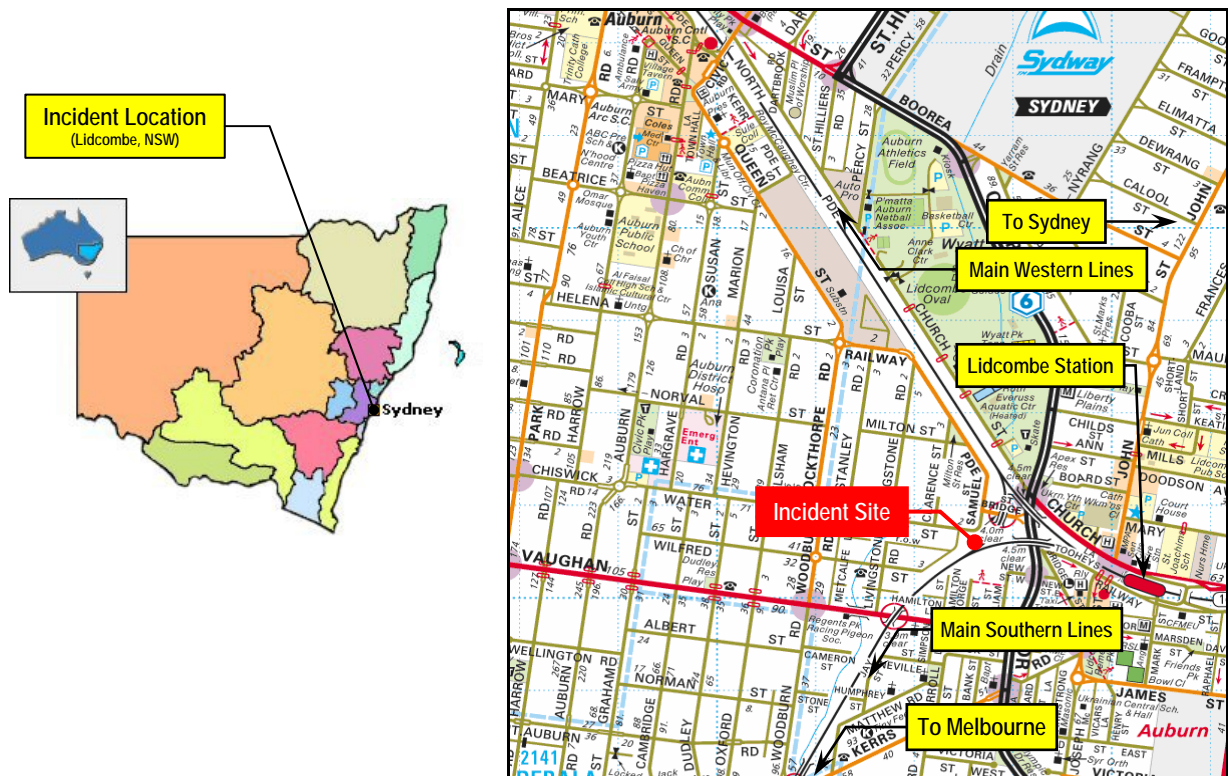
Figure 2: Incident Location

- 2.13 Lidcombe is a suburb and major rail junction located 17 kilometres by rail West of Sydney's CBD (see *Figure 2*).

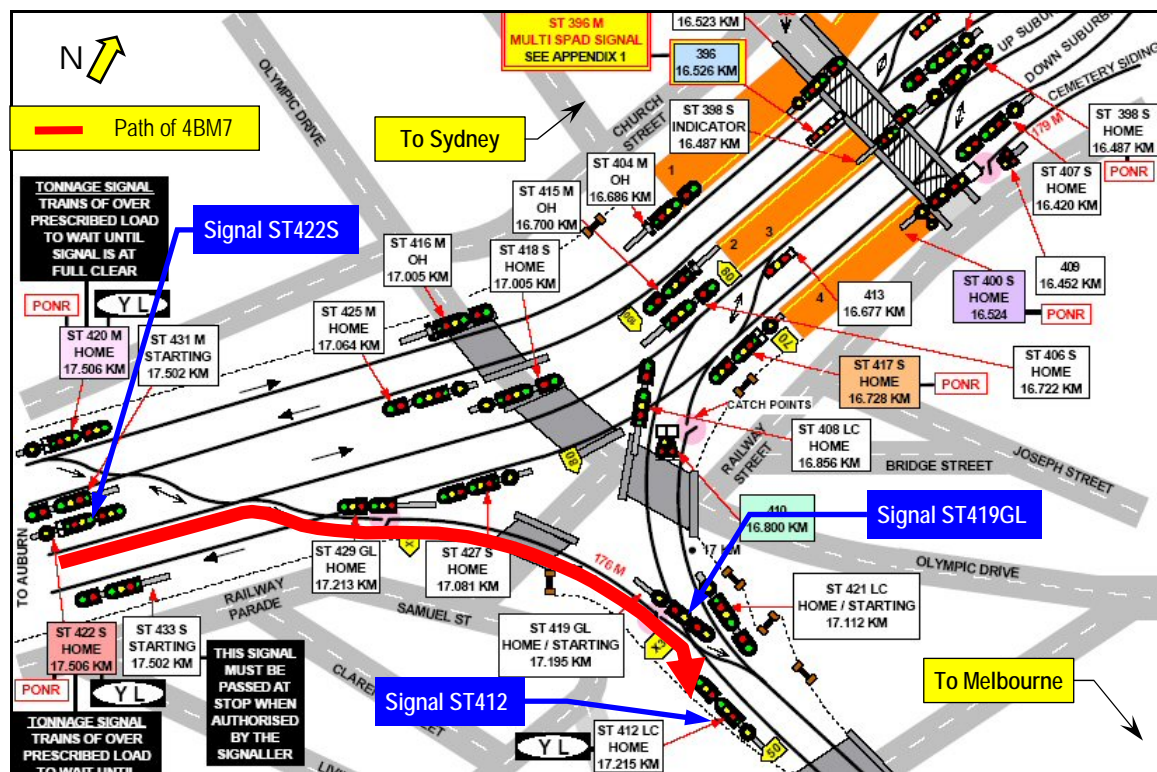
Figure 3: Track arrangement at Lidcombe

2.14 The Lidcombe Goods Loop is part of RailCorp's network and merges with Sydney's Main Western and Southern lines (see Figure 3).

- 2.15 The loop line is an electrified single line track, approximately 176 metres in length and sits on top of an eight metre-high embankment. The track is in close proximity to a number of roads and commercial properties. A bridge spanning a two-lane vehicular thoroughfare is located approximately mid way along the loop line.
