RAIL SAFETY INVESTIGATION REPORT

DERAILMENT OF PACIFIC NATIONAL WHEAT SERVICE 5424 OLD BURREN 6 APRIL 2005

OTSI File Ref: 03724

17 November 2005

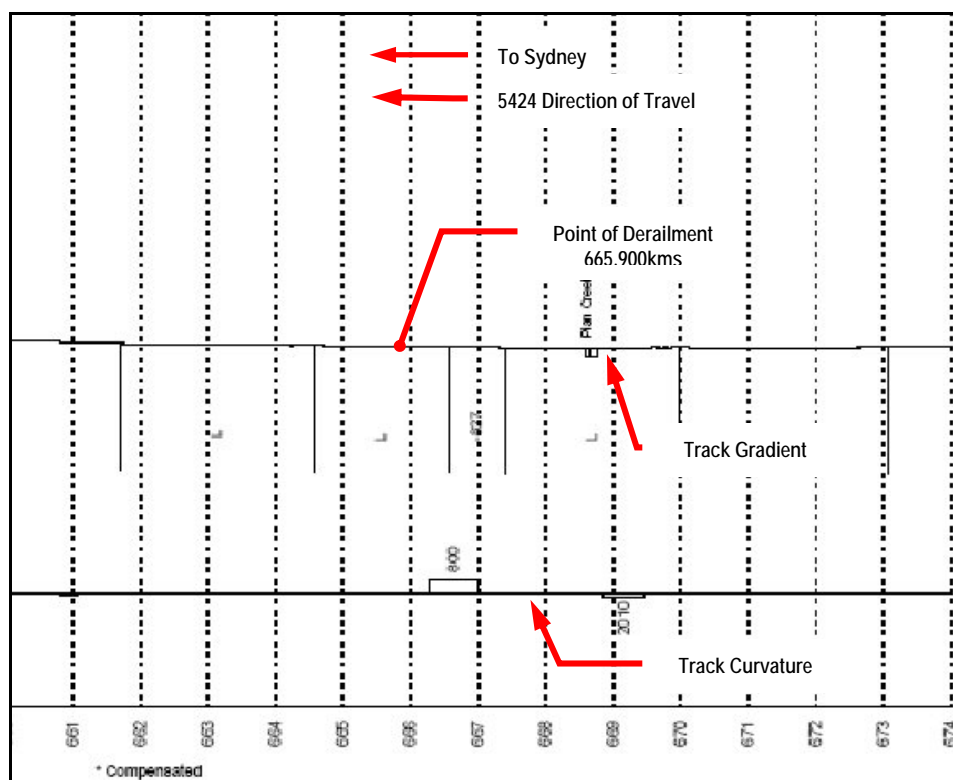
Figure 2: Curve and Gradient Diagram.

- 2.12 The line is standard gauge, single line, with a ruling gradient of 1:456. The immediate area around the incident was level (see Figure 2). The track consisted of 30kg/m (60lb/yd) rail fixed to timber sleepers by dog spikes, and interspersed with irregularly placed steel sleepers. A 40 metre section within the area of the damaged track was fixed to consecutive steel sleepers. These steel sleepers had been installed as part of track repairs from a previous derailment in 2002.
