RAIL SAFETY INVESTIGATION REPORT

SHUNTING FATALITY PORT BOTANY RAIL YARD 1 JULY 2004

1 JULY 2004

OTSI File Ref: 02325

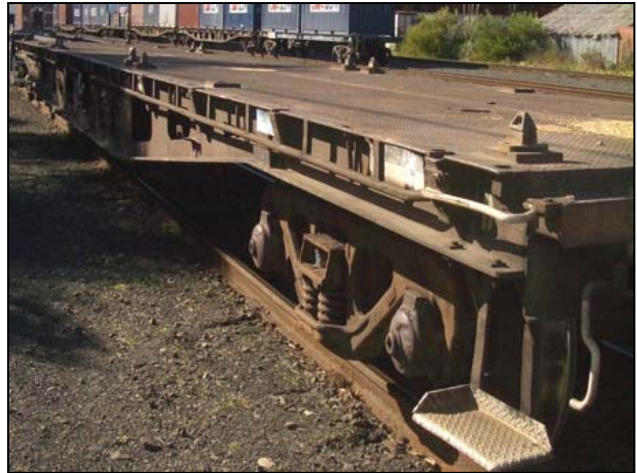
Figure 12 - WQCY type flat top wagon

- 3.14 The wagons being hauled within T250 varied in type. The 2nd last wagon consisted of a skeletal load-bearing frame with two wagon bogies supporting this frame, as depicted in Figures 9, 10 & 11. The limited decking surface on this wagon was noted to be of a smooth painted finish. In contrast, the last wagon on T250 was fully decked with a non-slip chequered plate surface, as depicted in Figure 12. Wagons of this type typically have a ground clearance of 80cm.

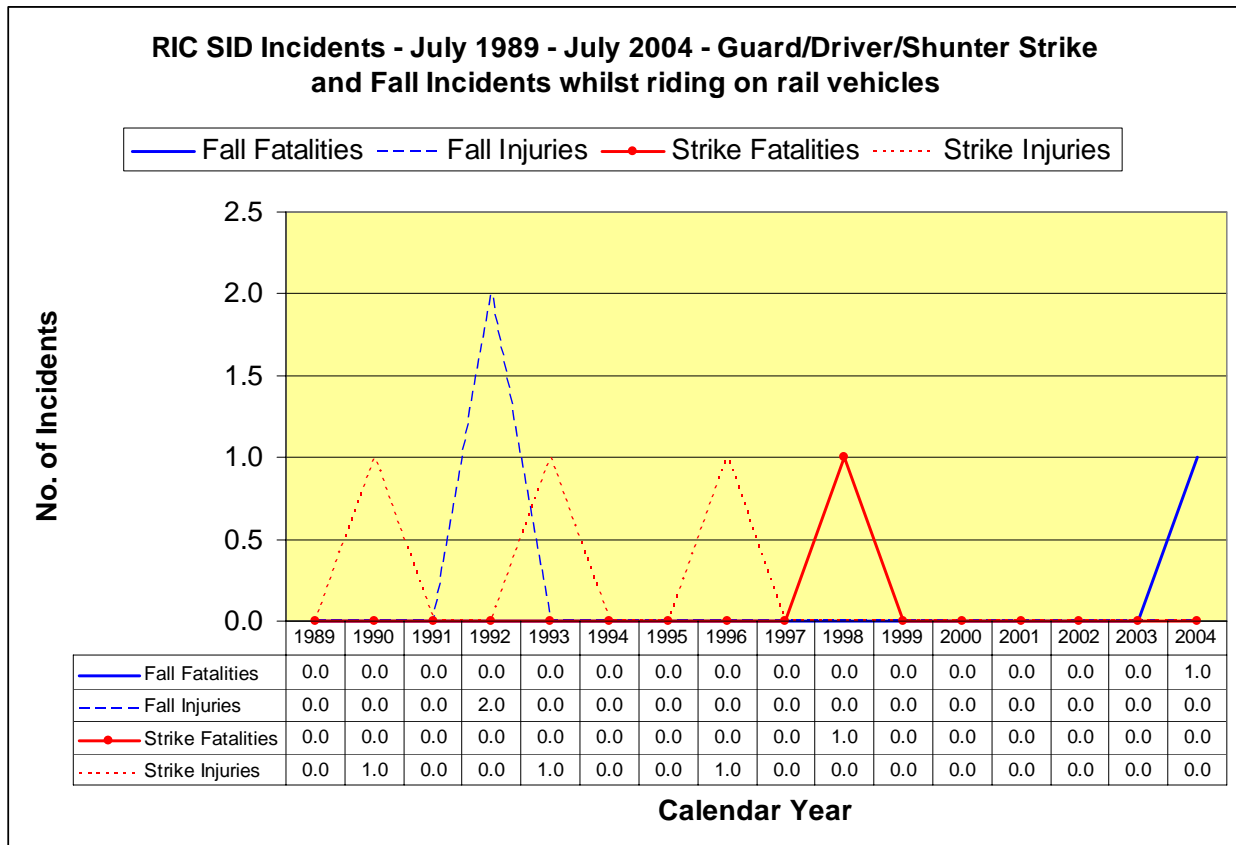
Figure 17 - RIC Safety Incident Database recorded incidents for Driver, Guard or Shunter fall or strike incidents - July 1989 to July 2004

- At the time of the accident Rail Infrastructure Corporation (RIC) maintained a rail safety incident database (SID) that recorded the occurrence of rail safety incidents on the NSW RIC Network. A review of the records in this database revealed 7 incidents where employees were riding on rolling stock whilst undertaking shunting/guard duties that resulted in either injury, serious injury or fatality (see Figure 17 and Table 1). The most significant shunting accident that has been recorded in the SID database prior to the Port Botany accident on 1 July 2004 occurred at Trangie on 27 October 1998 where a shunter was fatally injured whilst conducting a propelling movement. During the movement the shunter was crushed between the wagon that he was riding on and a wagon standing on an adjacent track. As a result of this accident the Safeworking rules prohibited riding on the side of wagons where reduced clearances between vehicles on adjacent tracks existed.
