Rail Safety Investigation Report

ROCKY PONDS

7 November 2002

Pacific National train 4YN2 derailed due to misalignment.

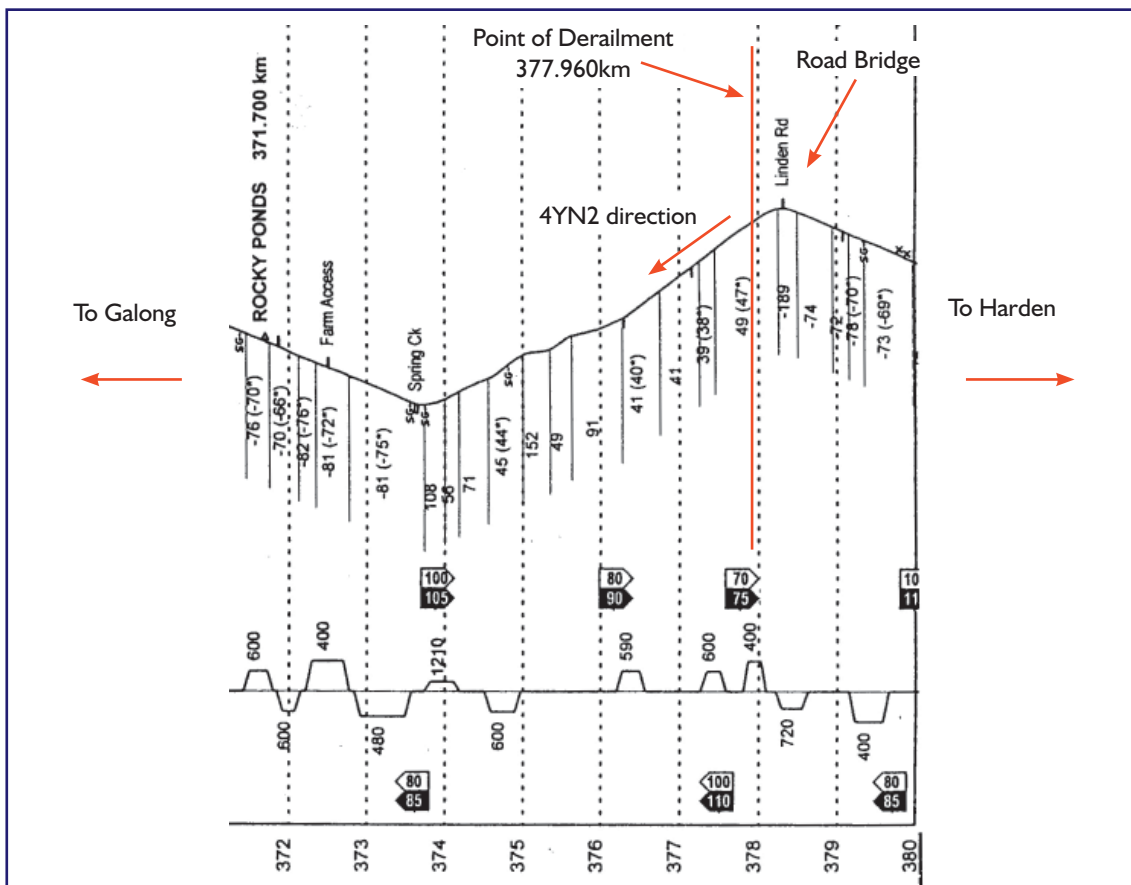
Figure 4.3 Curve and Gradient Diagram

The incident occurred at approximately 16:39 on Thursday 7 November 2002 on the Up Main South at 377.960km. On approach to the incident site 4YN2 had just negotiated a climbing 1:74 grade before traversing the crest of a hill at 378.300km and descending down the 1:49 grade to 377.960km. Just prior to the derailment site, the Driver applied the automatic brake with an 80kPa application in order to control the train speed leading into and on the falling grade. Refer to Figures 4.2 & 4.3 detailing the approaching and departing views to the point of derailment and the applicable curve and gradient diagram describing the derailment location respectively.
