RAIL SAFETY INVESTIGATION REPORT

DERAILMENT OF PACIFIC NATIONAL FREIGHT SERVICES CB76 AND 1WB3

LAPSTONE (CB76) 1 MARCH 2005

WAUCHOPE (1WB3) 7 MARCH 2005

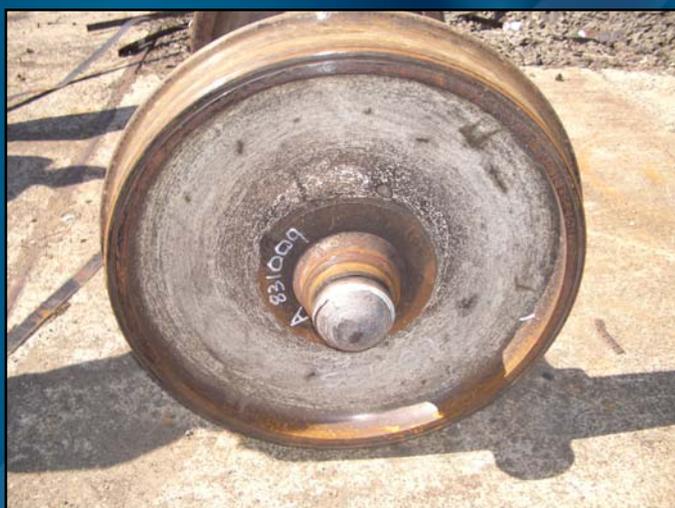
Photo 1 Damaged Wagon on CB76 (Lapstone)

- a. **CB76 (Lapstone).** In addition to the damaged bogie on wagon NHVF 35217U (see *Photo 1*), 436 concrete sleepers between kilometrage 65.770 and 65.200 and guard rail fastenings between 65.515 and 65.535 required replacement. Extensive repairs were also required to the Lapstone emergency crossover and associated signal equipment. In addition, the ballast formation between kilometrage 65.770 and 61.490 required reshaping to be returned to the required formation.

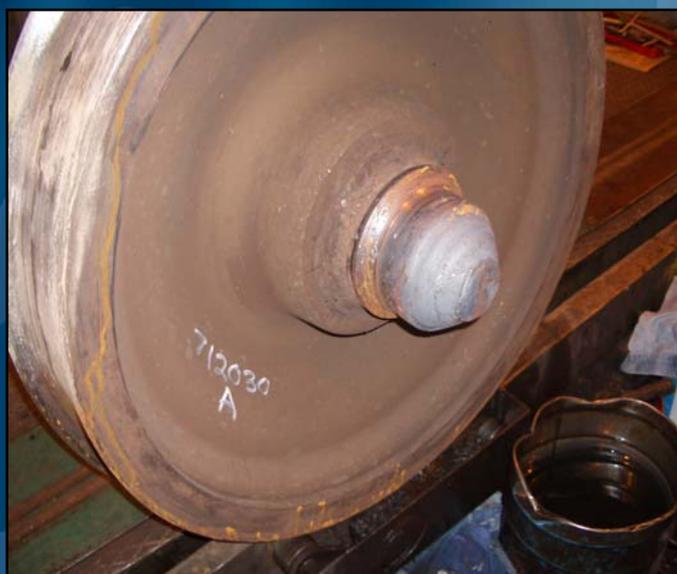
Photo 2 Damaged Wagon on 1WB3 (Wauchope)

- b. **1WB3 (Wauchope).** In addition to the damaged bogie on wagon RKDF 20411Q (see *Photo 2*), approximately 3km of track, between kilometrage 462.111 and 465.200, was extensively damaged. The Saltwater Creek rail bridge, located within the area of track that was affected, was also damaged but to a lesser extent.

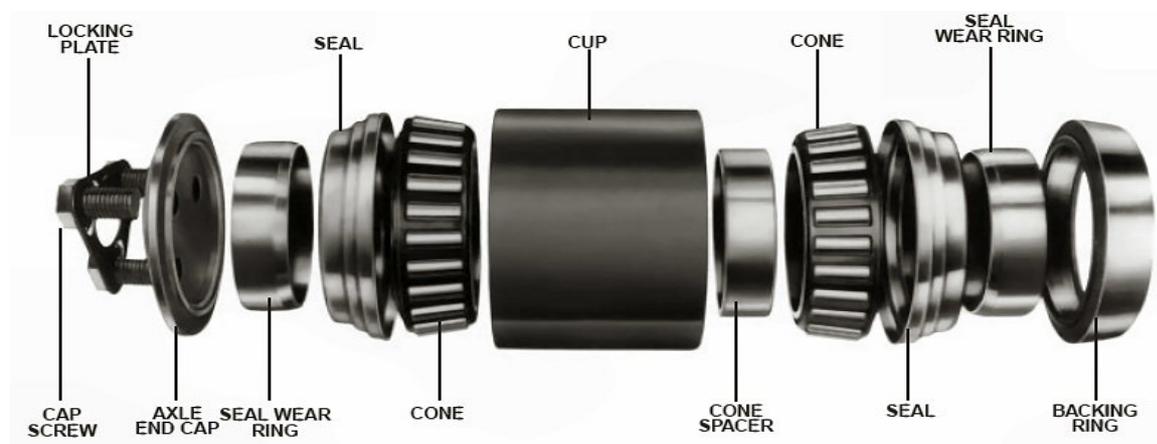
Figure 2 Exploded View of a Typical PUB

- 3.22 A fourth specialist eliminated the possibility that the failure was caused by a loss of interference/contact in/on the axle. OTSI's consideration of the specialist advice was also informed by technical commentary from a specialist within ITSRR. PN believes that the most likely cause of failure was ingress of water whilst the wagon underwent high pressure-cleaning. There were indications that the inner workings of the failed PUB on 1WB3 might also have been penetrated or that there may have been a loss of interference. This latter indication suggests that the inner 'race'¹³ on the outer cone, i.e., the left-hand cone depicted in *Figure 2*, which is not intended to rotate, had done so.
