Rail Safety Investigation Report

YASS JUNCTION

19 November 2002

Pacific National train G9821 derailed due to misalignment.

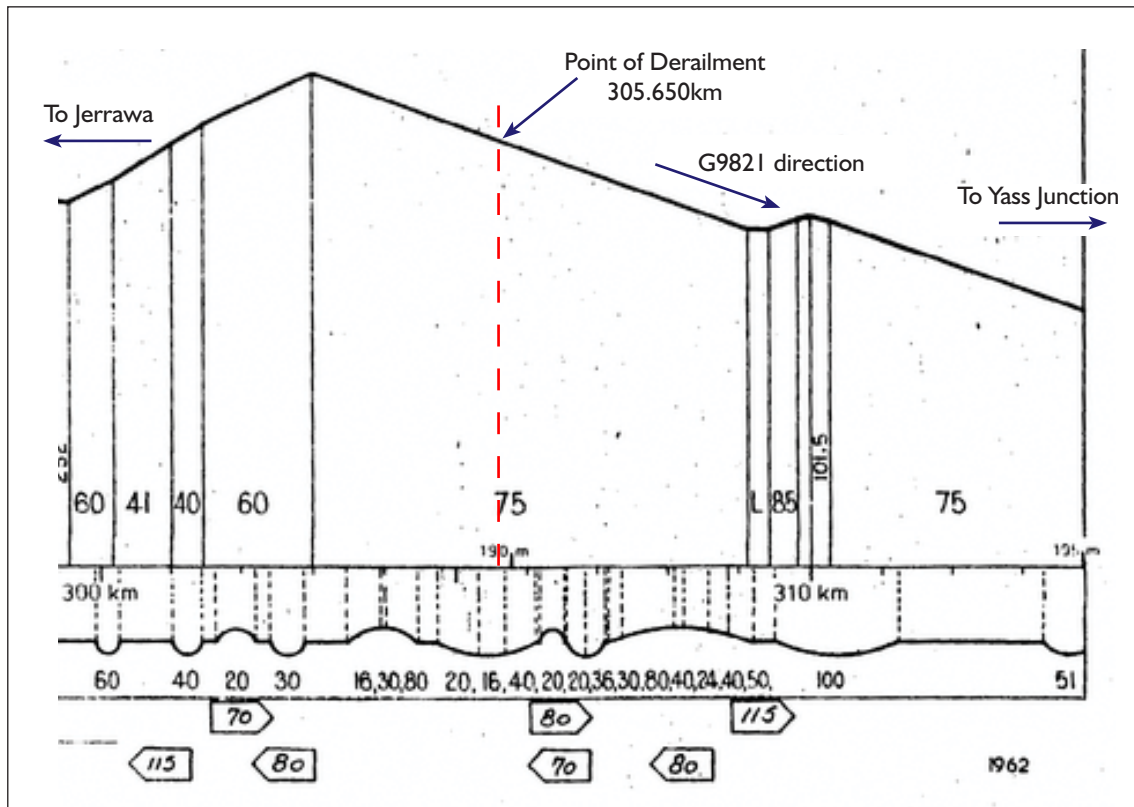
Figure 4.3 Curve and Gradient Diagram

The incident occurred at approximately 15:10 at 305.650km where the leading bogies of the 23rd, 25th, 26th, 30th and 39th positioned vehicles derailed. Shortly after the derailment (309.000km) the Driver became aware that the train was not handling in the normal manner. The Driver then checked the rear of his train and detected dust emanating from the rear. The Observer also confirmed the presence of an abnormal amount of dust at the train's rear. As a result of this observation the Driver then applied the automatic air brake³ with a minimum reduction, effectively bringing G9821 to a stand at 311.700km.

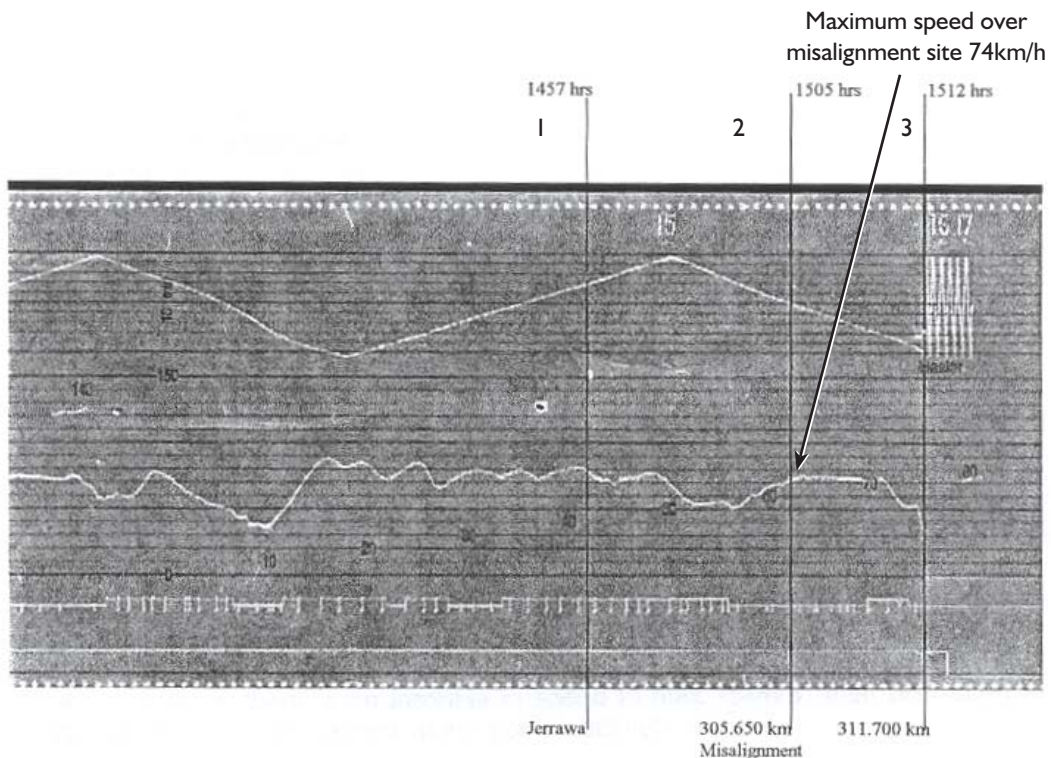
Figure 4.6 G9821 data logger print out 19 November 2002

Figure 4.6 below identifies the Hasler print-out for G9821 with reference lines 1 to 3, where these reference lines correspond to the ID data 1 to 3 in the table above.

Figure 4.6 above confirms that the rear section of G9821 was travelling at approximately 74km/h at the time of derailment.
