Office of Transport Safety Investigations

RAIL SAFETY INVESTIGATION REPORT

DERAILMENT OF PACIFIC NATIONAL TRAIN 7SP5

16 OCTOBER 2005

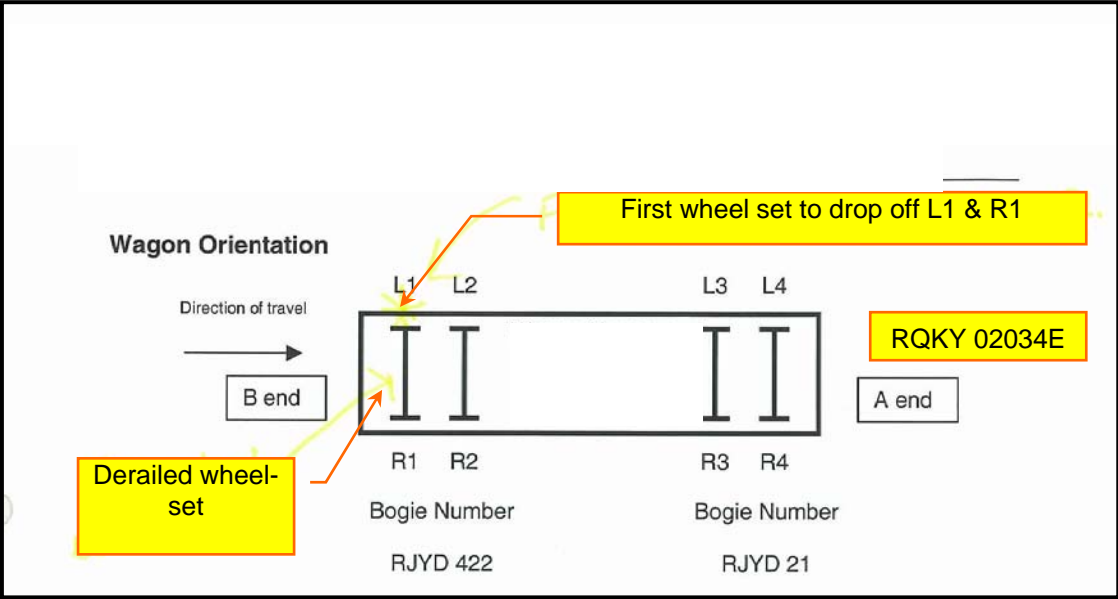
Figure 2: Diagrammatic representation of the wheel sets on the two bogies beneath wagon RQKY 02034E

- 2.1 An inspection of the track revealed markings on the 'Down' rail consistent with a wheel mounting the rail at 781.286km (point of mount (POM)) and dropping off the rail at 781.295km (point of derailment (POD)) (see *Photo 2*). The damage to the wagon showed that it was only the rear wheel set of the rear bogie, RJYD 422, that derailed. The train travelled a further 34.803km before the wheel set re-railed as revealed by marks on the pavement at the Cobb Highway level crossing near Ivanhoe.
- 2.2 In a derailment it is expected there will be evidence, in the form of marks or gouging, of the derailing wheel/s climbing the rail at and prior to the POM. No such signs or marks were found during an inspection of the site by both ARTC and PN representatives.

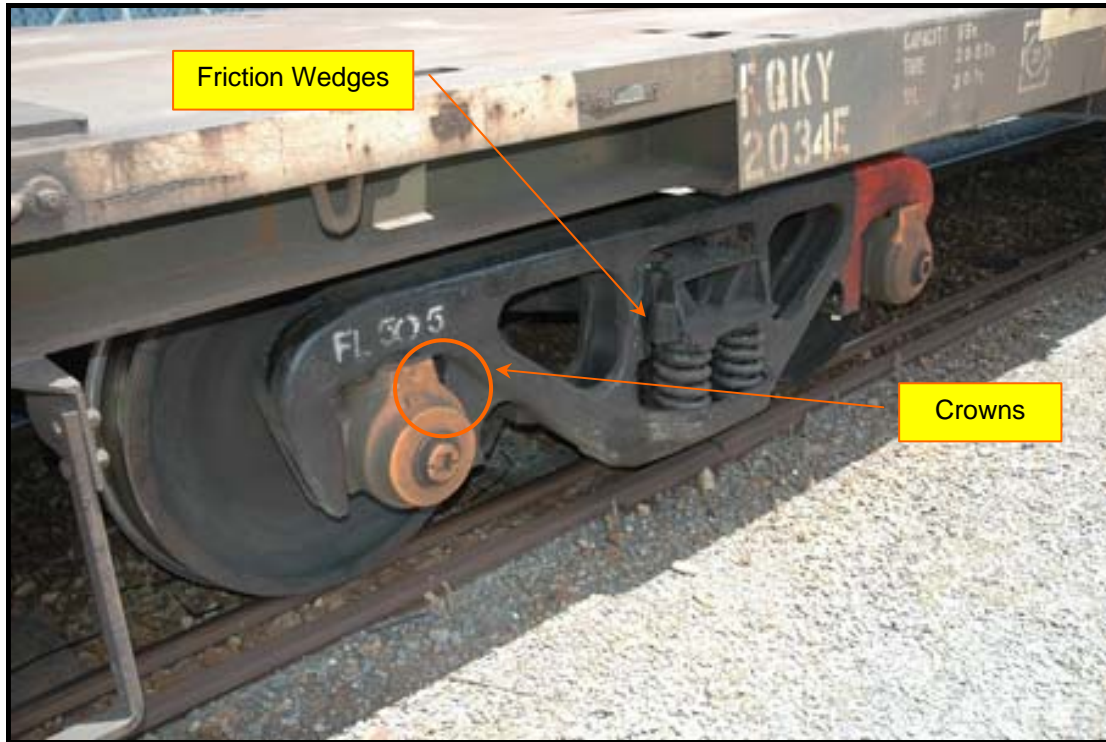
Photo 4: Wagon RQKY 02034E after repairs in December 2005

- 2.3 Wagon RQKY 02034E is typical of the type of flat top wagons utilised for the transportation of containers (see Specifications at *Appendix 6* and bogie details at *Photo 4* and *Figure 3*).

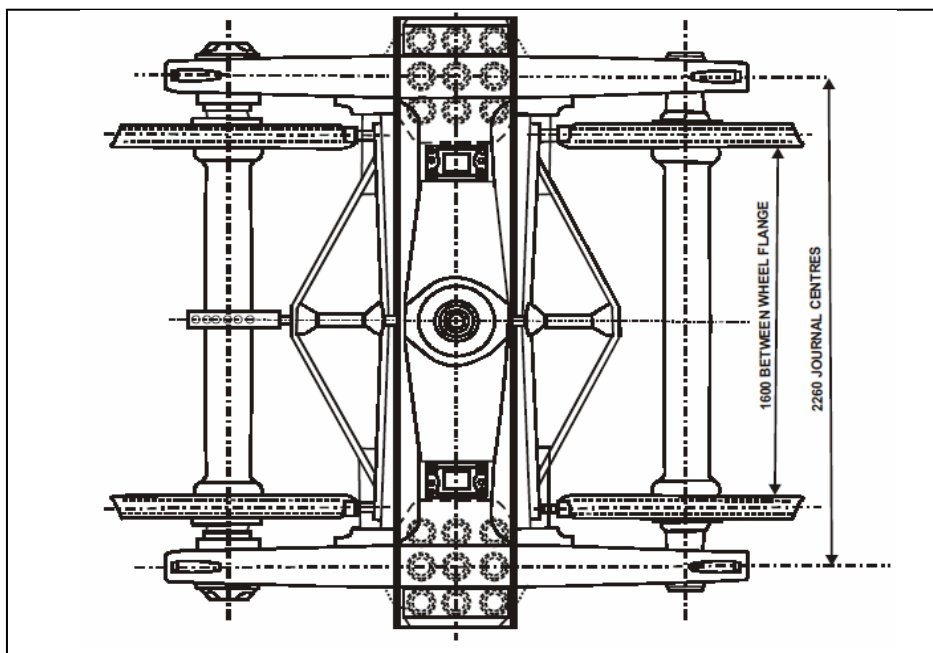
Figure 3: Bogie schematic showing location of constant contact side bearers

- 2.4 The flanges of the wheels of the rear wheel set of the rear bogie of the wagon were worn but within the required tolerances. The flange wear was consistent with the application of considerable lateral forces acting on the wagon over time.

- 2.5 On request, PN completed a report on the condition of the bogie (see *Appendix 7*) which included the following points of note:
- almost all bolster gibs showed signs of contact and wear (see *Figure 4* and *Photo 5*);
