## **RAIL SAFETY INVESTIGATION REPORT**

**DERAILMENT OF CITYRAIL SERVICE 312A**

**THIRROUL**

**11 SEPTEMBER 2006**

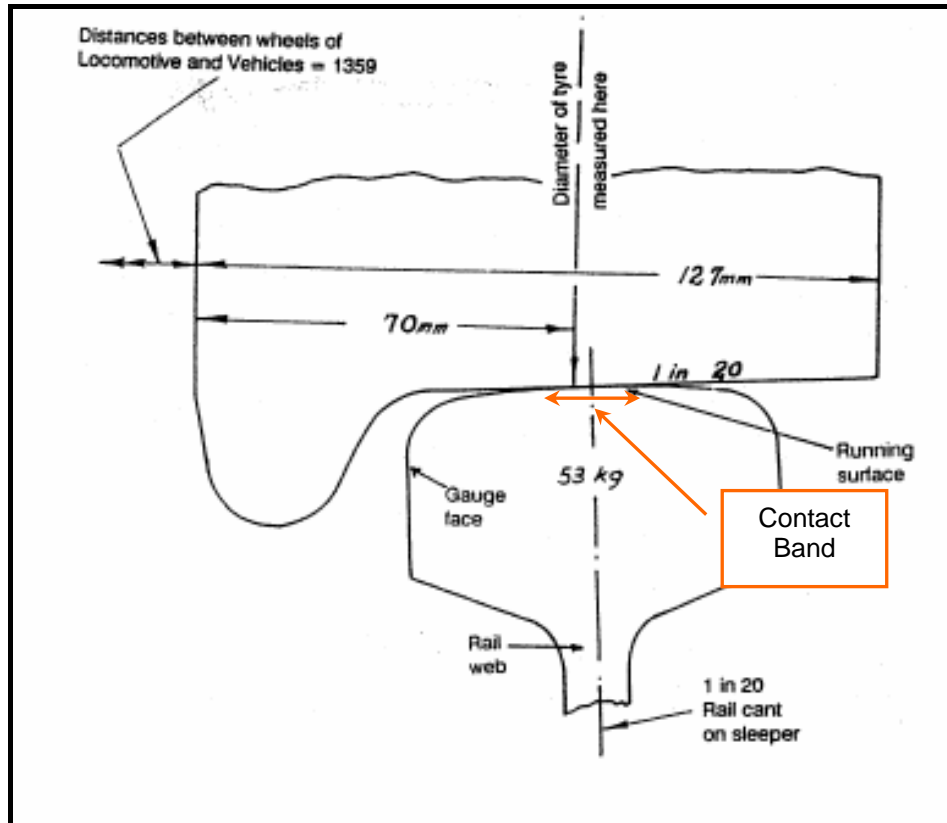
Figure 3: Wheel Rail Contact Band.

2.12. In addition to having a clean running surface, effective braking is dependent upon proper contact between a train's wheels and the rail. This requires that the profiles of both the wheels and the rail fall within specified parameters. Provided they do, a band of contact is established through which braking effort can be transferred onto the track. This 'contact band' is depicted in *Figure 3*. The contact band on the No. 3 Platform track varied between 20-50mm and as such was within acceptable parameters.

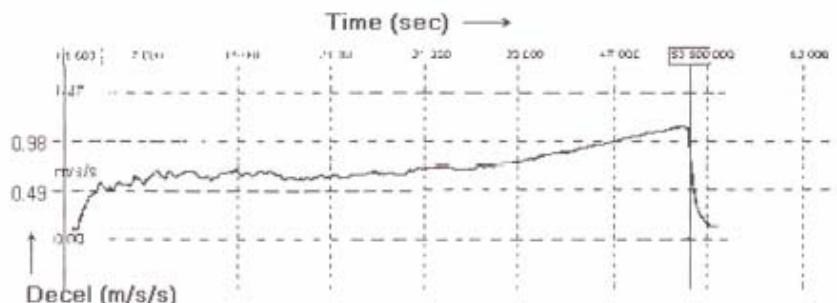
Fig A Typical DDS Full Service EP Brake Application from 110 km/h

Tread-braked rolling stock (DDS/DDIC) has a frictional characteristic that tends to climb as speed reduces. With temperature rise, this characteristic usually becomes more pronounced. Lower friction exists at high-speed, and greater friction towards the end of the braking application, with the climb starting at about 40 km/h, see example deceleration trace below.
