Bus Safety Investigation Report

Woodpark

3 March 2004

Air brake failure on bus resulting in a collision.

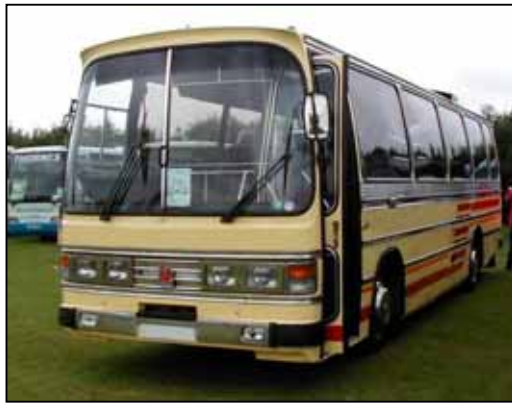
3.15 Bus Type

Manufacturer:	Bedford	Tare:	6900 kg
Model:	YLQ	GVM:	10180 kg
Date of manufacture:	January 1980	Type:	Charter
Registration number:	MO8053	Seating capacity:	55
State:	NSW	Passengers:	64

- 3.16 Bus Condition. The RTA inspected MO8053, for the purpose of re-registration, on 19 February 2004 and issued a defect notice (A5500283553) in relation to the following matters:
- inoperative left side parking light;
 - insecure seat and seat base, and
 - the interior roof light was dull.²
