## BUS SAFETY INVESTIGATION REPORT

SYSTEMIC INVESTIGATION INTO AN ALLEGED 'BLIND SPOT' ON MARK II AND MARK III MERCEDES-BADGED BUSES OPERATED BY THE STATE TRANSIT AUTHORITY.

**OTSI File Ref: 03004**

**27 September 2005**

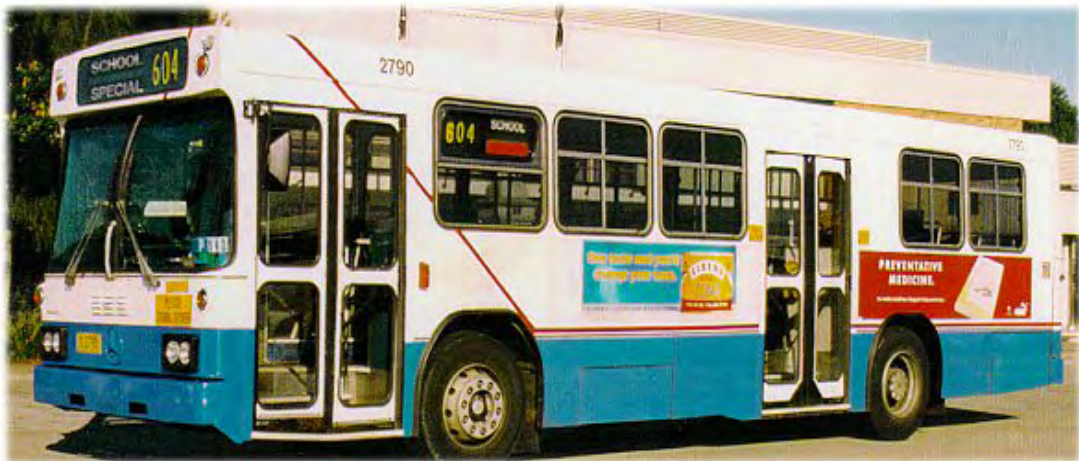
Photograph 3 - Mk IV "Mercedes"

4.4 More contemporary bus designs have narrower 'A' pillars, or an 'A' pillar incorporated into a triangular peep-window, thereby providing bus drivers with an improved field of vision. These design features are apparent in Photographs 3 and 4 of STA's Mercedes Mk IV and Scania variants below.
