Office of Transport Safety Investigations

BUS SAFETY REPORT

BUS FIRES IN NEW SOUTH WALES IN 2013

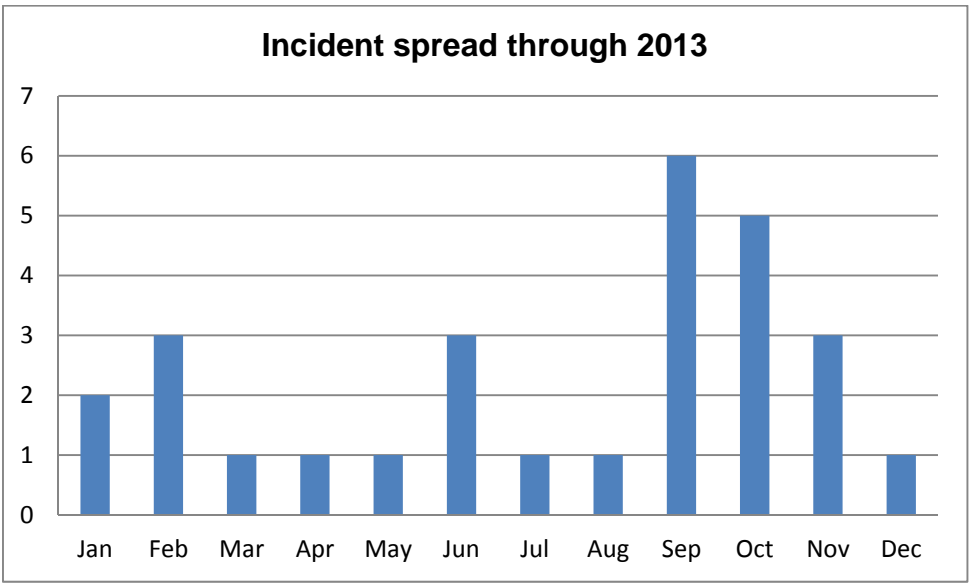
Figure 1

and three in November (see Figure1). This is not a pattern that has been identified previously so may be purely coincidental.

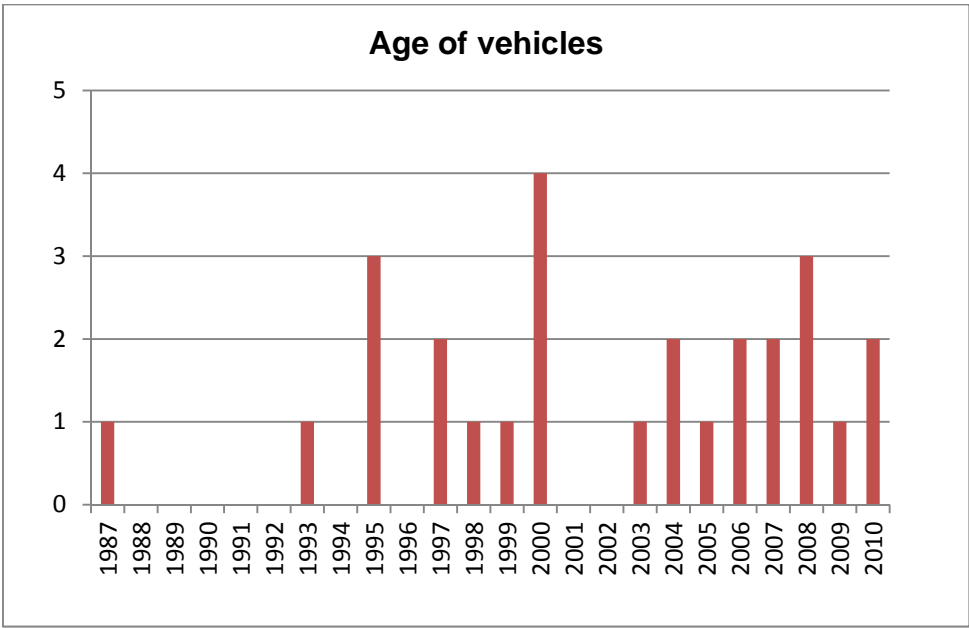
Figure 2

Apart from one 1987 model bus, the ages of the buses involved ranged from three to 20 years (see Figure 2) and eight different makes of vehicle were involved. The majority of buses (75%) were diesel-fuelled; the remainder were CNG-fuelled. There were no incidents involving fuel on the seven CNG-fuelled buses; six of those fires involved the coolant system and the other involved sticking brakes.

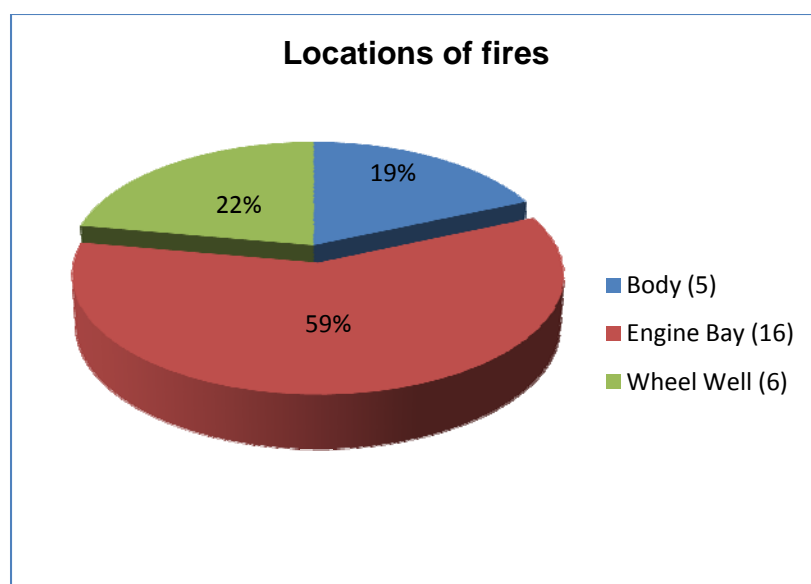
Figure 3

Sixteen fires originated in the engine bay, six in a wheel well and five in another location within the body of the vehicle (see Figure 3). (The vehicle destroyed in an arson attack has not been included in these figures.) There were no instances of fires caused by debris being caught up in a vehicle as had occurred on several previous occasions.

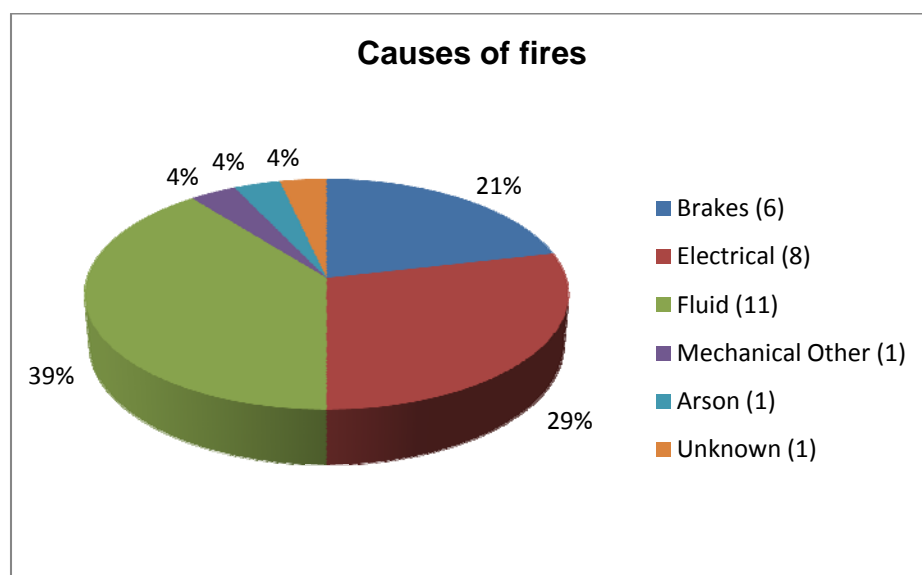
Figure 4

The data for the causes of fires is shown in Figure 4. Apart from the main three causes and arson, one could not be established definitively due to the extent of damage and one was caused by mechanical failure of the intercooler bearing.
