FERRY SAFETY INVESTIGATION REPORT

FERRY *FRESHWATER* COLLISION

WHARVES 4 & 5 CIRCULAR QUAY, NSW

4 JANUARY 2018

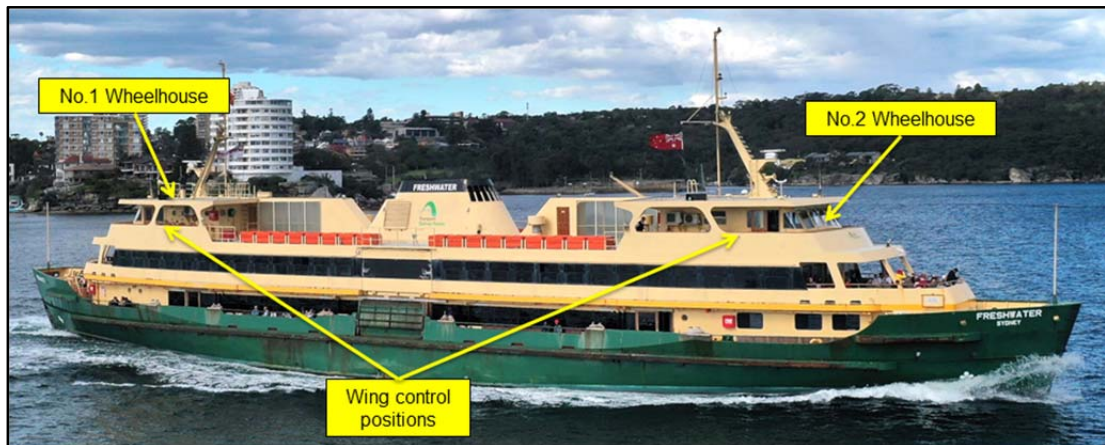
Figure 7: *Freshwater*

1.31 *Freshwater* is a 70 metre (m) long double-ended ferry with a 12.5 m beam⁹ and a displacement of 1140 tonnes (see *Figure 7*). The vessel has a steel hull and aluminium on steel superstructure. It is powered by two 2206 kW diesel engines which drive fully feathering, controllable pitch propellers at either end of the vessel. A rudder is fitted to each end and normal service speed is 14 knots on one engine (see *Figure 8*).

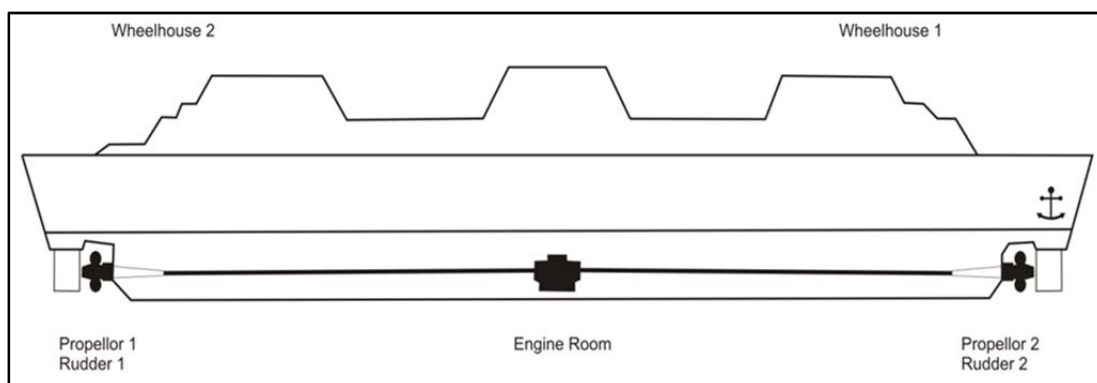
Figure 8: *Freshwater* Double ended controls

- 1.33 Once the ferry has departed a wharf, a helmsman, under the master's direction, navigates *Freshwater* from the wheelhouse at the bow of the direction they are travelling. When the ferry nears its destination, the master takes over direct control of the ferry. When the ferry begins the final stages of berthing, the master moves to a wing position to control the ferry. The wing positions, located either side of the wheelhouse, provide a superior view of the wharf and crew during the berthing process (see *Figure 7*).

- 1.34 Once relieved by the master, the helmsman moves to the wing position to prepare it for berthing.
- 1.35 The master navigates the ferry by entering steering commands to a helm toggle. Engine power and direction of travel are entered via a single telegraph lever, known as the "X-Y lever". These commands are transmitted electronically to the engines and rudders (see *Figure 9*).

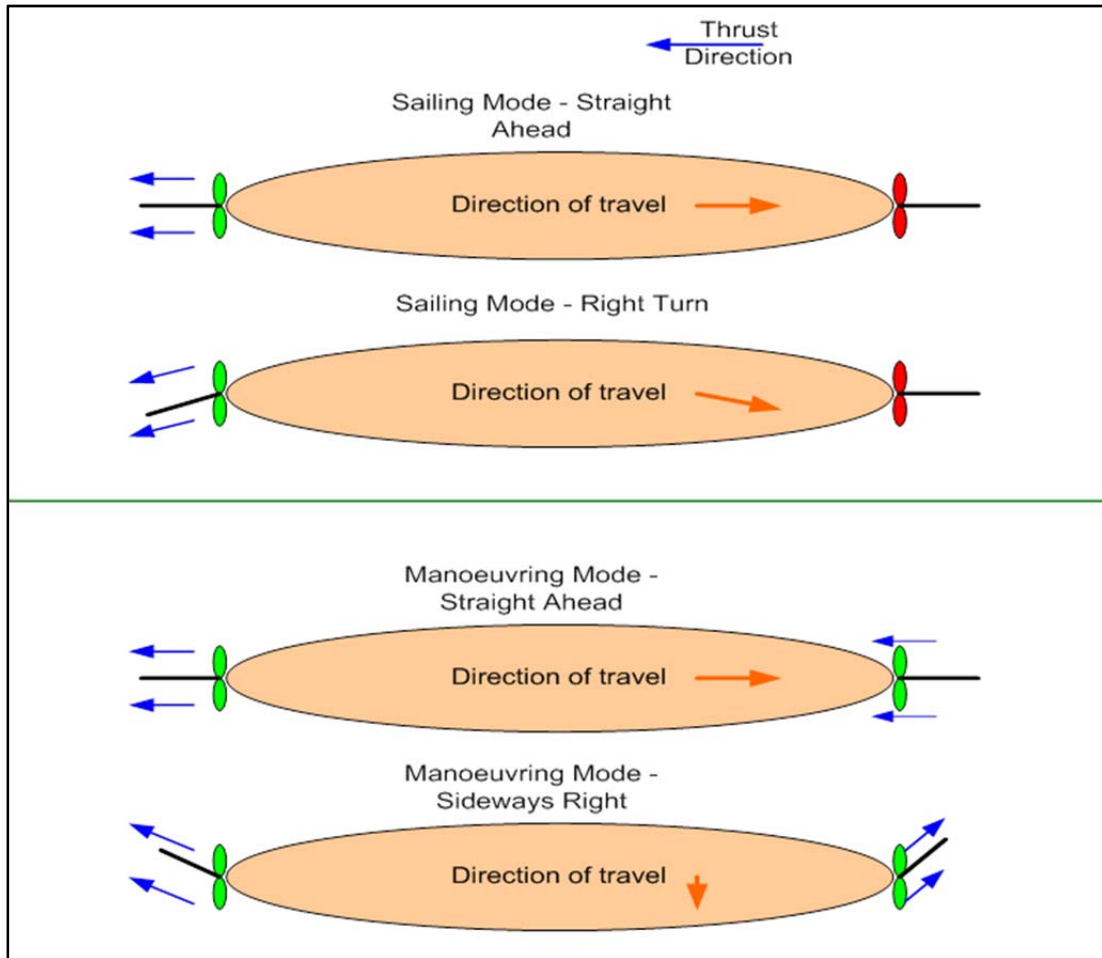
Figure 10: *Freshwater* propulsion modes

- 1.37 Manoeuvring mode is engaged when the vessel is required to be berthed or otherwise manoeuvred in close proximity to objects at low speed. In manoeuvring mode, the bow propeller blades are rotated from the feathered position to a coarse pitch. The rotation of the propeller blades to a coarse pitch causes the propeller shaft to rotate, due to the force of the water flowing over the blades. Once the propeller blades fully rotate to a coarse pitch, the clutch is engaged allowing both bow and stern propellers to provide thrust.

- 1.38 In manoeuvring mode, both rudders and propellers work in conjunction to increase manoeuvrability (including sideways movement) and stopping performance (see *Figure 10*). The transition from one mode to the other takes approximately 17 seconds.

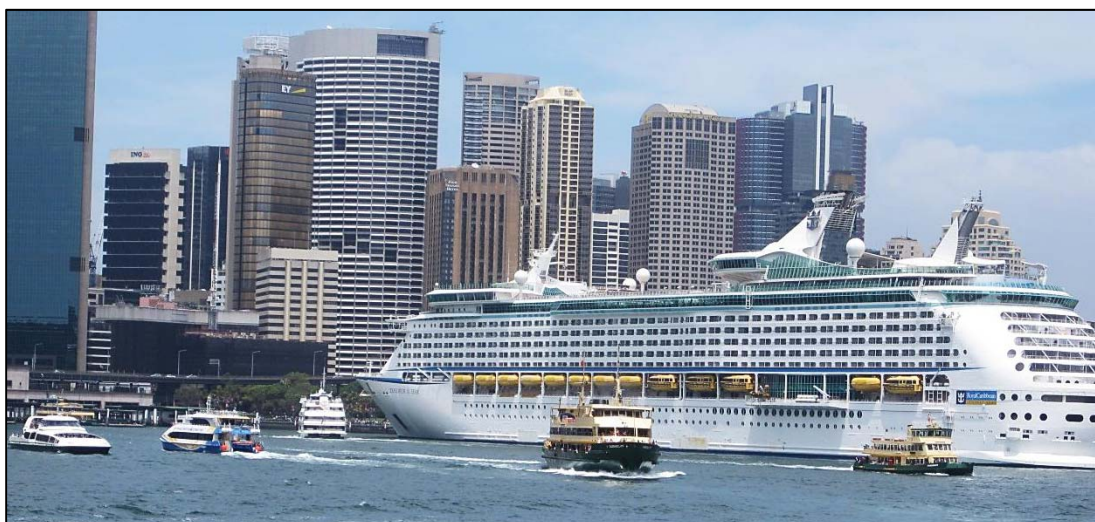
Figure 11: *Explorer of the Seas* with a *Freshwater* class ferry in the foreground

- 1.42 *Freshwater* is fitted with Vessel Data Recording System (VDRS)¹² and Automatic Identification System (AIS)¹³. At the time of the incident, AIS data was not recording on the VDRS. No other operational faults were logged by the VDRS.
- 1.43 *Explorer of the Seas* was a 311 m long, 39 m beam ocean liner that displaced 137,308 tonnes. The liner had a passenger capacity of 4290 and 1185 crew (see *Figure 11*).
