FERRY SAFETY INVESTIGATION REPORT

PASSENGER FATALITY – *MV LADY ROSE*

SYDNEY HARBOUR, NSW

2 FEBRUARY 2019

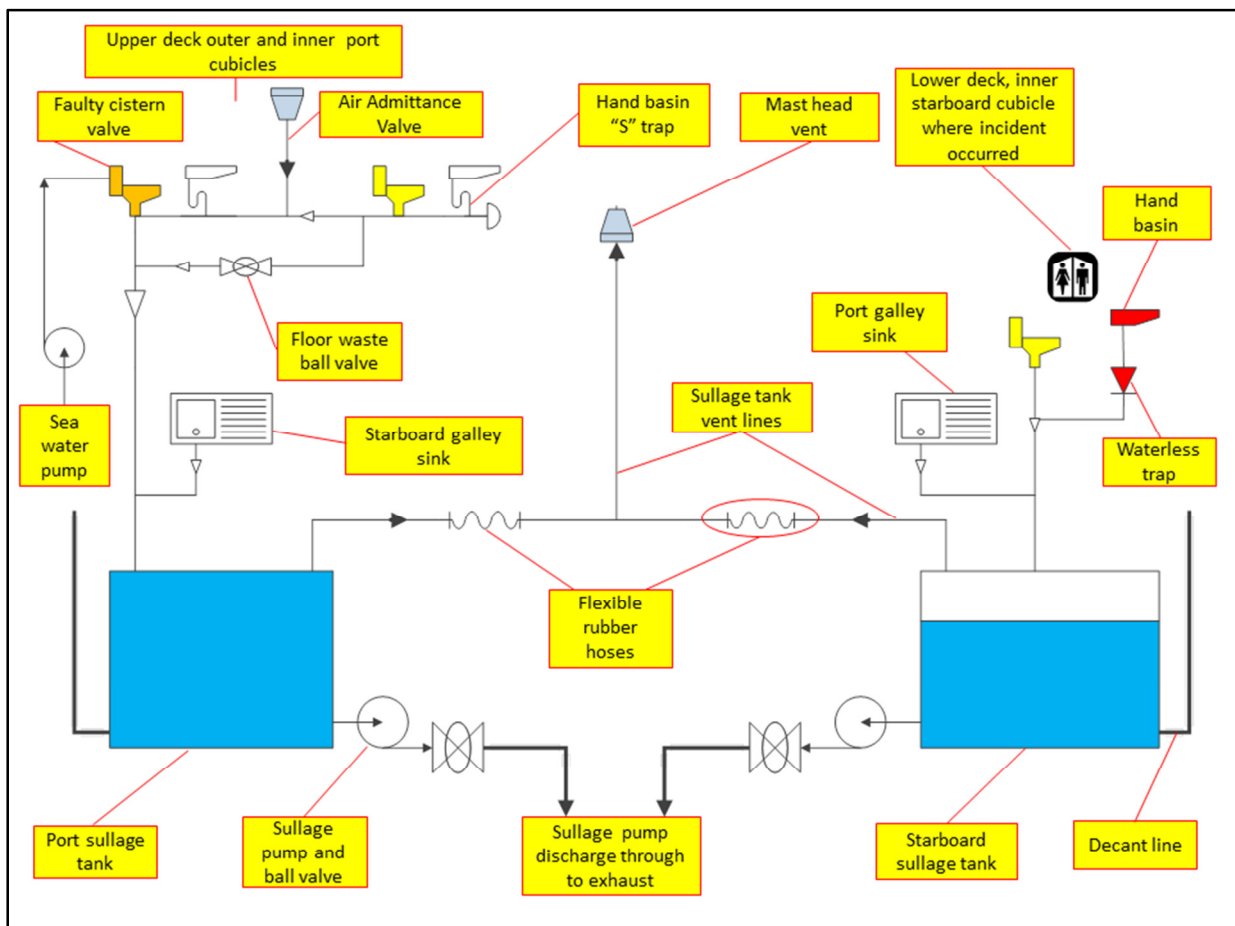
Figure 9: Simplified *Lady Rose* basic sewage system schematic

2.43 *Lady Rose* is fitted with nine toilet cubicles in total; six are located on the lower deck with an additional three on the upper deck. Each are fitted with a flushing toilet, hand basin and floor waste drain. The schematic in *Figure 9* provides a simplified layout of the system showing only the toilet cubicles that are relevant to the investigation.

- 2.47 The port and starboard sullage tanks are vented to atmosphere via a network of pipes. A vent pipe runs horizontally between the two tanks which join in the centre to a vertical pipe at a three way junction. Each of the horizontal pipes had a section of flexible rubber hose fitted (refer to *Figures 9 and 12*).

- 2.78 The exception to this is the AAV fitted to the sewer line joining the two toilets on the upper portside deck (refer to *Figure 9*). It is likely the AAV was installed sometime after *Lady Rose* was constructed to alleviate what was most likely an odour problem with these toilets due to line vacuum caused by the flushing of the toilets.
- 2.79 The AAV fitted to the upper portside sewer line provided venting to the six portside toilets. This one-way valve addresses vacuum in the drainage system created when a toilet was flushed. This prevented vacuum from drawing water from the conventional S traps which could allow sewer gases to bypass the trap (refer to *Figure 20*).

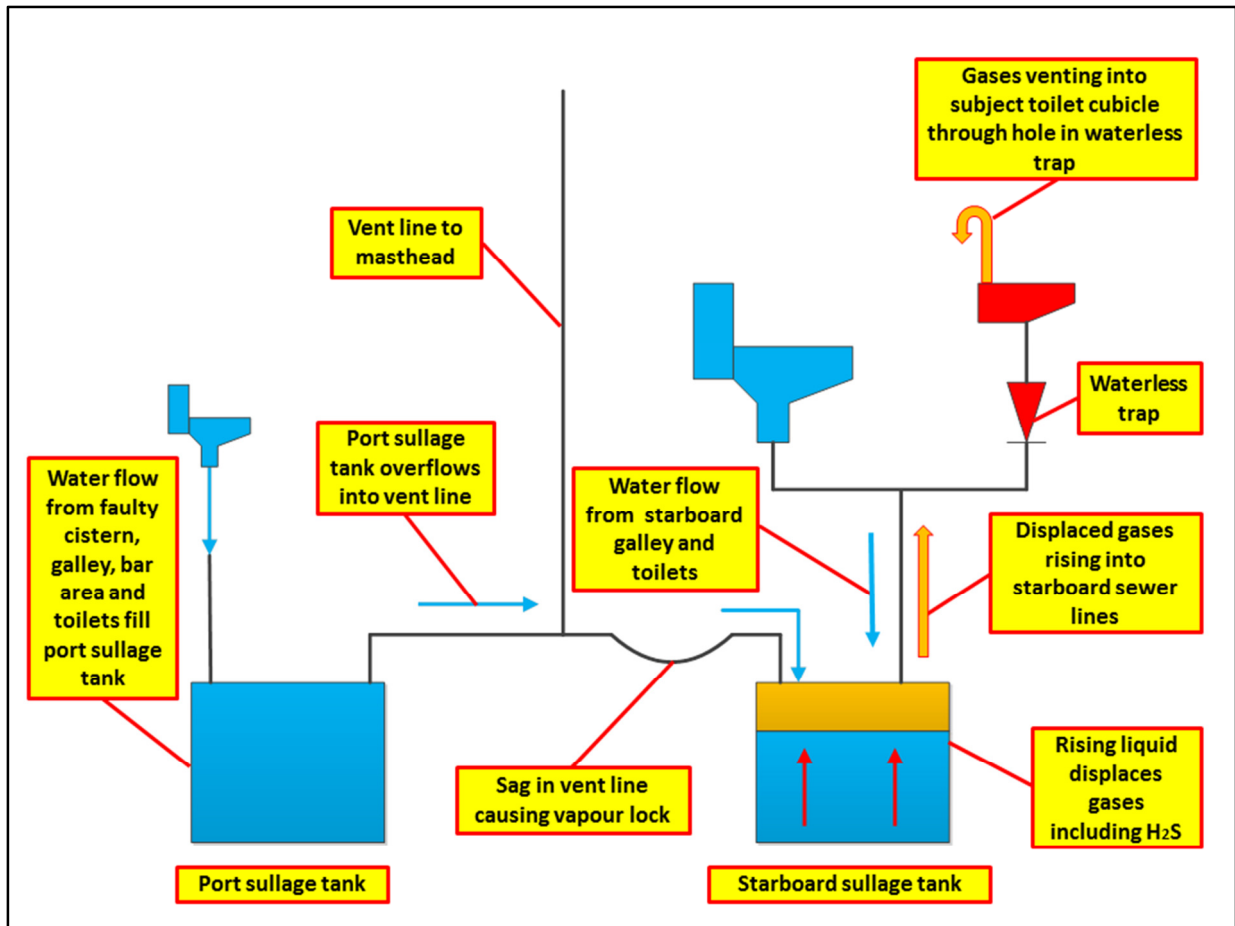
Figure 13: Simplified sewage system diagram

- 2.69 It is likely that the liquid observed within the rubber hose originated from the port sullage tank due to the tank overflowing from the faulty cistern valve. With the inflow of liquid from the port tank via the vent line and the starboard toilets and galley, it is likely that the available air space in the starboard tank was reduced. As the normal pathway for the sewer gases was impeded by the blocked tank vent line, it is likely that sewer gases from the tank were forced into the main starboard sewer network (refer to *Figures 13 and 14*).

- 2.77 The schematic in *Figure 19* shows a simple land-based layout for the venting of sewer gases and the inlet of fresh air to avoid displacement of water in S type water traps. When compared to the schematic in *Figures 9 and 13*, the system on board *Lady Rose* lacked the ability to vent gases from within the sewer line system. The configuration of the starboard side system did not allow air into these lines to avoid possible depletion of water from within S type traps when toilets are flushed.

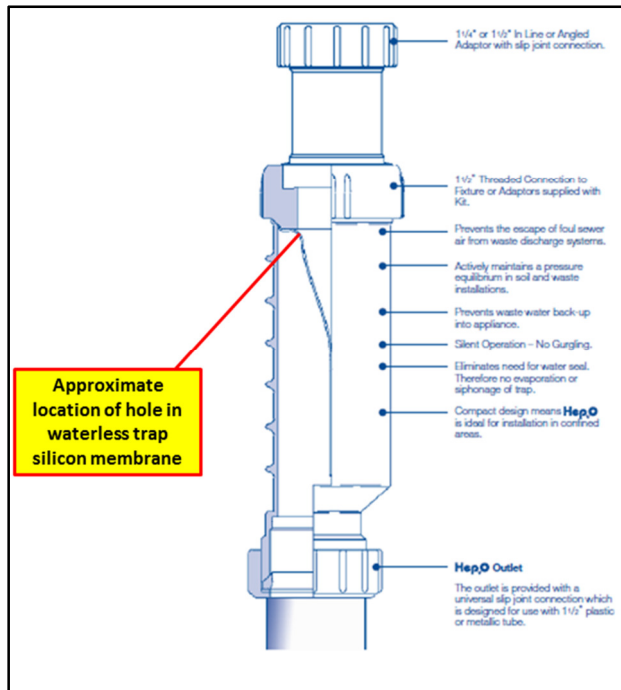
Figure 18: OEM diagram of waterless trap

The investigation found that it was likely the passenger was overcome by exposure to hydrogen sulphide that permeated into the toilet cubicle through a faulty waterless basin trap. This was also the opinion of a consulting Forensic Pharmacologist. The investigation also found that the sewage system design, construction, maintenance, and deficiency of applicable standards contributed to the build-up of hydrogen sulphide in the toilet cubicle.
