# Locomotive fire

Awaba, New South Wales | 5 June 2014

## **ATSB Transport Safety Report**

RO-2014-010

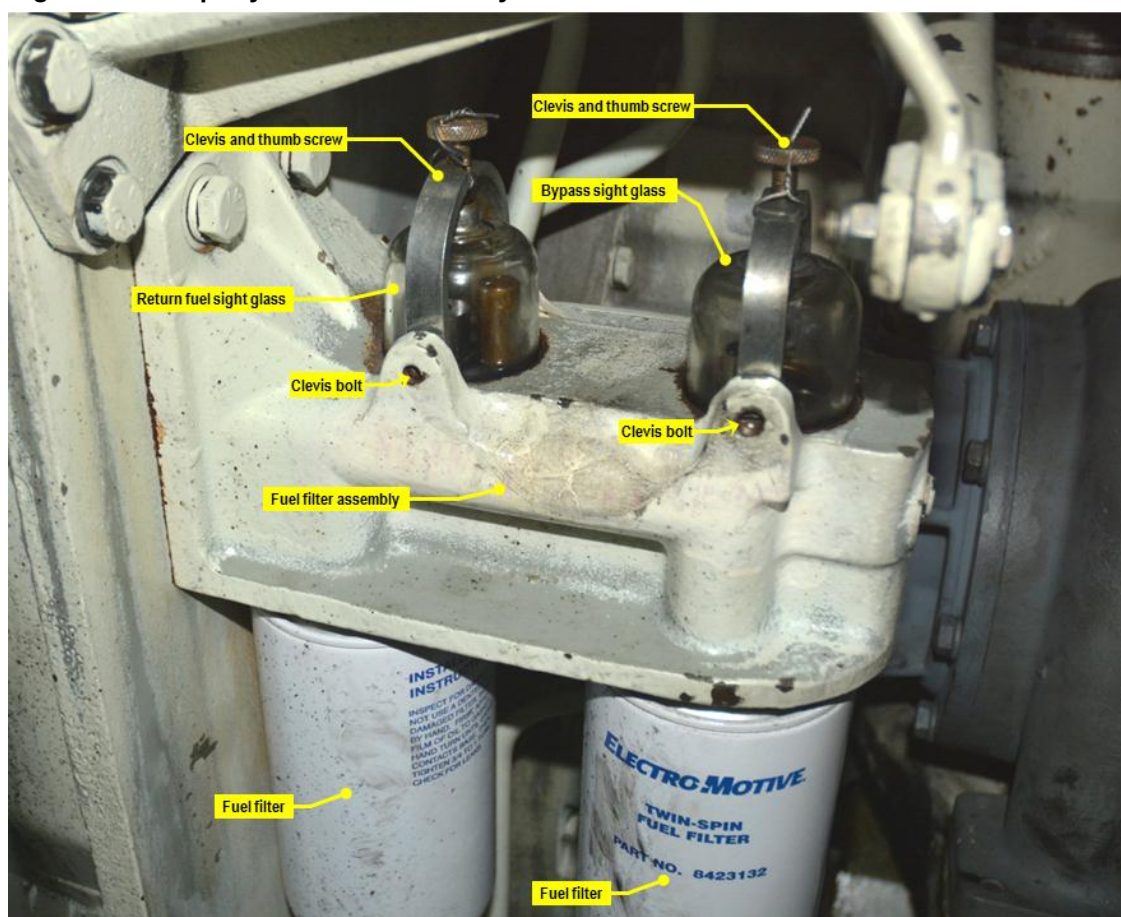
**Figure 2: Exemplary fuel filter assembly**

To maintain engine power, fuel is circulated throughout the engine at the rate of approximately 1500 litres per hour (25 litres per minute) by a conventional diesel fuel injection system. Operating pressures in the system vary up to 410 kPa (60 psi). The fuel is filtered by dual filters located on an assembly inside the engine bay at the front of the engine (Figure 2). Two sight glasses that indicate blockage of the fuel filters to maintenance staff form part of the assembly. After the fuel is filtered, it flows via the fuel rails to the injectors where it is metered into the combustion chamber. Once metered by the injectors all excess fuel is returned to the fuel tank.
