# Derailment and collision between coal trains

Ravenan (25km from Muswellbrook), New South Wales, on 26 September 2018

## **ATSB Transport Safety Report**

RO-2018-017

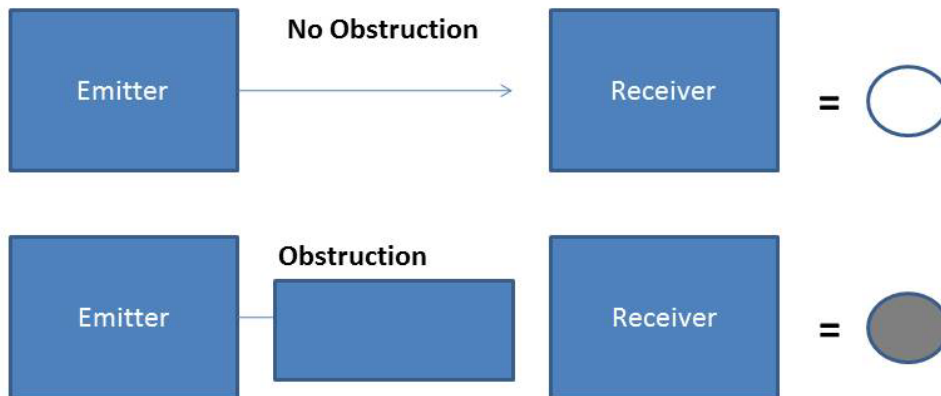
**Figure 4: PE Sensor operation**

The sensors are known as photo electric (PE) sensors. The sensors work by emitting and receiving electromagnetic radiation. If there is an obstruction, the receiver cannot detect the emitted radiation and hence knows there is an obstruction. If the receiver can receive the emitted radiation, the system knows that there is no obstruction.

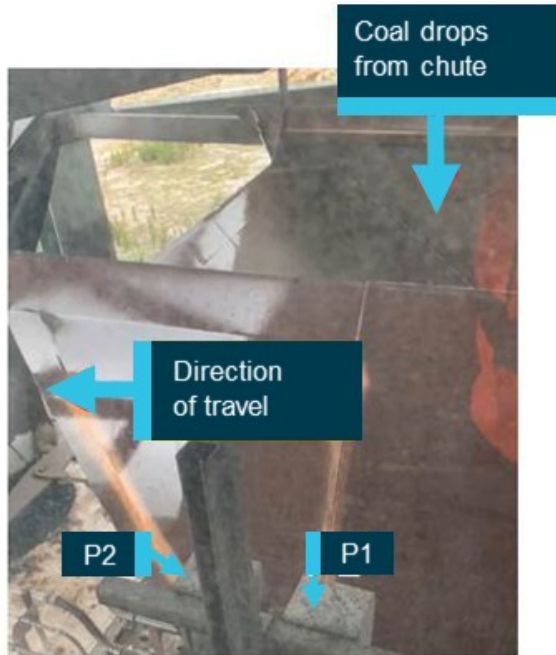
**Figure 5: Sensor P1 and P2 instructing system to drop coal**

The sensors detect a gap between the front of the wagon to be loaded and the rear of the wagon which had just been loaded. Once the front of the wagon to be loaded obstructs P1 and P2, there is a delay and the system instructs the bin gates to open to commence loading.
