RAIL SAFETY INVESTIGATION REPORT

SAFEWORKING BREACH

GLENLEE

28 OCTOBER 2009

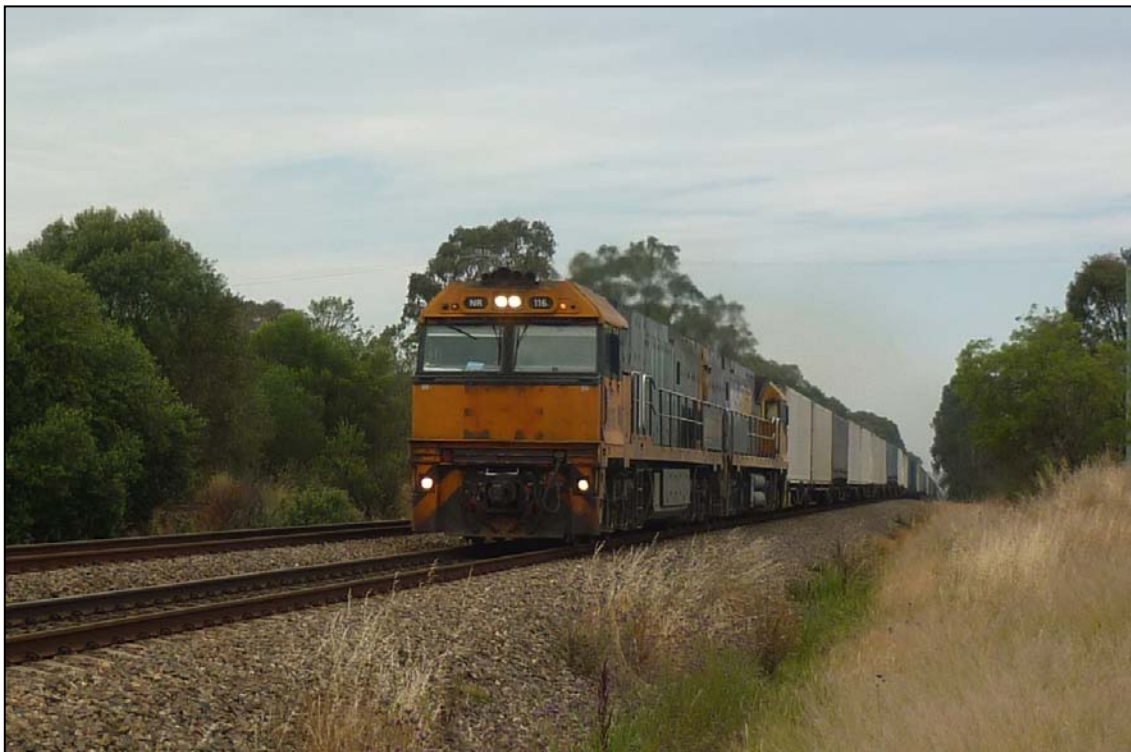
Photo 2: PN NR Class locomotives at Glenlee

- 1.16 PN freight service 2XW4 was a regular service that originated from Spencer Junction in South Australia, and was travelling to Port Kembla via Melbourne and Chullora. It consisted of two NR Class diesel-electric powered locomotives (see *Photo 2*) and 49 freight wagons. 2XW4 had a total length of 905m and a weight of 1,730t.
