## RAIL SAFETY INVESTIGATION REPORT

### DERAILMENT OF 4BM7 LIDCOMBE

4 NOVEMBER 2005

15 December 2006

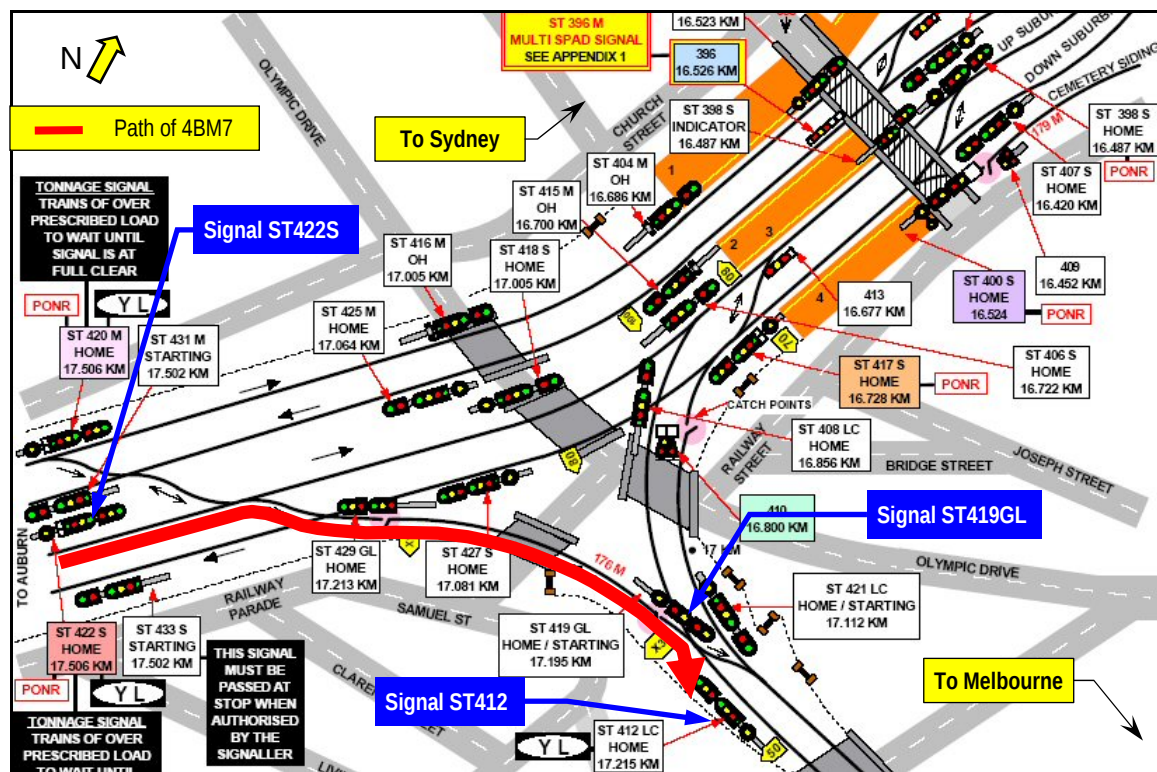
Figure 3: Track arrangement at Lidcombe

2.14 The Lidcombe Goods Loop is part of RailCorp's network and merges with Sydney's Main Western and Southern lines (see Figure 3).

- 2.15 The loop line is an electrified single line track, approximately 176 metres in length and sits on top of an eight metre-high embankment. The track is in close proximity to a number of roads and commercial properties. A bridge spanning a two-lane vehicular thoroughfare is located approximately mid way along the loop line.
