Office of Transport Safety Investigations

RAIL SAFETY INVESTIGATION REPORT

FATAL LEVEL CROSSING COLLISION

NUNDAH

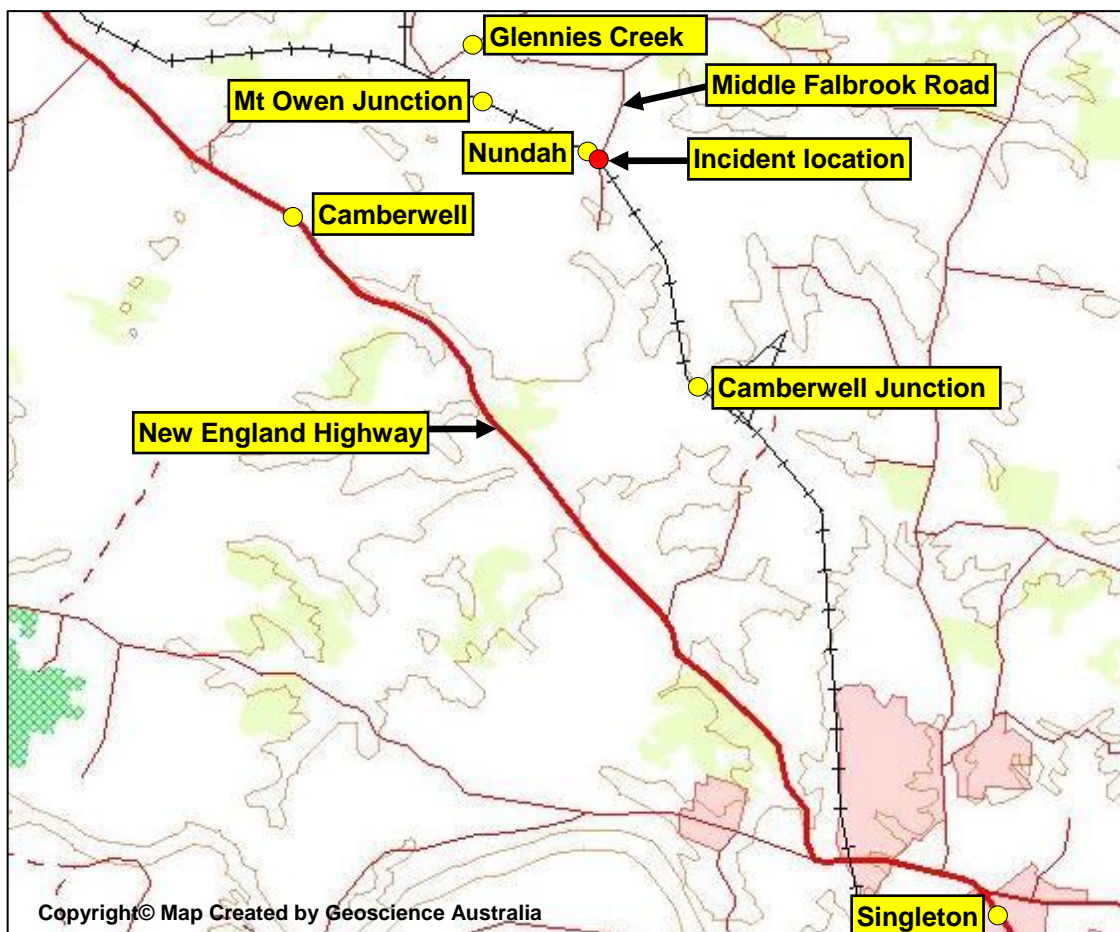
Figure 1: Incident location

- 1.4 Nundah is a rail location in the Camberwell to Mt. Owen Section of the Main North line, 251 km by rail from Sydney and a short distance north-west of the railway crossing at which the collision occurred (see *Figure 1*). The surrounding area is known as Glennies Creek.

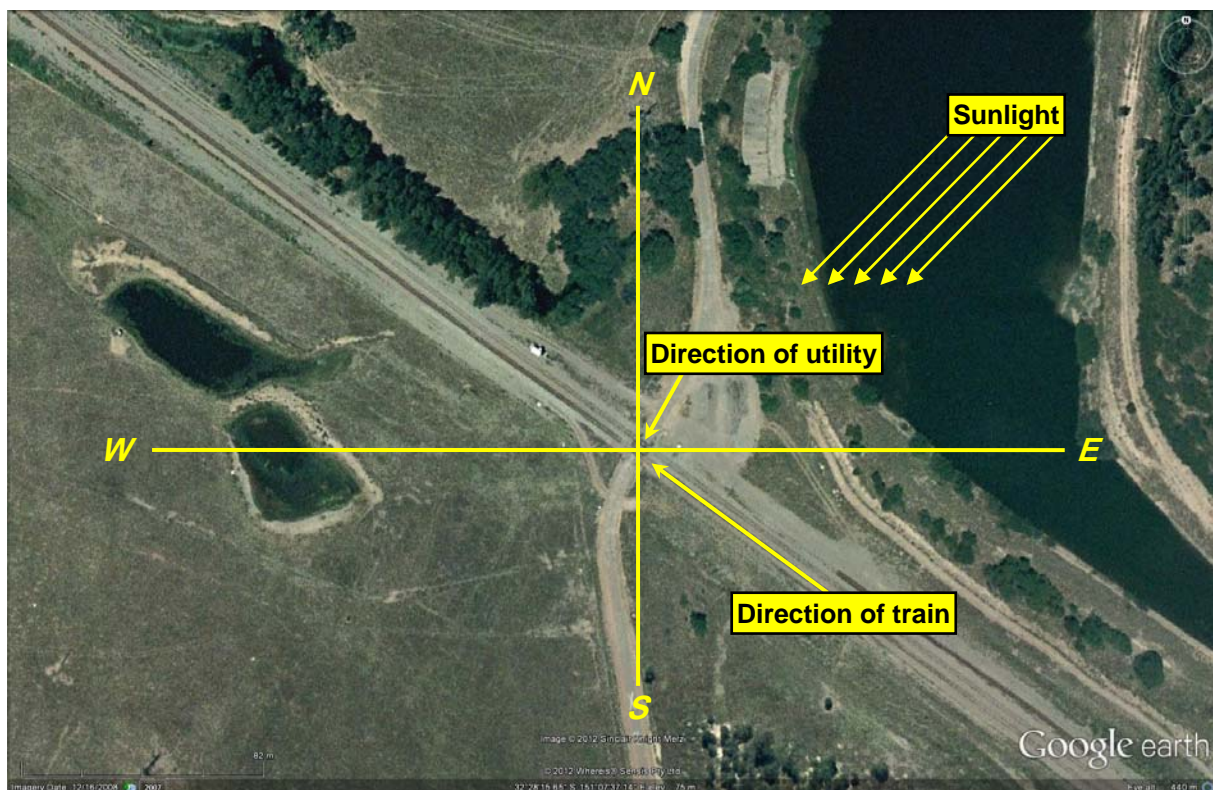
Figure 2: Sun direction relative to utility and train

- 1.18 The weather at Singleton was not recorded by the Bureau of Meteorology on the day of the collision, but records from the days before and after, and from nearby recording points on the day, indicate that the temperature at 0900 was around 15°C and there was a light breeze. The sun was at an azimuth of 44.5° and an altitude of 28.2°. The alignment of the road at the crossing was approximately 26° east of north, resulting in a sunlight direction from behind and to the left side of the utility driver and from the right hand side of the train driver, as illustrated in *Figure 2*.

- 1.19 Neither driver would have been looking toward the sun as they approached the crossing.
