Office of Transport Safety Investigations

RAIL SAFETY INVESTIGATION REPORT

DERAILMENT OF CITYRAIL SERVICE 312A

11 SEPTEMBER 2006

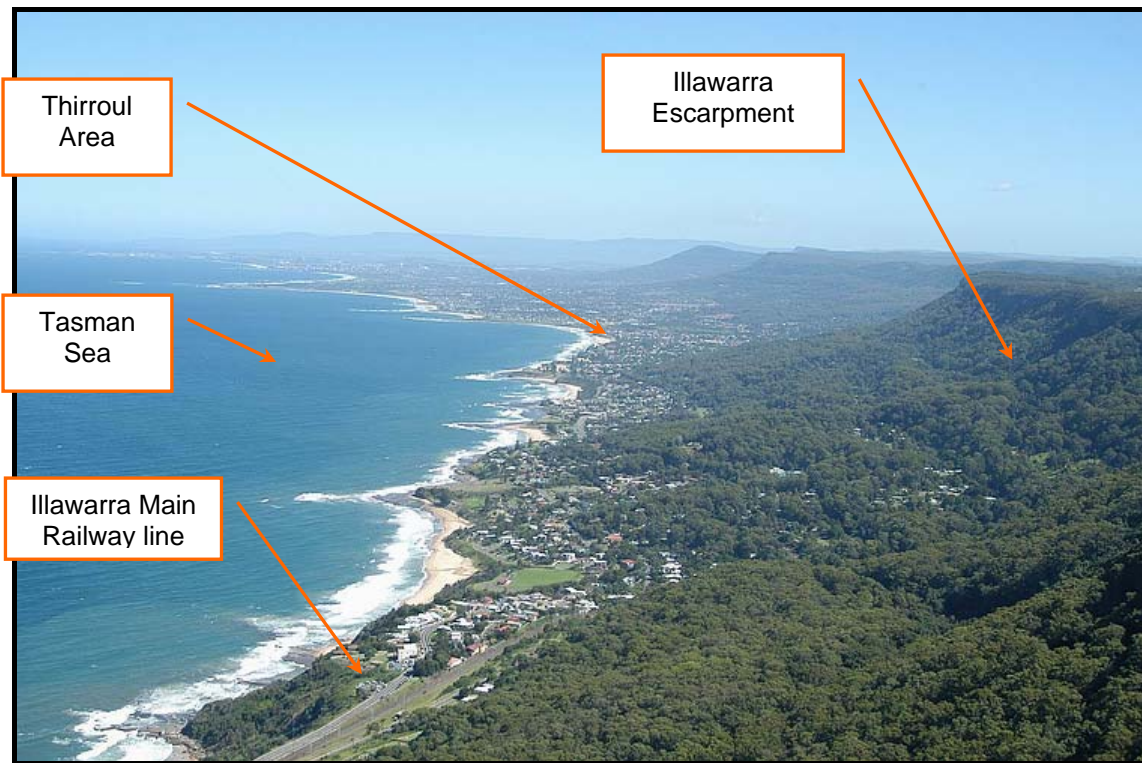
Photo 2: Aerial Photo of Illawarra region.

- 1.3 Thirroul is located in the Illawarra region of NSW, 70km South of Sydney and 13km North of Wollongong (see *Figure 1*). It is bounded by the Tasman Sea to the East and the Illawarra escarpment, which is approximately 300 metres above sea level, to the West (see *Photo 2*).

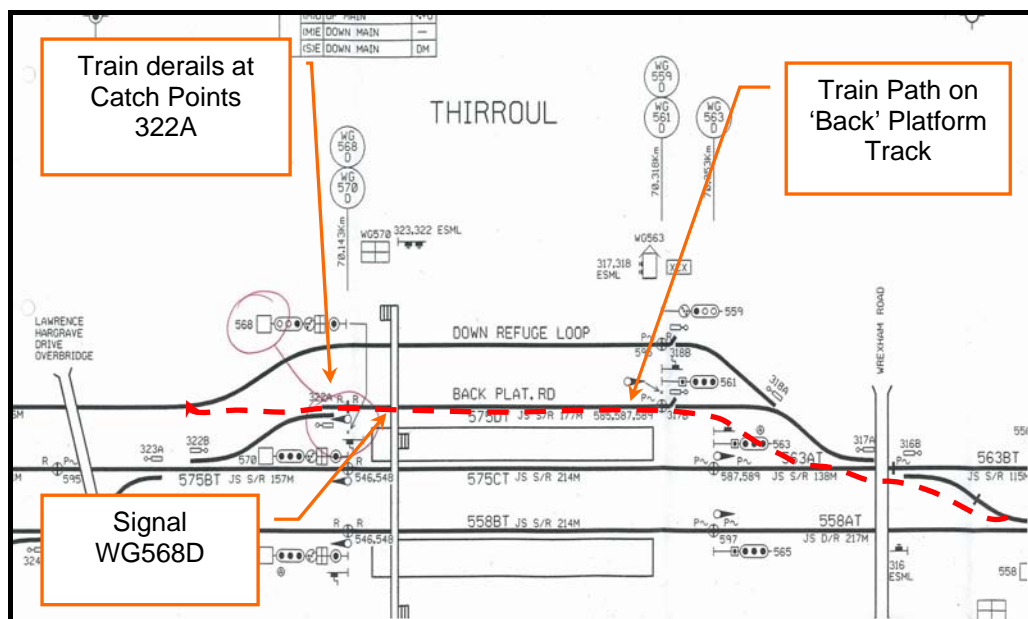
Figure 2: Map of track layout.

- 1.14 The Driver saw Signal WG 568D displaying a 'Stop' indication at a distance of approximately 100 metres, approximately halfway down the No. 3 Platform track (see *Figure 2 and Photos 3 and 4*).

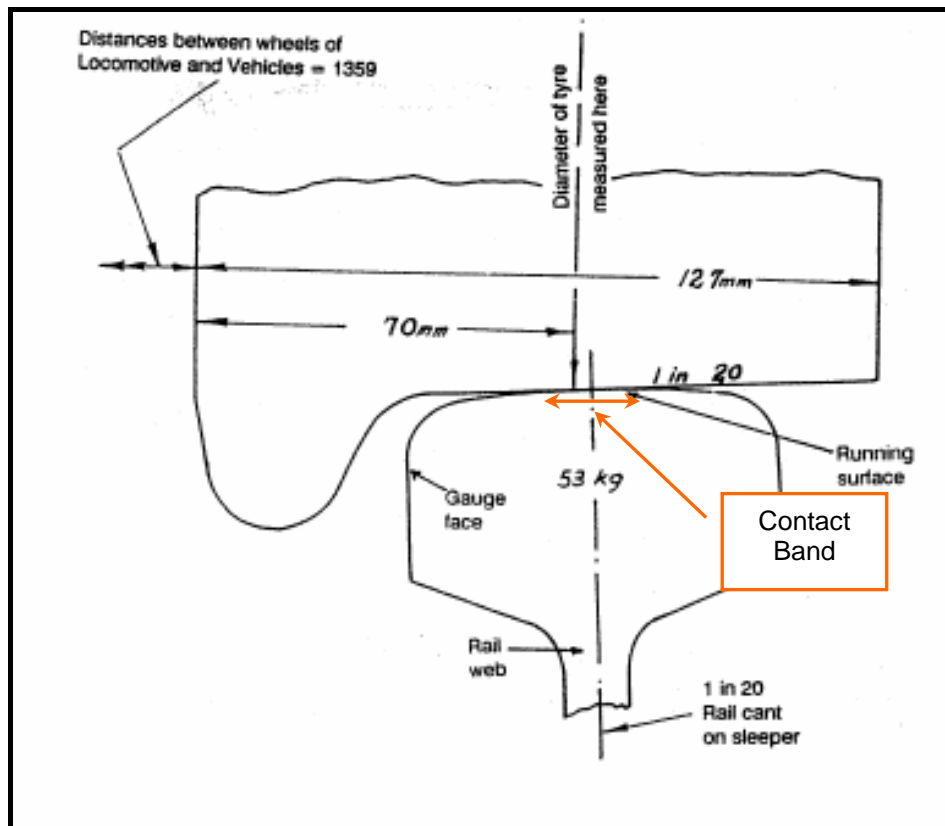
Figure 3: Wheel Rail Contact Band.

2.12. In addition to having a clean running surface, effective braking is dependent upon proper contact between a train's wheels and the rail. This requires that the profiles of both the wheels and the rail fall within specified parameters. Provided they do, a band of contact is established through which braking effort can be transferred onto the track. This 'contact band' is depicted in *Figure 3*. The contact band on the No. 3 Platform track varied between 20-50mm and as such was within acceptable parameters.
