Office of Transport Safety Investigations

TECHNICAL INSPECTION FINDINGS

CITY SIGHTSEEING TOURS BUS FIRE

7 SEPTEMBER 2012

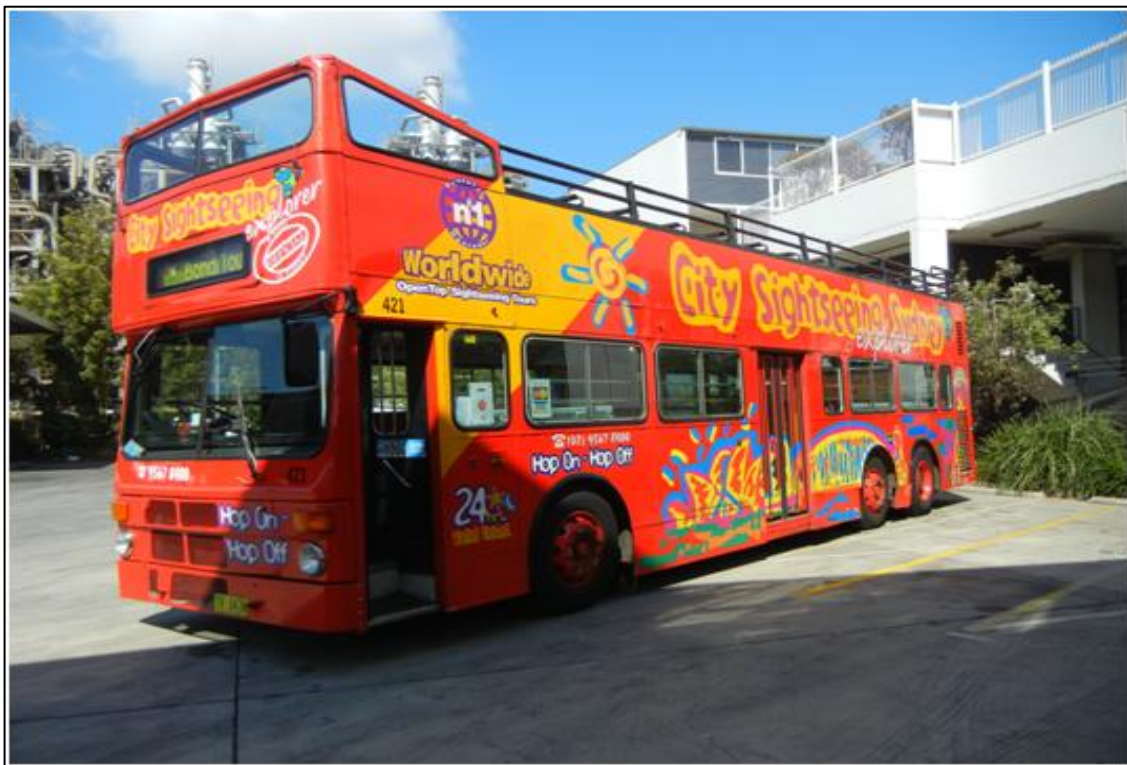
Photograph 4: MCW Metrobus MKII

Bus details. The bus was registered in NSW and issued with registration plates TV5654. It was an open-top double-decker bus built in England by Metro-Cammell Weymann (MCW) in 1983 (see *Photograph 4*). The bus was exported from England to Hong Kong and used by New World First Bus. In 2000, the bus was imported into Australia by City Sightseeing Tours. At this time its engine was replaced with an 8.3 litre Cummins ISC turbocharged diesel engine. The bus was one of ten similar buses in the City Sightseeing Tours fleet. (For further bus details see *Appendix 1*.)

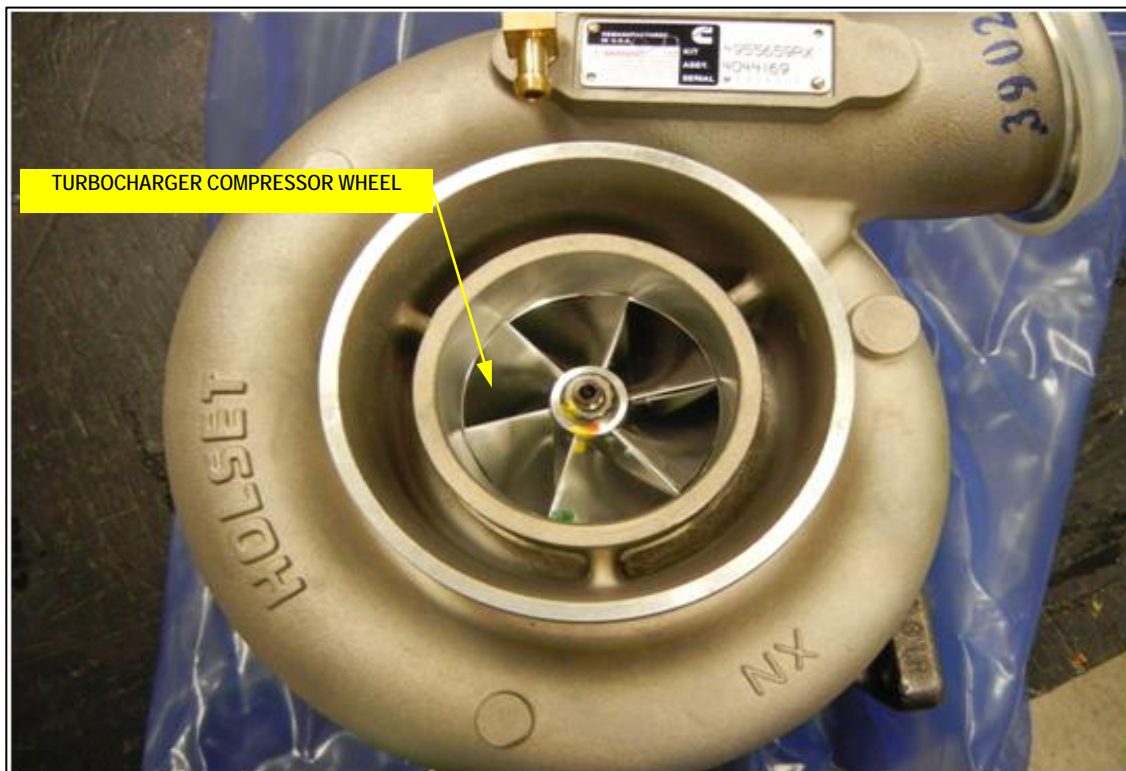
Photograph 6: New Holset turbocharger

Turbocharger. The pattern of the fire was similar to that which would be associated with fire initiation in the region of the turbocharger resulting in a loss of power. This is consistent with the driver's account of the loss of power he experienced. The engine was fitted with a Holset HX40 turbocharger³ (see *Photograph 6*). (For further Turbocharger details see *Appendix 2*.)
