Office of Transport Safety Investigations

TECHNICAL INSPECTION FINDINGS

FIRE INVOLVING TRANSDEV SHORELINK BUS MO1970

16 DECEMBER 2011

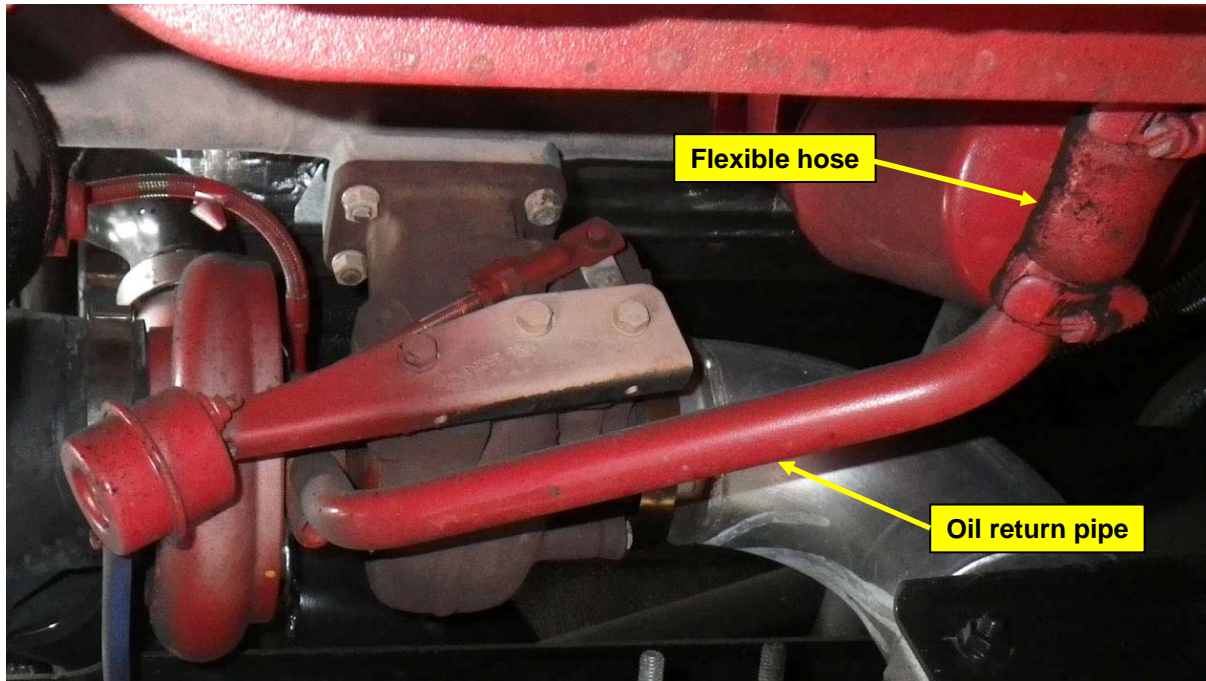
Photograph 10: Turbocharger oil return viewed from below

Lubrication oil supplied to the turbocharger is returned to the engine's sump through a large bore steel pipe with a bolted flange connection to the turbocharger and a flexible hose connection to the engine. The configuration on a similar vehicle is shown in *Photograph 10*.

The flexible hose between the return pipe and the engine had been completely burned away, and the hose clamps were no longer in place. The condition of the return pipe can be seen in Photograph 11.

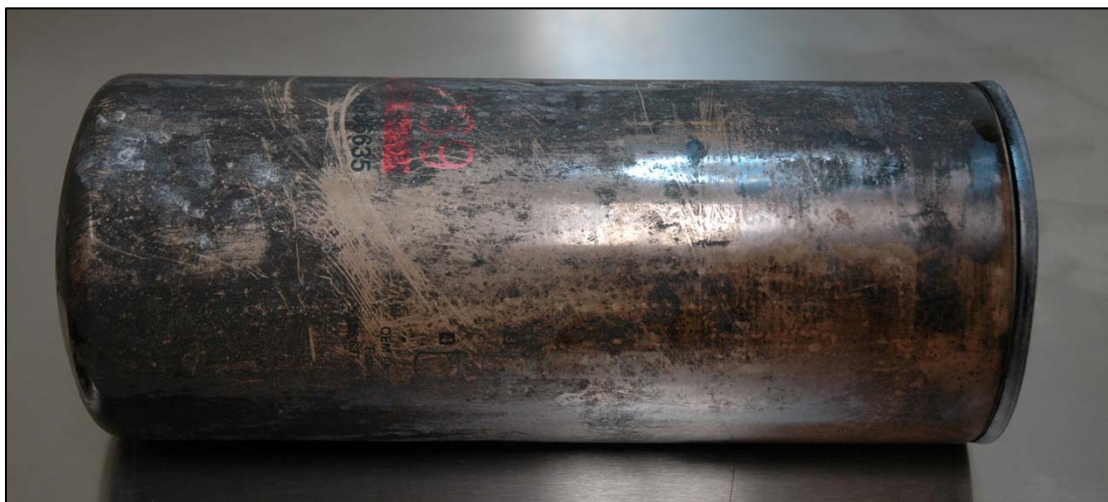
Photograph 12: Oil filter

The oil filter, seen in *Photograph 12*, was removed for examination. It was found to be full of oil, with the oil having the same appearance and odour as that from the sump.

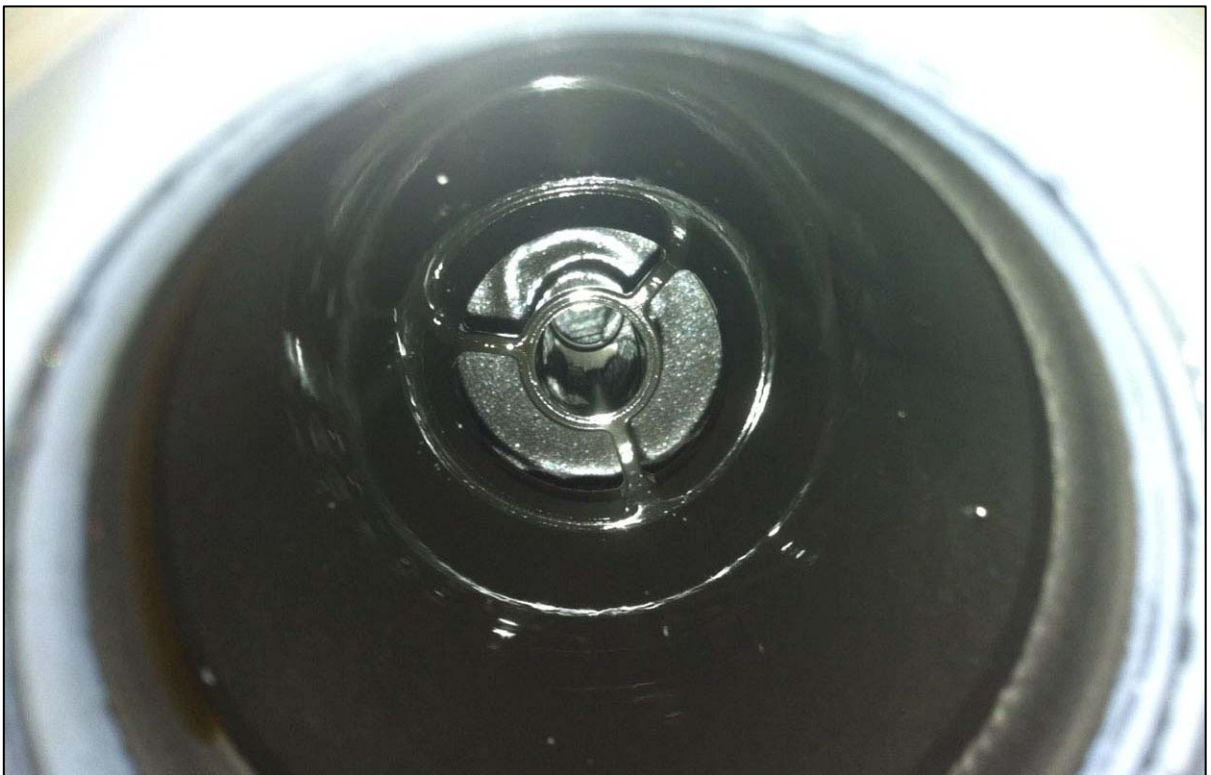
Photograph 14: View inside undamaged filter (Photograph courtesy of Transdev Shorelink)

A filter was then removed from a nominally identical bus, and found to contain a black insert as seen in *Photograph 14*. Cummins documentation indicated that the filter was of a combined full-flow and bypass type, and that the insert was a venturi used to control the flow of oil as it re-combined after leaving the two filter sections.

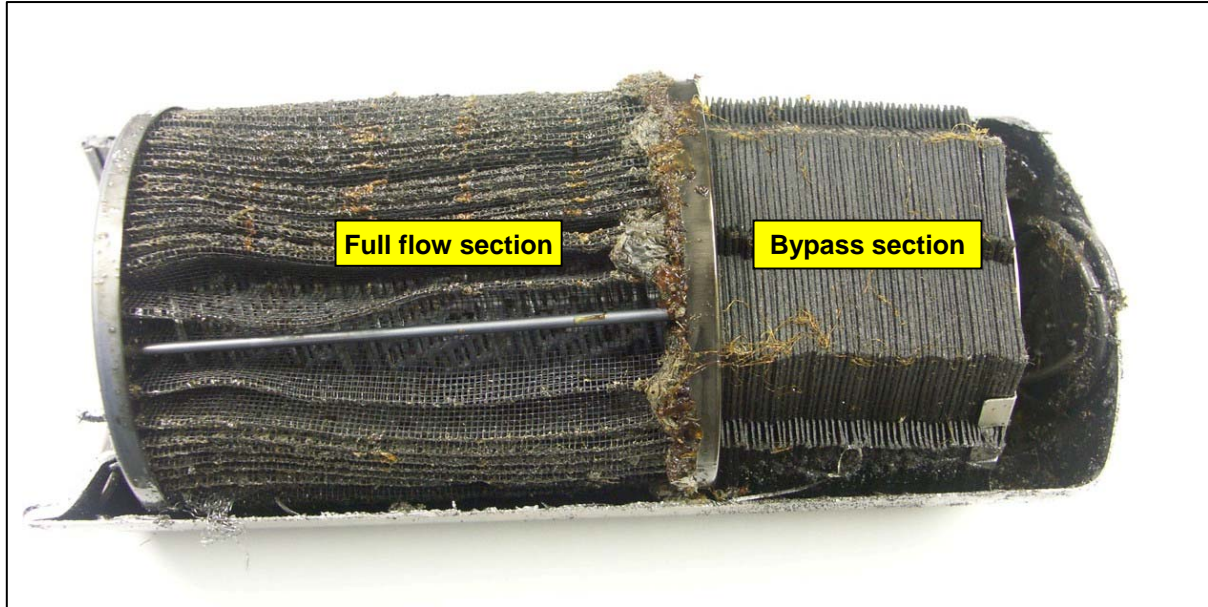
Photograph 15: Longitudinally sectioned filter

The filter from the burnt bus was then sectioned longitudinally, as seen in *Photograph 15*. The two sections of the filter can be seen, with the full-flow section being of conventional folded paper construction while the bypass section used stacked cards to provide a finer level of filtration.
