Office of Transport Safety Investigations

TECHNICAL INSPECTION FINDINGS

MAKEHAM'S COACHES BUS FIRE

4 JANUARY 2013

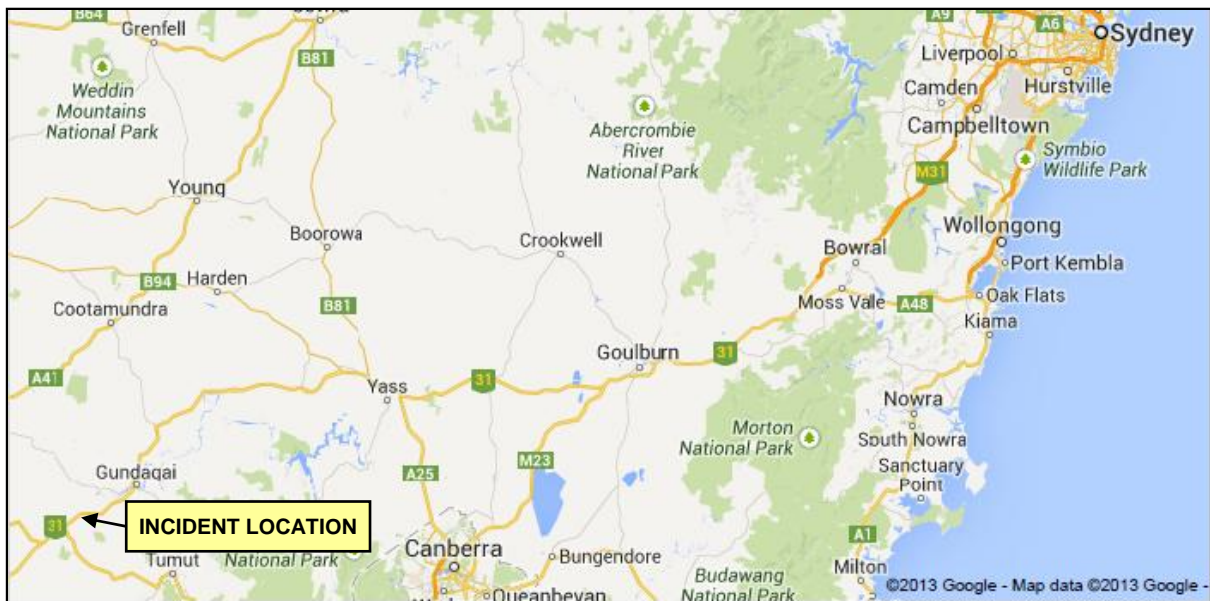
Figure 1: Incident location at Tumblong

At approximately 1205¹ on Friday 4 January 2013, a Makeham's Coaches bus caught fire as it was travelling south on the Hume Highway, 22 kilometres south of Gundagai near a locality known as Tumblong (see *Figures 1 and 2*). The bus was completely destroyed by the fire and a small bushfire was started at the location where the bus pulled over. Both fires were eventually extinguished by the Rural Fire Service (RFS). Some passengers were slightly affected by smoke inhalation, but otherwise no injuries were sustained by passengers or the crew.
