# Safety Investigation Report

**Pedestrian Fatality  
Bondi Junction, NSW**

16 December 2020

**Investigation Reference I00222**

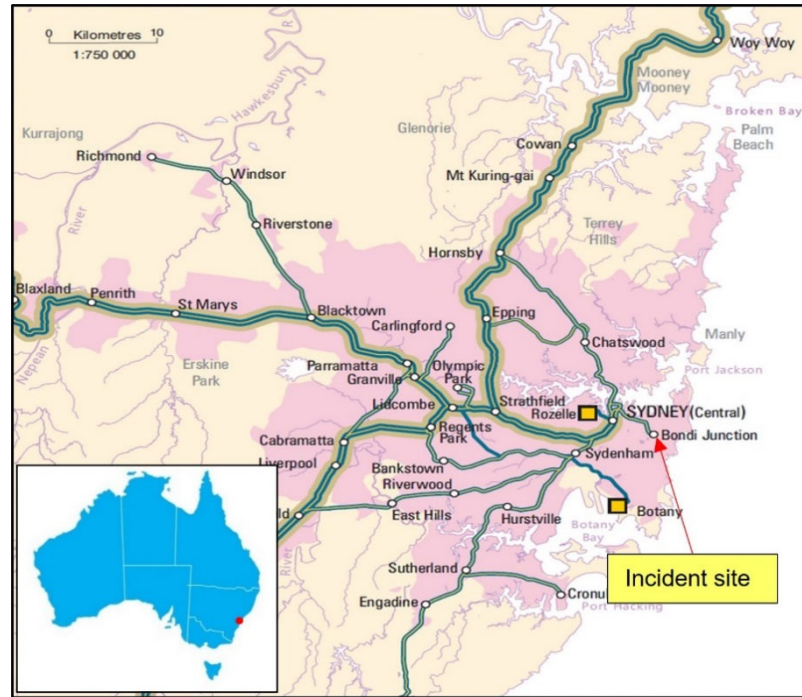
Figure 4: Incident location

- 1.22 The incident occurred on Grafton Street at Bondi Junction NSW, in proximity to the intersection of Grosvenor Street and Grafton Street, Bondi Junction and the BJI (Figure 1, Figure 3 and Figure 4). The Grosvenor Street and Grafton Street pedestrian crossing was configured with a continuous stop line and two pedestrian crossing walk lines across each of the four pedestrian foot crossings as depicted in Figure 1 and Figure 3.
- 1.23 The road and pedestrian traffic light configuration at the intersection provided a green walk indication at the same time as a green light indication for road motor vehicles on Grosvenor Street.

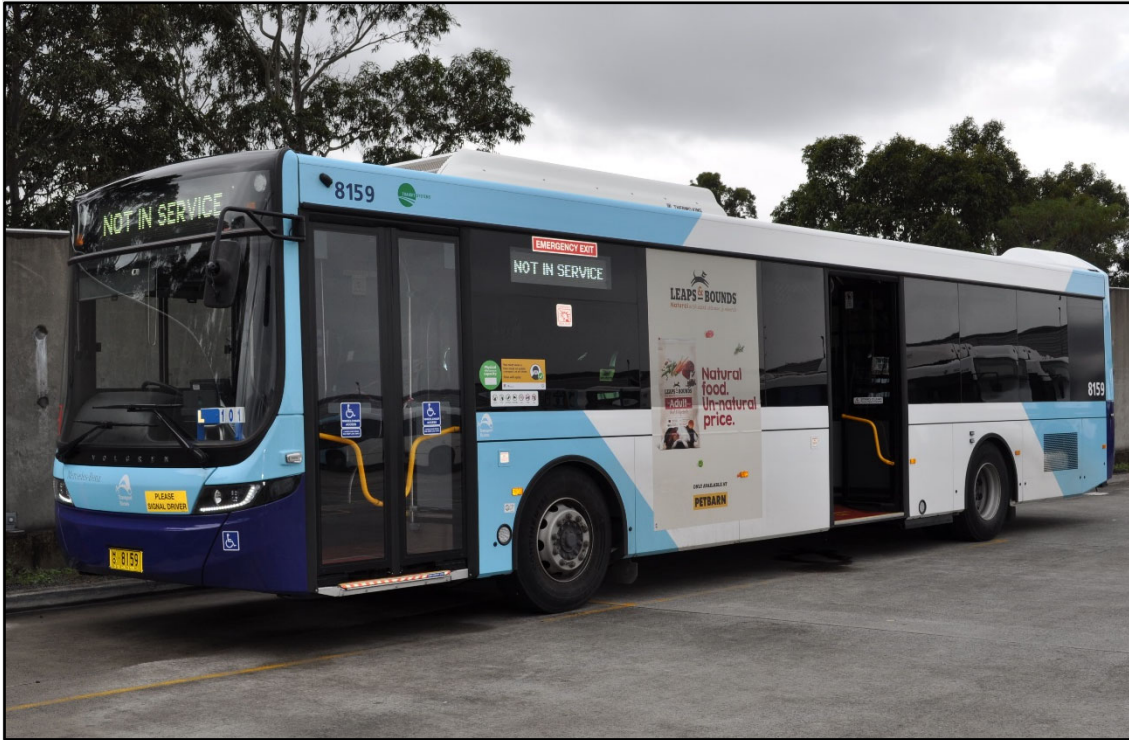
**Figure 5: Transit Systems bus m/o 8159**

- 1.25 The bus involved was a diesel fuelled Volgren bodied 0500LE Mercedes bus. The body was manufactured by Volgren Australia Pty Ltd in July 2020 and was registered in NSW as m/o 8159 (Figure 5). The bus was 12.5 m in length, 2.5 m in width, twin axle and permitted to carry 43 seated and 34 standing passengers. The involved bus was approved to operate under the Heavy Vehicle National Law and classified as a heavy vehicle.

- 1.30 An examination of the bus undertaken post incident did not identify any defect that was considered to have impacted on the bus performance in negotiating the left-hand turn into Grafton Street. The condition of mirrors, front windscreen and front glass door leaf seals provided visibility consistent with standard requirements.

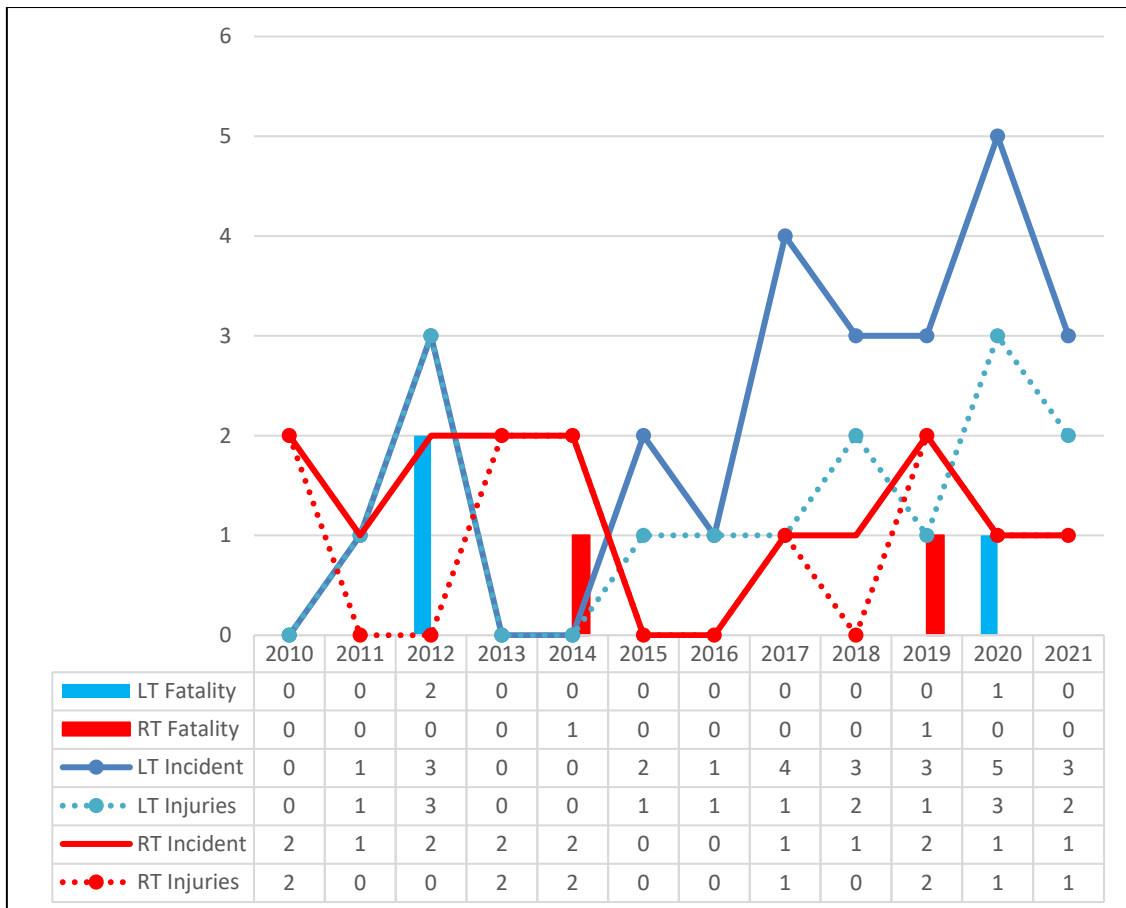
Figure 8: BIMS reported pedestrian left and right turn bus collision incidents, injuries and fatalities

- 1.58 OTSI has reviewed more recent pedestrian collision data between 2010 to 2021 from the TfNSW Bus Incident Management System (BIMS) database and OTSI's incident reporting records (Figure 8). This review has identified a similar ratio of left- and right-hand pedestrian collisions with a left-hand pedestrian collision being approximately 50% more likely when compared to a right-hand collision.

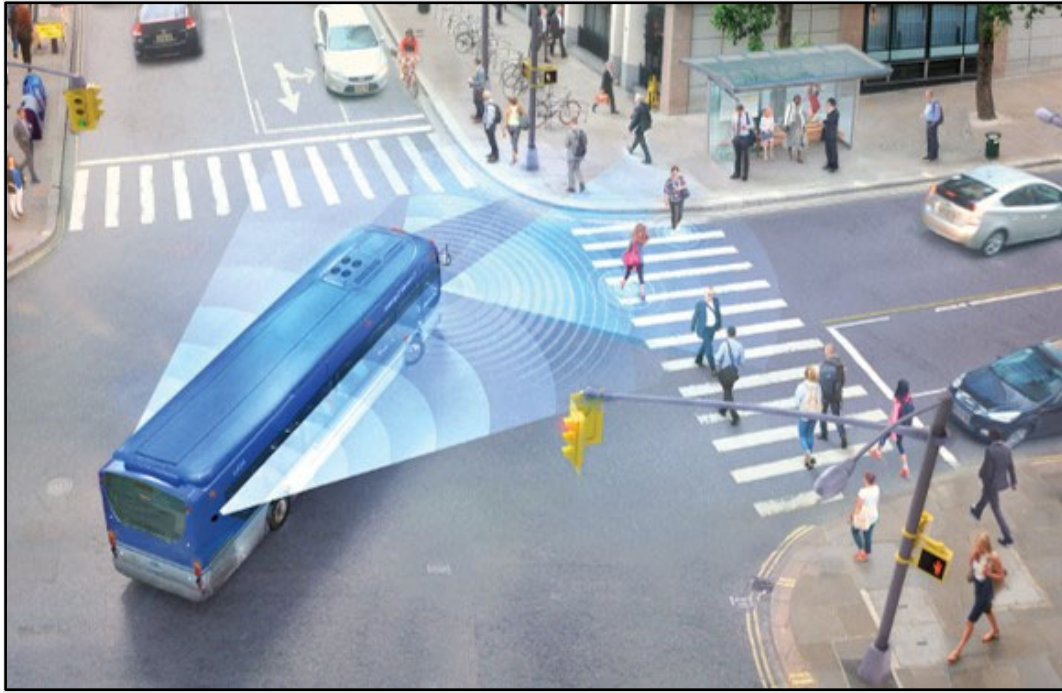
**Figure 9: Pedestrian and cyclist warning detection technology - example of system detection envelopes**

- 1.67 At the time of the investigation report there was technology that could be retrofitted to buses to provide visual, audible and vibration alerts to bus drivers, in the event pedestrians were detected in defined blind spots. This technology employed sensors and detection algorithms to identify pedestrians in vulnerable locations. The technology was promoted to function at slow speeds (below 30km/h), recognise inanimate objects and pedestrians located within safe zones (e.g., footpaths). Figure 9 provides a pictorial representation of the capabilities of the technology.
