Office of Transport Safety Investigations

# FERRY SAFETY INVESTIGATION REPORT

## COLLISION OF MV *FRESHWATER* WITH MANLY WHARF

22 June 2013

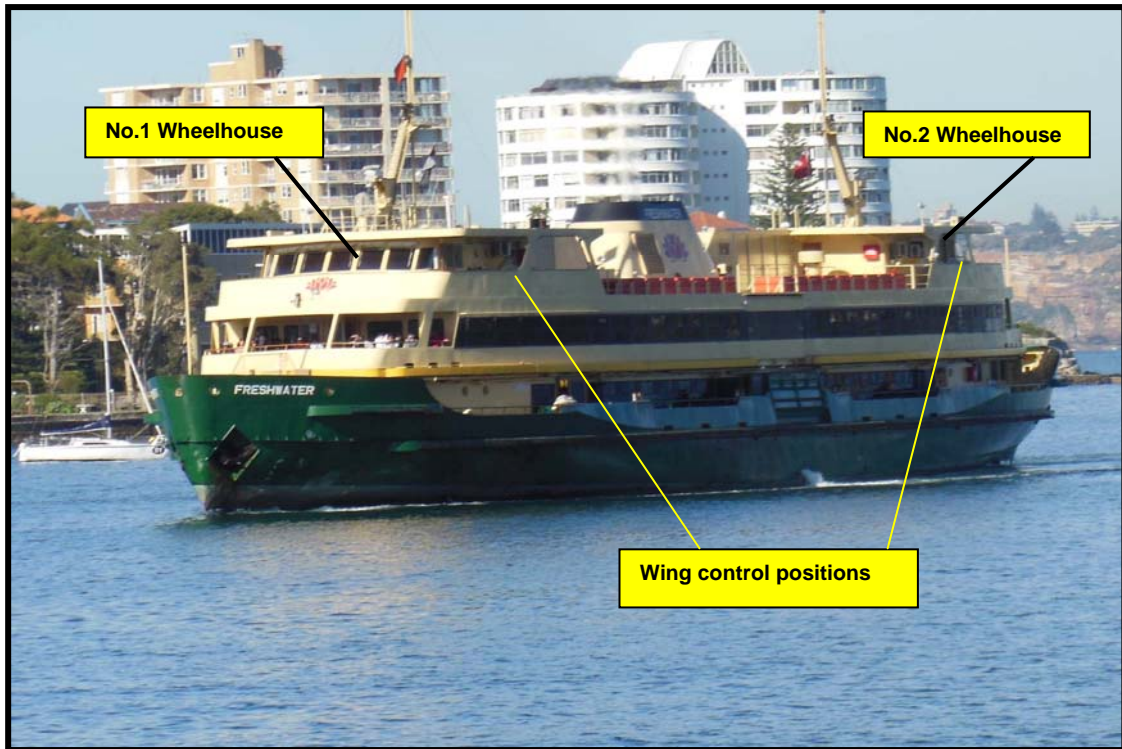
**Photograph 1: *Freshwater***

- 1.9 The Freshwater ferries have identical bridges at both ends, designated No.1 wheelhouse and No.2 wheelhouse (see *Photograph 1*). This configuration allows the ferry to be operated on return trips from Circular Quay to Manly without having to turn around. At both Circular Quay and Manly wharves, the ferries have to manoeuvre to a position where hydraulic passenger ramps located on the wharves align with the hydraulic ramps on the ferries.

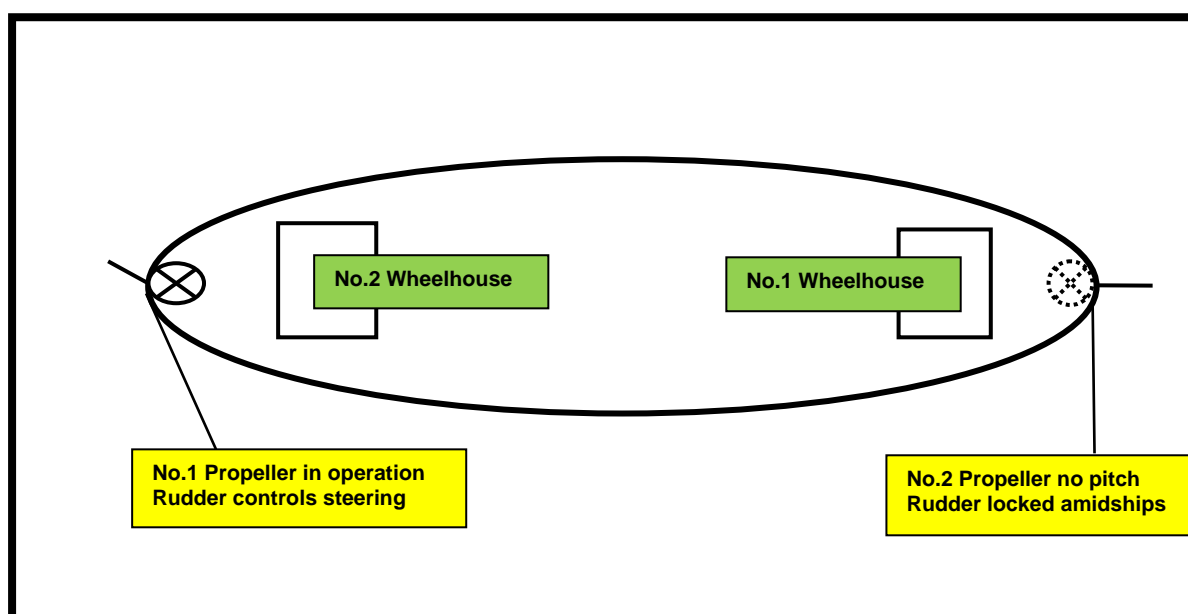
**Diagram 1: Freshwater sailing mode**

- 1.13 Freshwater class ferries operate in two modes of propulsion, *sailing* and *manoeuvring* modes. In *sailing* mode the variable pitch propeller at the stern or rear end drives the ferry forward. To stop or go astern, the same propeller operates in the reverse direction by changing the pitch of the propeller blades. When operating in *sailing* mode the forward rudder is locked amidships and cannot be used. (See *Diagram 1*) Under normal operations the passage between Circular Quay and Manly is carried out in *sailing* mode with the ferry reaching a cruising speed of 13 - 14 knots (24 - 26 kph).

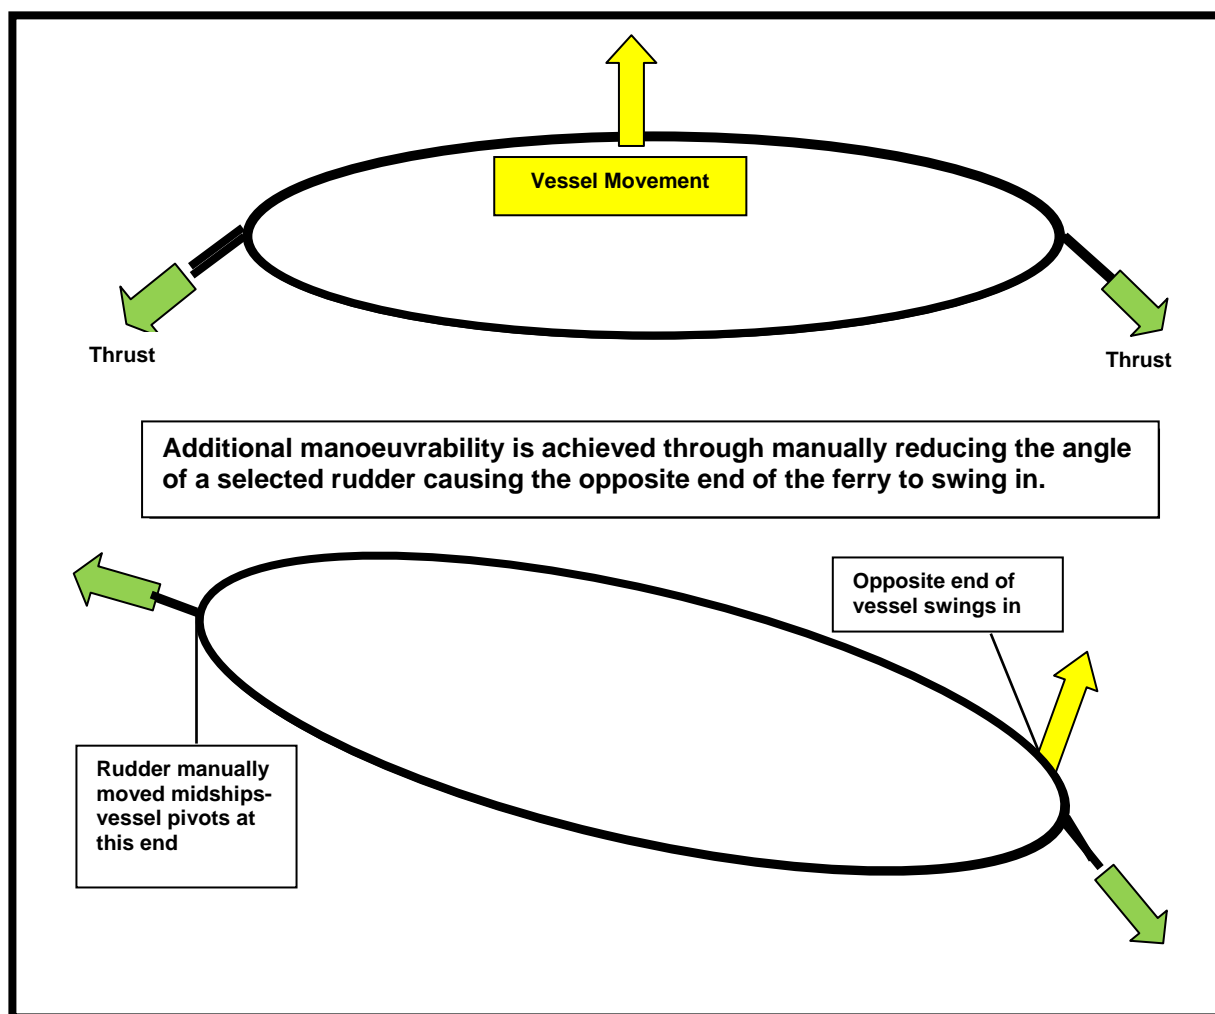
**Diagram 2: Freshwater manoeuvring mode**

- 1.14 In *manoeuvring* mode both propellers and rudders are utilised in different combinations allowing the vessel to move sideways or swing one end or the other. To change from *sailing* mode to *manoeuvring* mode the vessel's speed must be reduced to below 5 knots to avoid damage to the system and allow time for the variable pitch propeller to engage. (See *Diagram 2*)

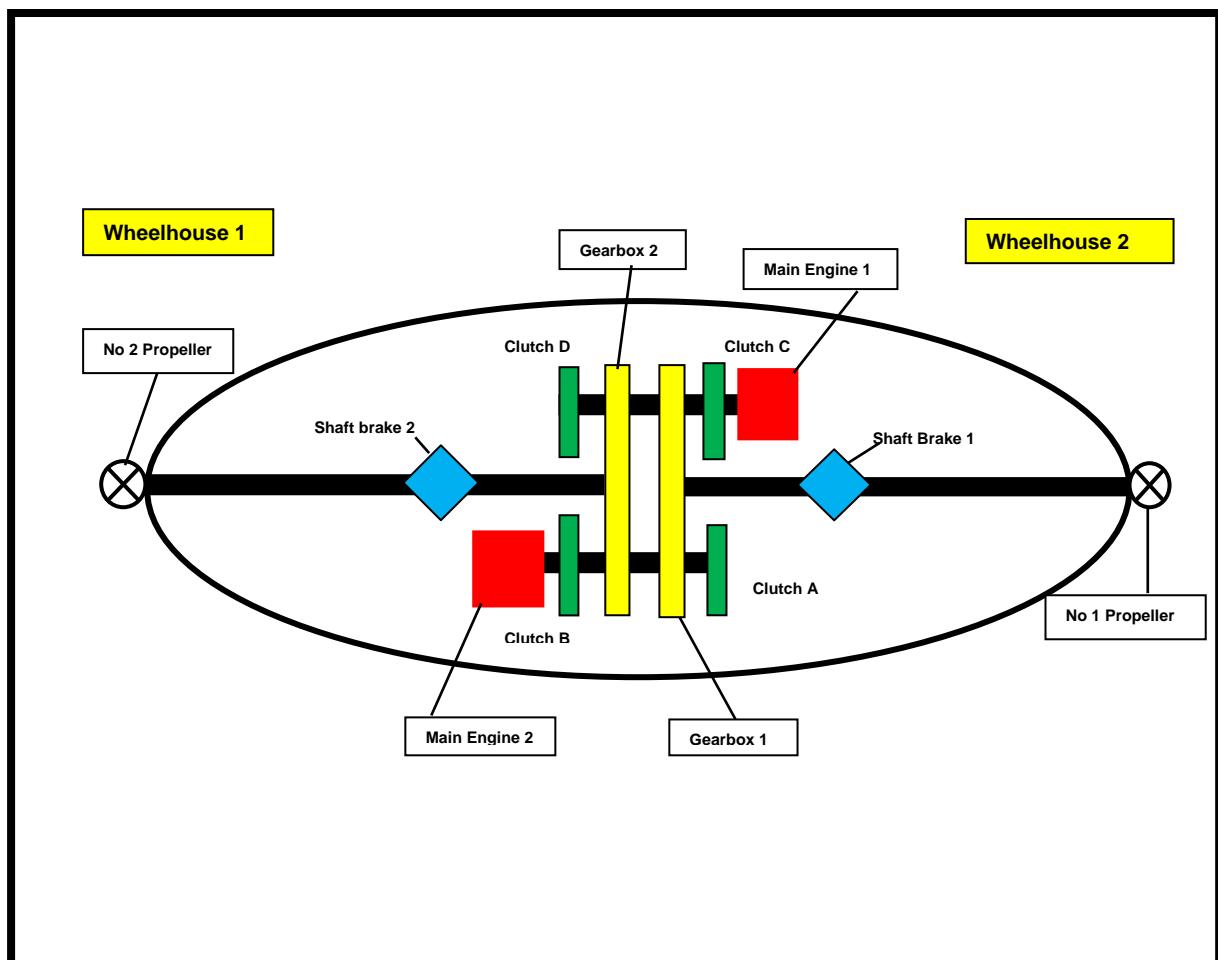
Diagram 3: Freshwater engine operating systems

- 1.28 The Freshwater class ferries are powered by two 2238 kW (3000BHP) Daihatsu diesel engines which drive fully feathering, controllable pitch propellers at each end of the vessel. The propellers and propulsion system in both wheelhouses were designed and manufactured by LIPS B.V. of Holland.
- 1.29 The main engines operate through twin input, single output, back-to-back, gearboxes which were manufactured in Germany. Each gearbox input shaft is fitted with a clutch and each propeller shaft with a brake. The arrangement of each engine / clutch / gearbox / brake is such that both engines, together or individually, can drive one or both propellers. Each engine has a variable speed range of 325 to 600 RPM (with clutch engaged) that converts through the gearbox to a range of 160 to 270 RPM at the propeller. The gearboxes are both unidirectional. (See *Diagram 3*)
