RAIL SAFETY INVESTIGATION REPORT

TRAIN COLLISION WITH ROAD MOTOR VEHICLE

WOY WOY

2 SEPTEMBER 2011

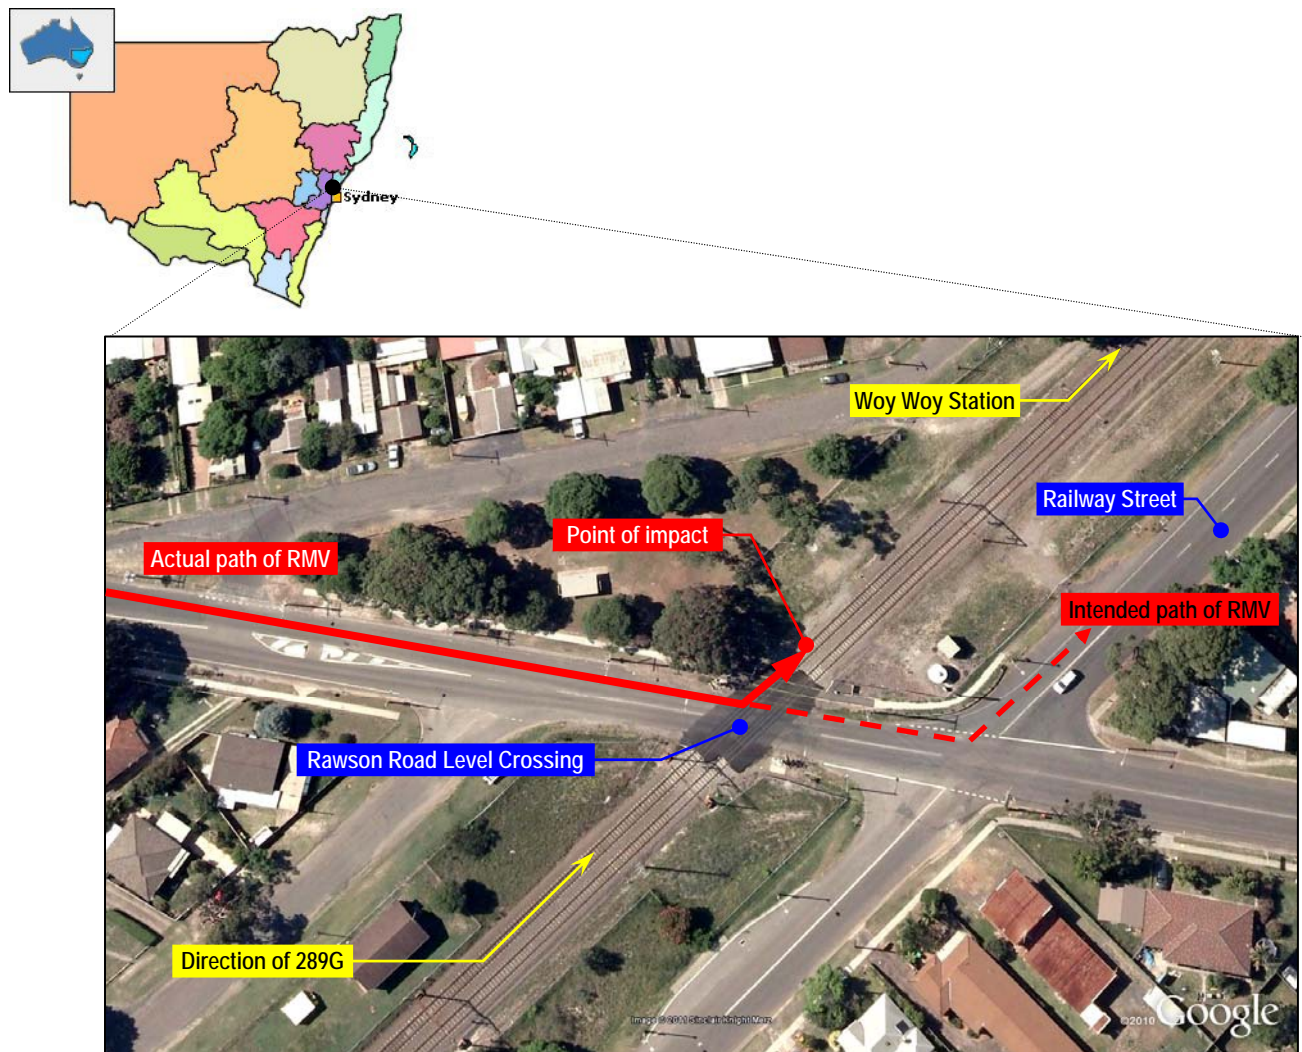
- 1.1 At approximately 6.17pm on 2 September 2011, CityRail's Sydney to Wyong interurban passenger service 289G, struck a stationary, unoccupied road motor vehicle (RMV) on the Down Main line approximately 10 metres North of the Rawson Road level crossing at Woy Woy on the Central Coast of NSW (see *Figure 1*). The RMV had become stuck on the line after its driver became disoriented while trying to locate a street running parallel to it. 289G pushed the RMV, which had become wedged underneath the leading car, for approximately 300 metres along the track without derailing, before coming to a stand.

Figure 1: Incident location

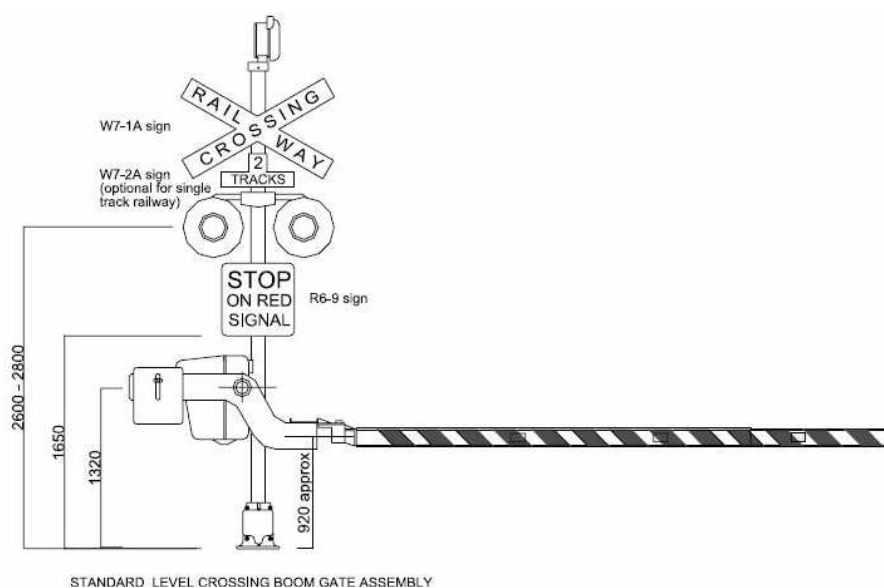
- 1.5 The crossing measures approximately 13 metres in width and is fitted with active ("F" type) protection consisting of several flashing light assemblies, audible warning devices and half boom gates on both approaches (see *Figure 2* and *Photographs 1 and 2*). The equipment conforms to the requirements of Australian Standard AS 1742.7, Manual of uniform traffic control devices, *Part 7: Railway crossings*. A pedestrian crossing protected by fencing and automatic swing gates on its approaches also spans the tracks in conjunction with the roadway on the crossing's Northern side. All the equipment functioned as designed on the approach of 289G.

Figure 2: Diagram of F Type protection

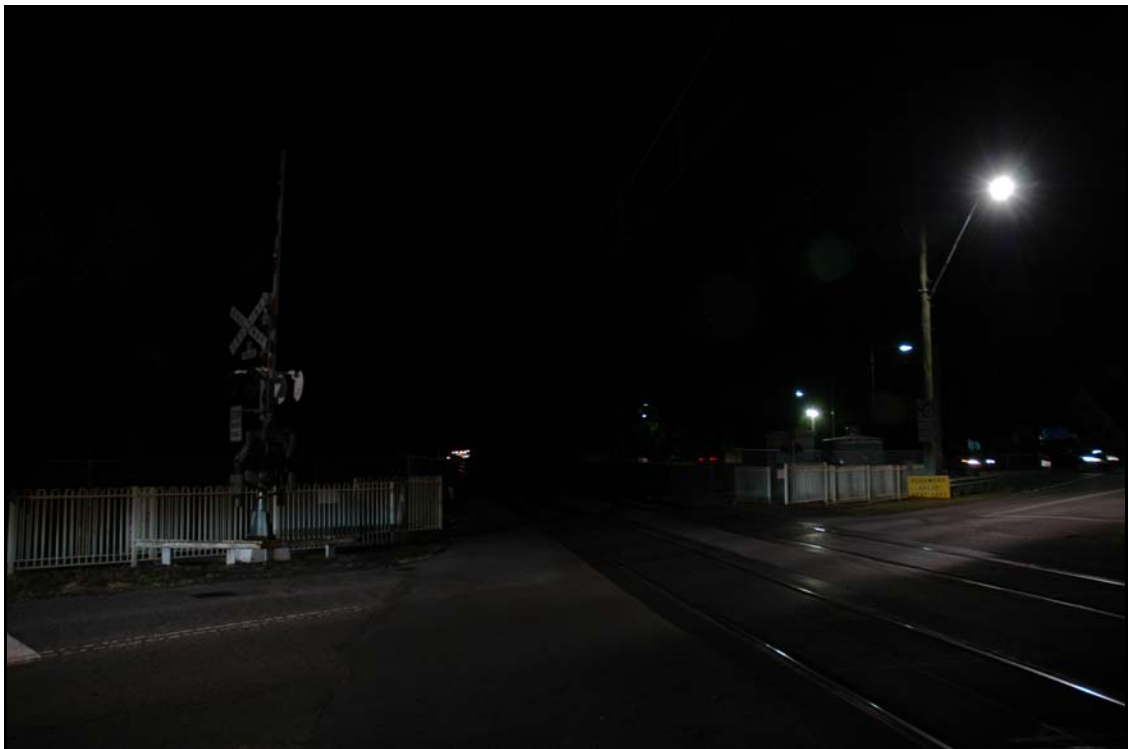
- 1.4 The RMV had been travelling along Rawson Road in an Easterly direction with the driver intending to turn left into Railway Street, a street running parallel to the line immediately past the crossing.

Photograph 2: Level crossing area where RMV driver entered rail corridor

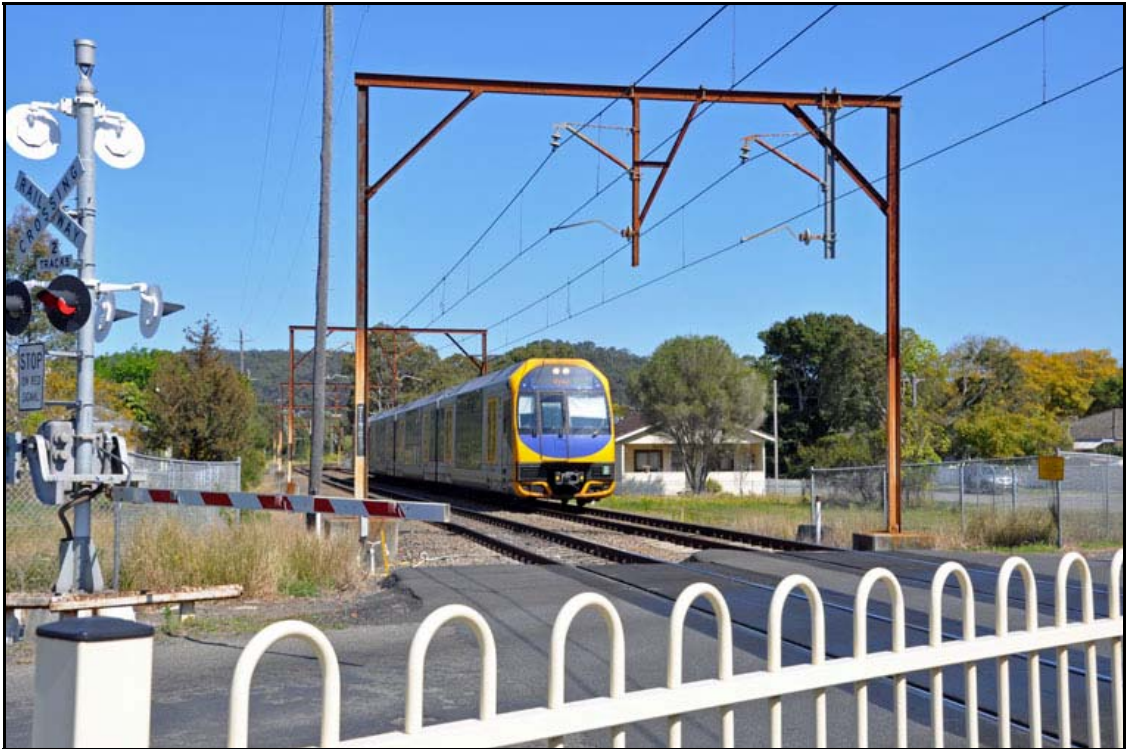
- 1.13 289G consisted of two OSCAR electric multiple unit (EMU) sets (H15 and H24) coupled together measuring approximately 160m in length and weighing 400 tonnes (see *Photograph 4*).
- 1.14 It was crewed by a driver based at Gosford Depot and a guard based at Sydney Depot. Both were familiar with and qualified for the route.
- 1.15 The service had departed Central Station at 5.00pm en route to Wyong under fixed signals, and was running to schedule.

Photograph 4: An OSCAR EMU set approaching the level crossing

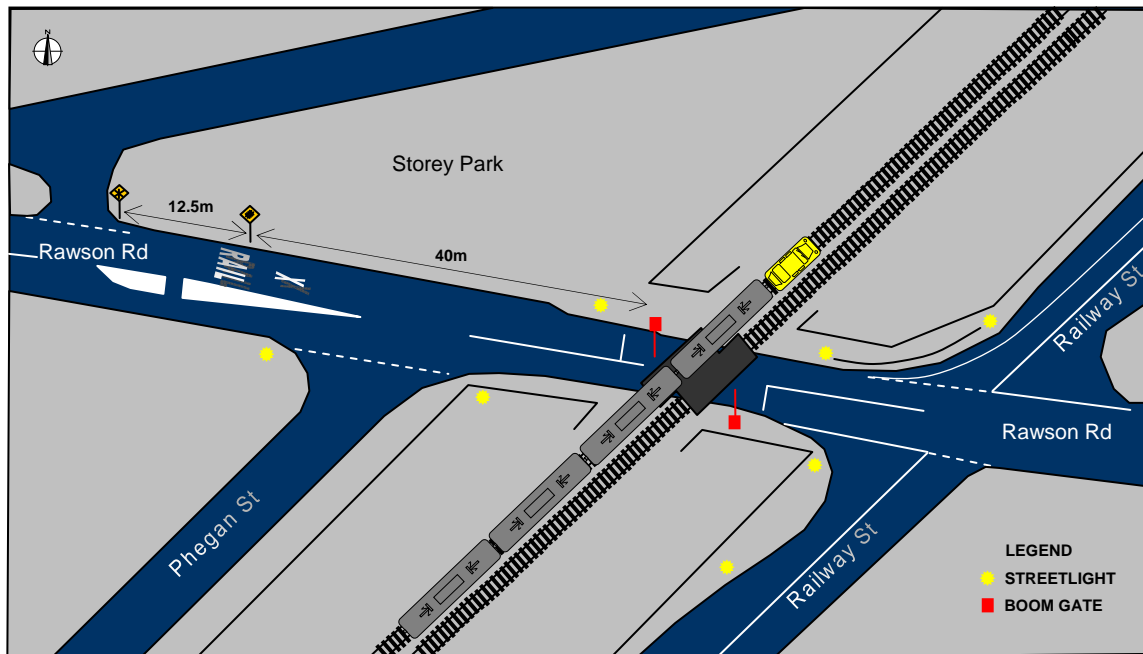
- 1.29 The conditions at the time of the incident were dark, clear and dry. The sun had set at 5.37pm with civil twilight at 6.02pm. There was no fog or rain in the region at the time.
- 1.30 Although dark, there were seven overhead street lights in the immediate vicinity of the crossing (see *Figure 3*). All these lights were operating at the time.
- 1.31 There were multiple road and pedestrian signs in varying colours, fonts and sizes on the approach to and immediately after the crossing.
- 1.32 Visibility through the RMV windscreen could not be determined due to the damage sustained in the collision.

Figure 3: Position of street lighting in vicinity of crossing
