Bus Safety Investigation Report

Bus fire m/o9340 — Lane Cove Tunnel, 14 April 2022

Investigation Reference I02024

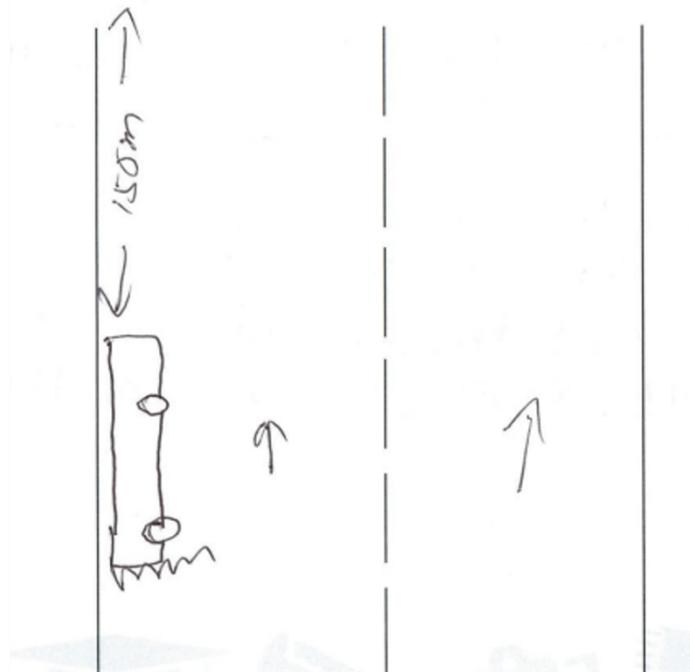
Figure 5: Lane Cove Tunnel smoke scenario

1.44 As part of the scenario for the Lane Cove Tunnel, the driver was required to detail where they would park the bus, who they would contact, and if they would evacuate into the tunnel. The driver was also required to draw the positioning of the bus in the lane. The driver's response was to stop in the left lane (Lane 1), contact the Operations Control Centre (OCC) by mobile and evacuate 150 m in front of the bus (Figure 5).

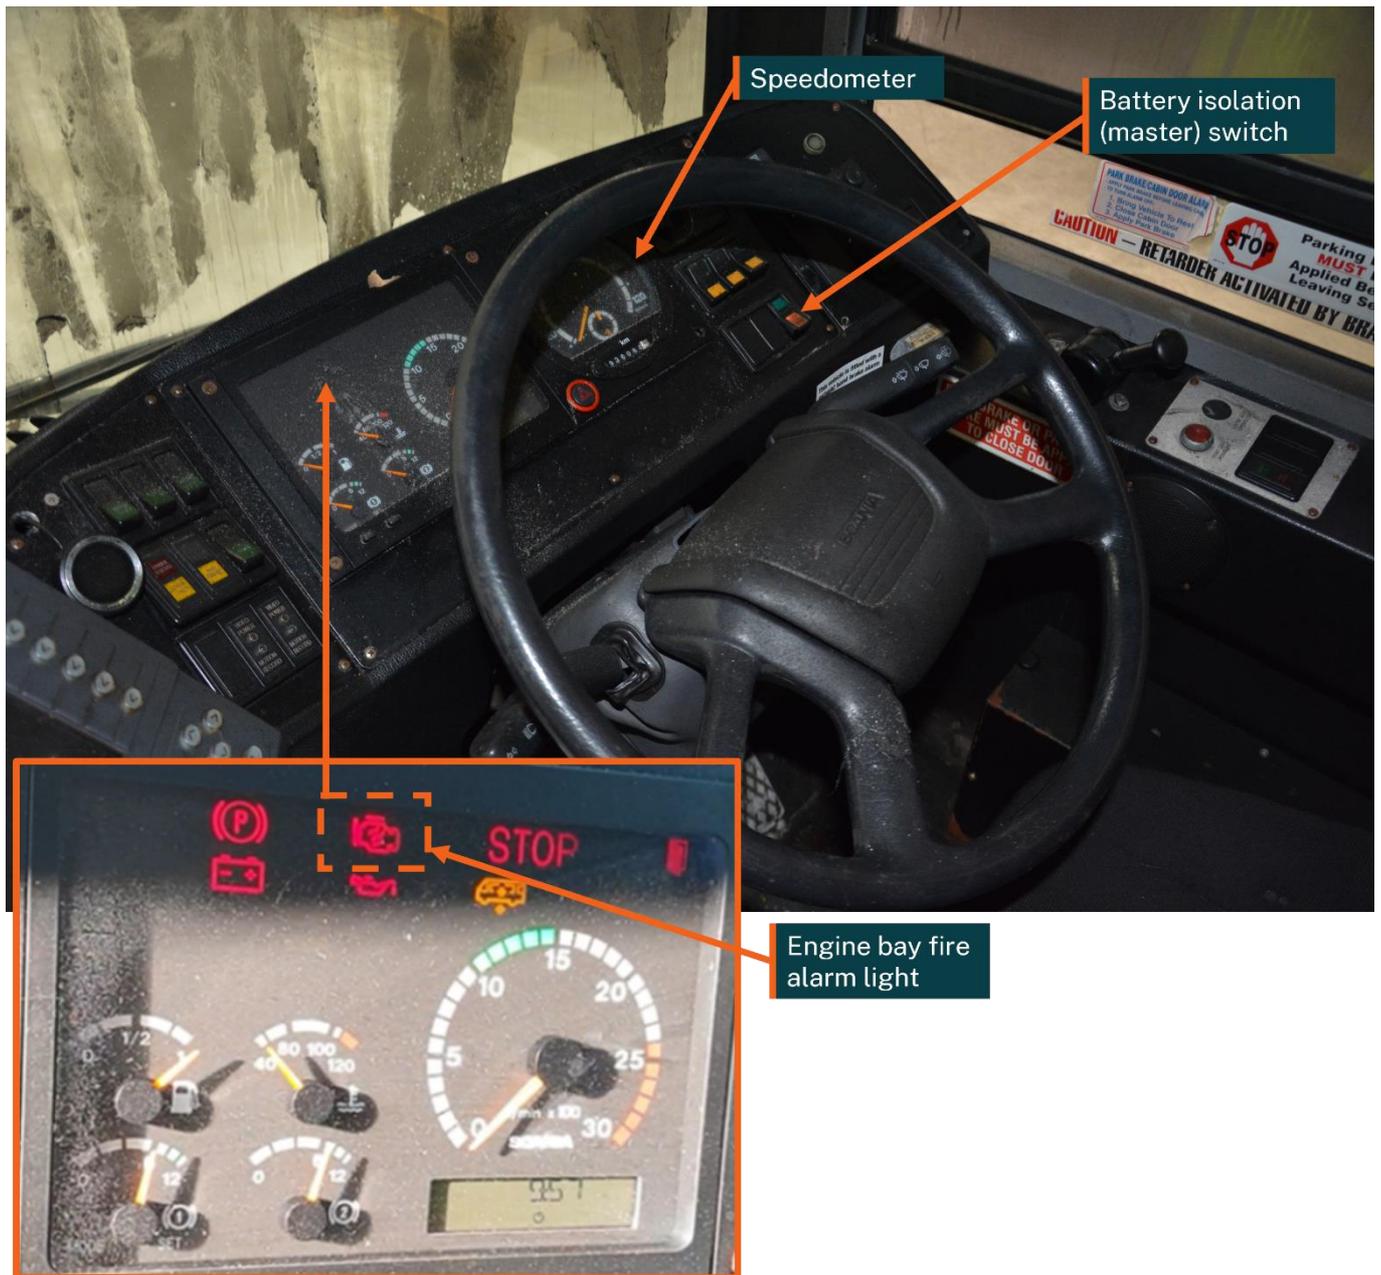
Figure 6: Bus m/o9340 dashboard and fire alarm

- 1.56 There were three Scania engine bay fire sensors (thermal cut off) in the engine bay. The three sensors were connected in series¹⁹ and if triggered and serviceable, would provide an engine fire alarm (red) warning light on the dashboard to alert the driver (Figure 6). The sensors were normally closed²⁰ with an opening temperature of 130°C±10°C. The sensor would automatically

The control unit would also activate an alarm (horn and light output) that was connected to an engine fire alarm light on the driver's dashboard and audible alarm (Figure 6). The audible alarm to alert the driver was not unique to the EBFSS and was the same alarm used for multiple other alerts or faults.

- 2.14 The driver reported that they did not see or hear any alarms and were observing the speedometer once within the tunnel. The engine fire alarm light was near the speedometer if it was activated (Figure 6). The on-board CCTV did not record audio and there was no vision of the dashboard to confirm if a warning light or audible alarm was present.

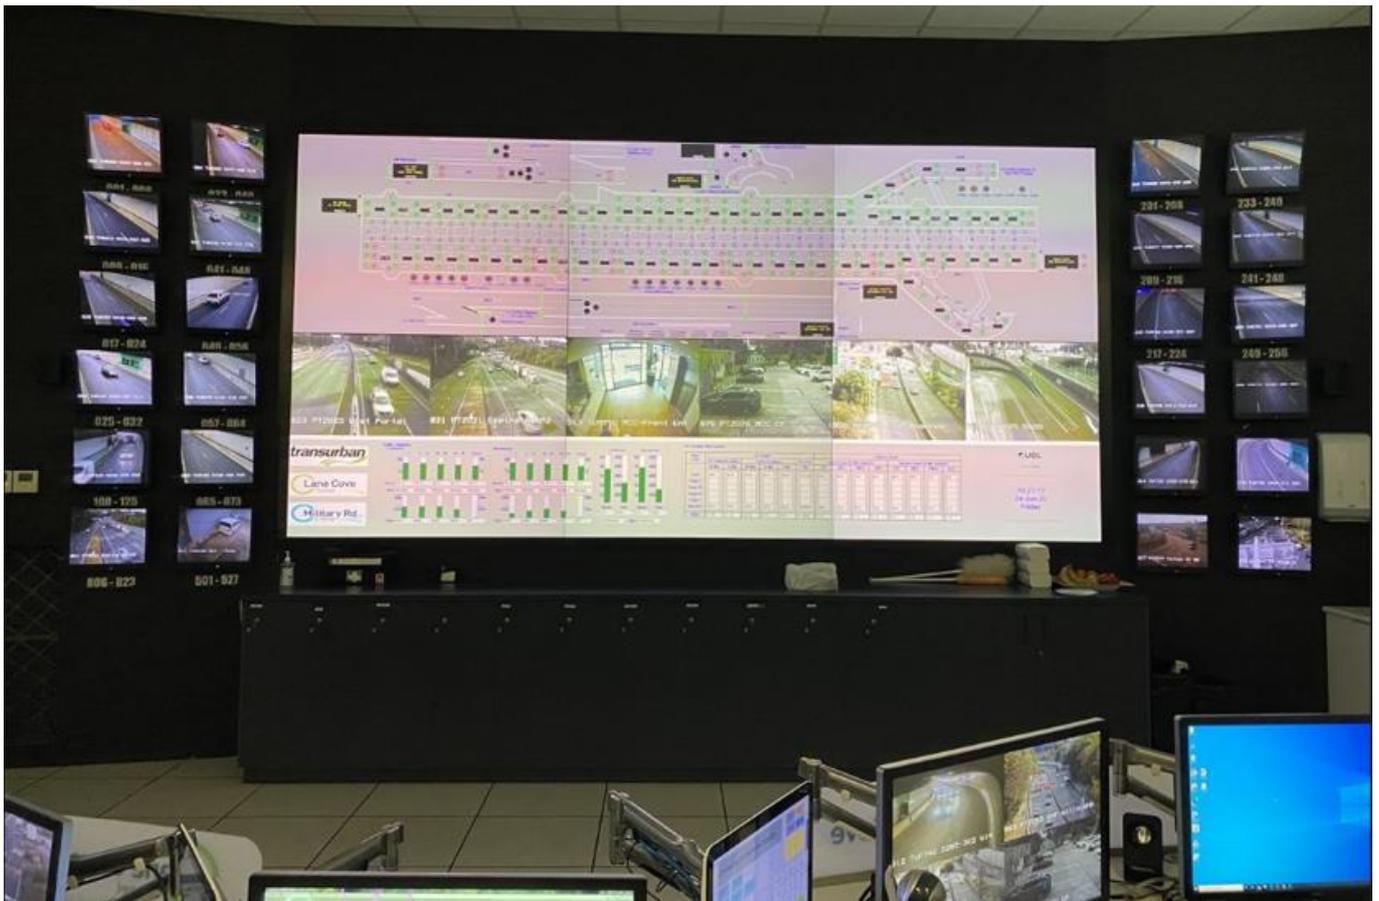
Figure 7: Lane Cove Tunnel control room display

- 1.67 The tunnel and motorway were operated by Transurban²⁴ and controlled by the Traffic Control Room Officers (TCROs) at the Motorway Control Centre (MCC). The MCC was configured with a large display that provided a graphical representation of the tunnel and equipment, and six selected CCTV displays (Figure 7). There were also 24 CCTV screens that scrolled every three seconds showing the cameras from the tunnel and motorway.

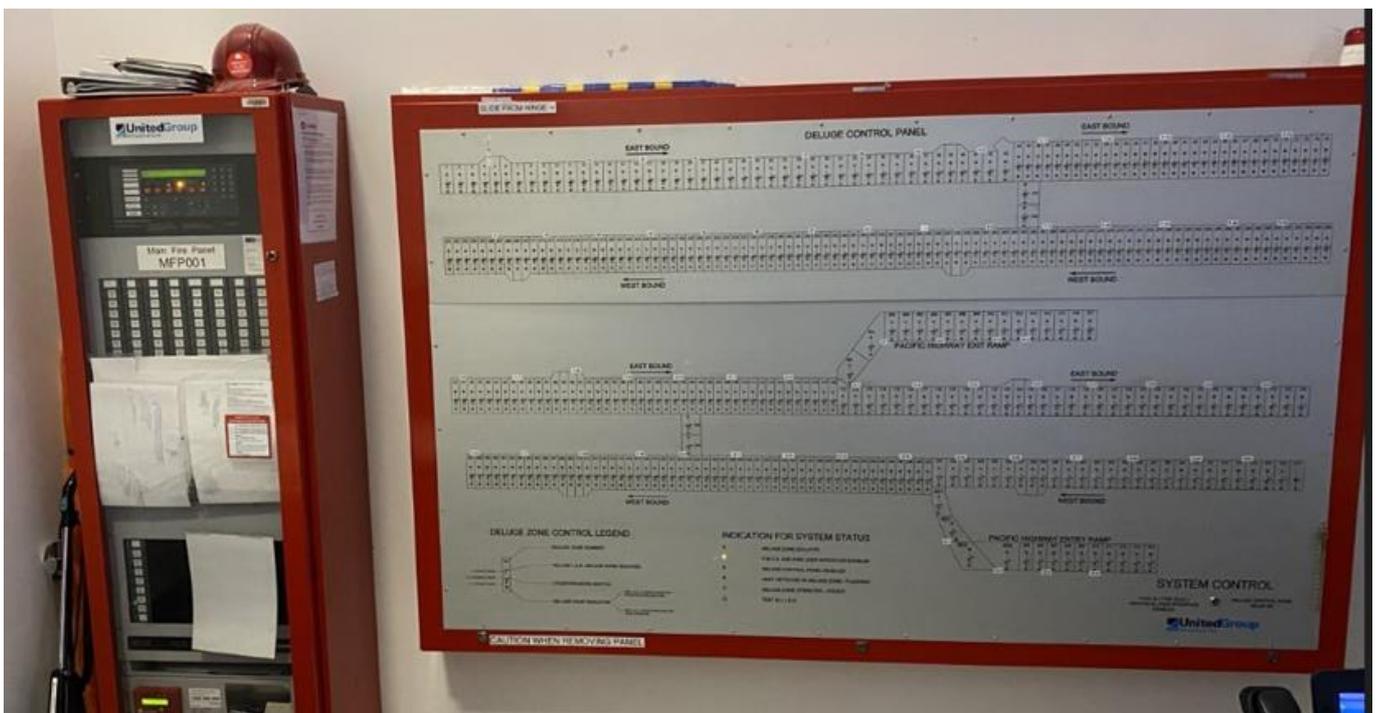
Figure 8: Fire and deluge control panel

- 1.68 There were two workstations for the TCROs where they could control the tunnel operations management control system (OMCS). The fire panel and deluge control panel were also located within the control room (Figure 8).
- 1.69 Two TCROs were on shift at the time of the fire and responded to the incident. Both operators were trained and competent to perform their roles.
- 1.70 Both TCROs had completed scenarios-based assessments for their responses to a vehicle fire within the tunnel using a training simulator. The assessments were completed in November 2019 for one TCRO and February 2022 for the other.
