Bus Safety Investigation Report

Bus Fire 2169ST Camperdown, NSW
13 January 2022

Published
November 2023

Investigation Reference I02019

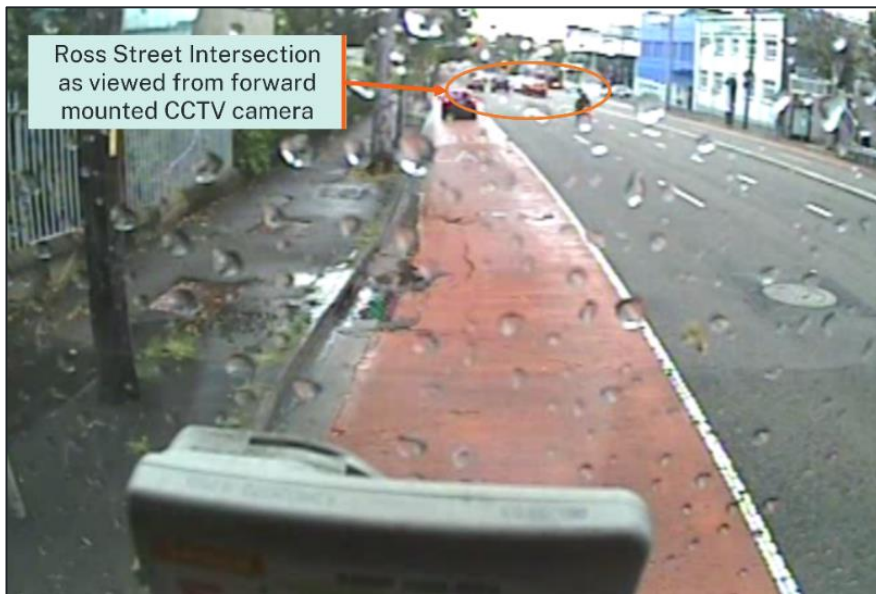
Figure 2: Bus final stopped position at 1553:12 from forward facing CCTV camera

- 1.17 The incident occurred approximately 85 m east of a traffic light-controlled intersection of Parramatta Road and Ross Street, Camperdown (Figure 1, Figure 2). The intersection is located approximately 3 km from the Sydney CBD. The bus had been travelling in a westerly direction along Parramatta Road.

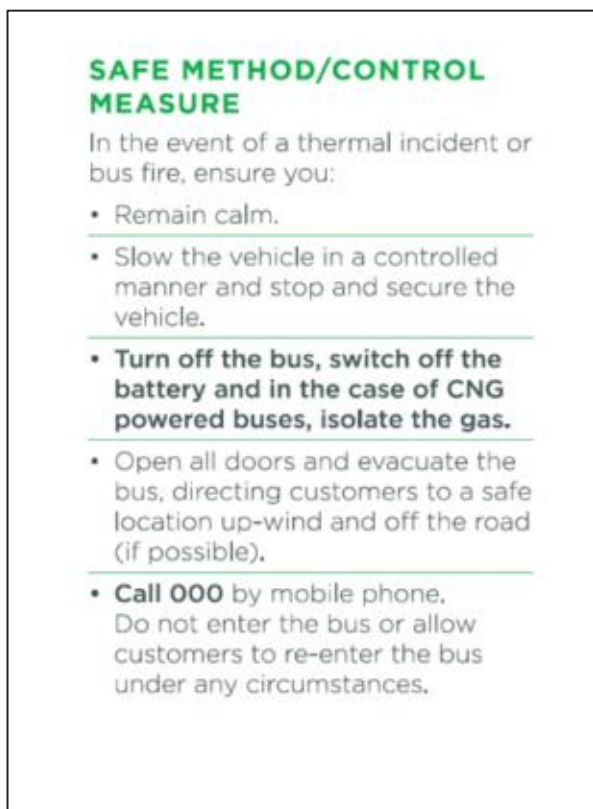
Figure 3: Operator's driver guidelines handbook excerpt

- 1.25 TSW had a driver training program in place which included annual emergency response training.
- 1.26 The TSW operator's 'Drivers Guidelines Handbook' contained a page on bus fires and associated actions (Figure 3). On 1 July 2019, TSW released a new Driver Guidelines Handbook, which included Thermal Events/Bus Fire response. TSW had reported that all employees were issued the new book and were allocated paid time to read and understand the handbook.

- 1.27 Driver training documentation titled 'Fire Control Systems' and 'Predeparture Checks', also contained information relating to the operation of Tyre Monitoring Systems, how to deal with fire in engine bays, operation of fire extinguishers and an overview of the Fogmaker Fire Suppression System (Figure 3, Figure 4).

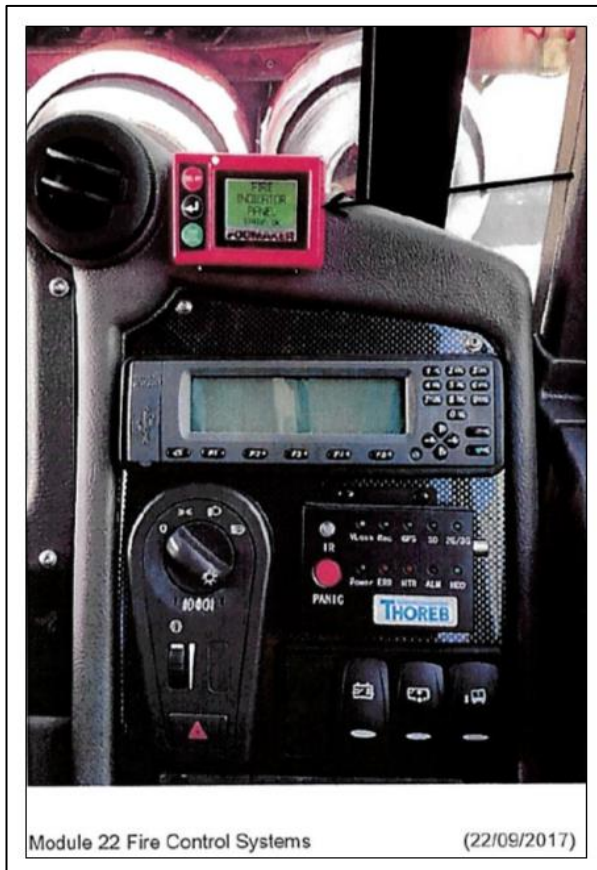
Figure 4: Fogmaker EBFSS Smart Panel

- 1.28 It was noted that the Fogmaker Fire Suppression System alarm panel shown in 'Module 22 Fire Control Systems' was not fitted to 2169ST.

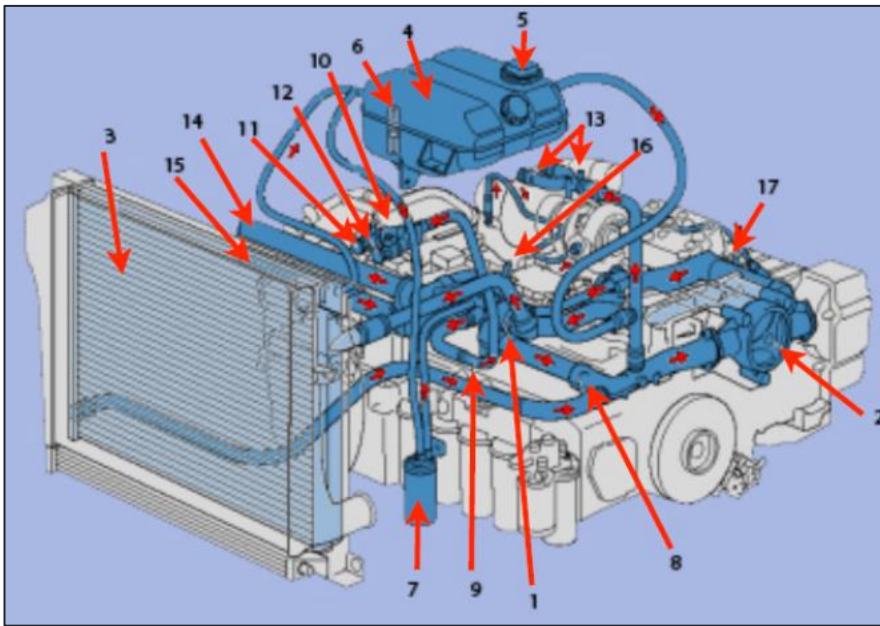
Figure 5: Volvo B12BLEA cooling system components

- 2.17 Additionally, given the volume of the cooling system, location of the header tank (Figure 5, item #4), and that the cooling system was pressurised, it is highly likely that coolant continued to flow from the split in the hose after the engine was shut down. This would supply further fuel to the immediate area of the concentration of the observed fire activity possibly resulting in reignition of the fire.

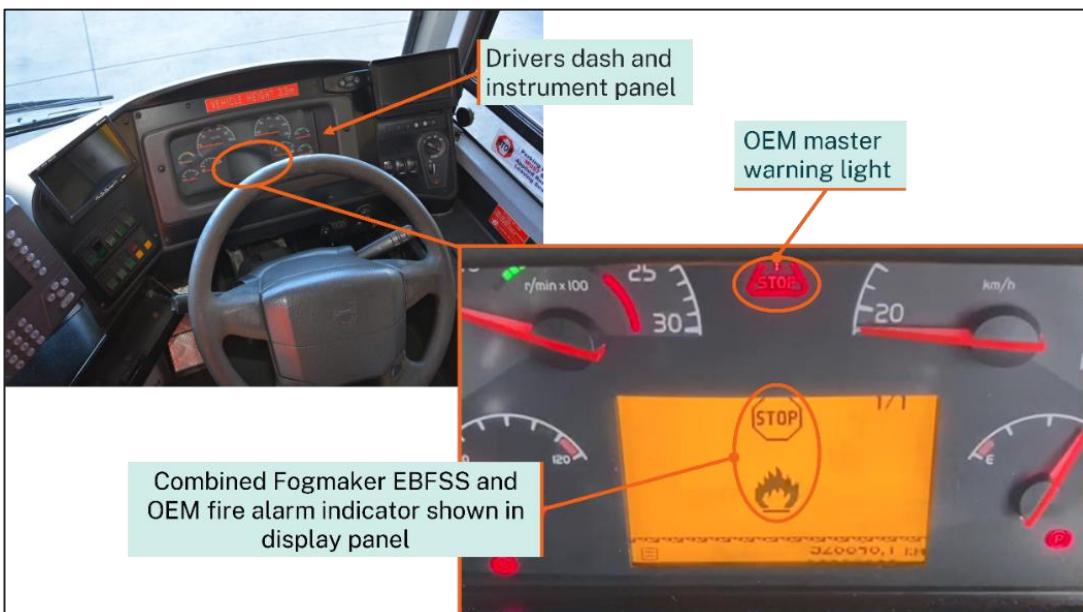
Figure 8: Drivers instrument panel engine bay fire alarms

- 1.37 The bus was fitted with two separate engine bay fire alarm systems, one fitted by the Original Equipment Manufacturer (OEM) and the other incorporated into the Fogmaker Engine Bay Fire Suppression System (EBFSS).
- 1.38 The OEM and EBFSS fire alarms were incorporated into the instrument panel and utilised the same audible alarm in addition to other systems: high engine temperature, low engine oil pressure, and low brake air pressure (Figure 8).
- 1.39 Both the OEM fire alarm and EBFSS alarm also utilised the OEM master alarm warning light. This was depicted by a red triangle with the word stop (Figure 8). This symbol was also utilised by the same alarm systems as mentioned in 1.38.

- 1.52 If both switches provided signals, as a result of loss of pressure in both the detection canister and agent tank, a fire alarm was provided to the driver on the instrument panel in both audible and visual forms (Figure 8).

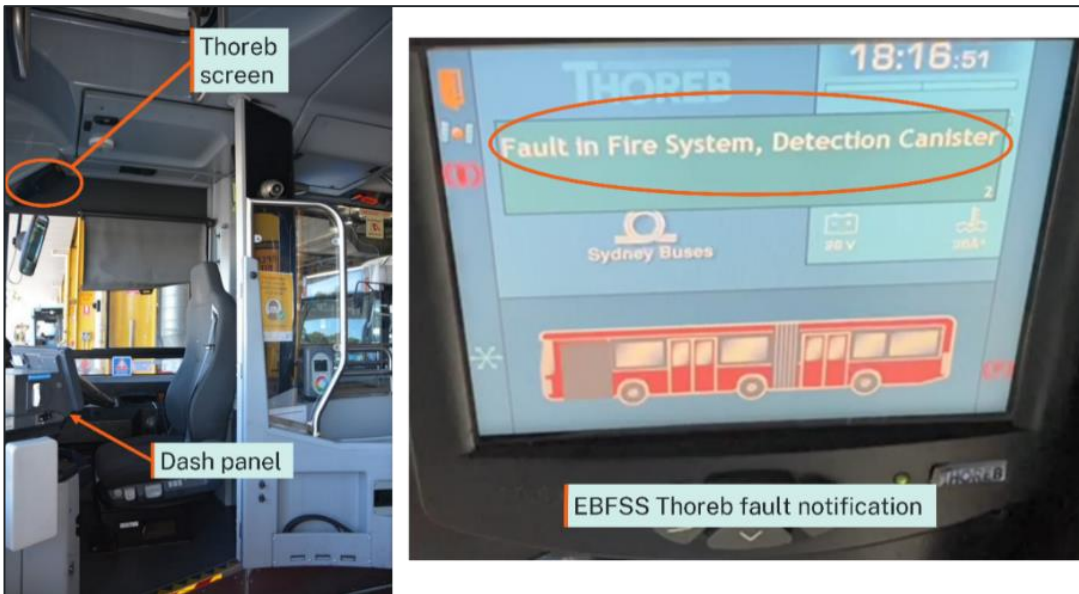
Figure 9: Location of Thoreb screen, driver’s dash panel and Thoreb fault notification

1.40 The Fogmaker EBFSS system had two separate alarms. In addition to the alarms previously mentioned, a visual only fault indicator appears on the Thoreb⁶ display panel (Figure 9).

- 1.51 The Fogmaker EBFSS alarm relied on signals from two pressure switches: one attached to the detection canister and the other to the agent tank. A signal from only one switch, either the agent tank or detection canister, gave a fault notification which displayed on the Thoreb screen above the driver in visual form only (Figure 9).

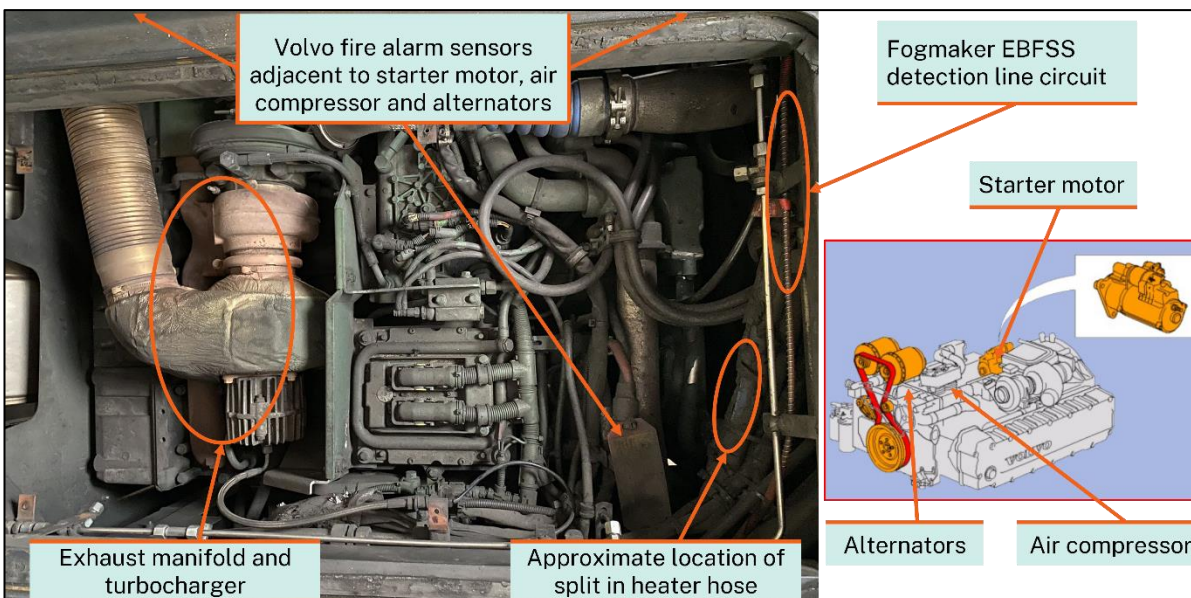
Figure 10: Location of OEM fire sensors and EBFSS detection tube

1.41 The OEM fire alarm utilises three thermal sensors located on the engine assembly. Of the three sensors, two are set to activate at 110°C and the other at 150°C. They are located adjacent to the starter motor (110°C), alternators (110°C), and air compressor (150°C) (Figure 10).

- 2.39 The OEM fire alarm sensors were located adjacent to the starter motor, air compressor and alternators and are below the level of the EBFSS detection line (Figure 10, Figure 22).

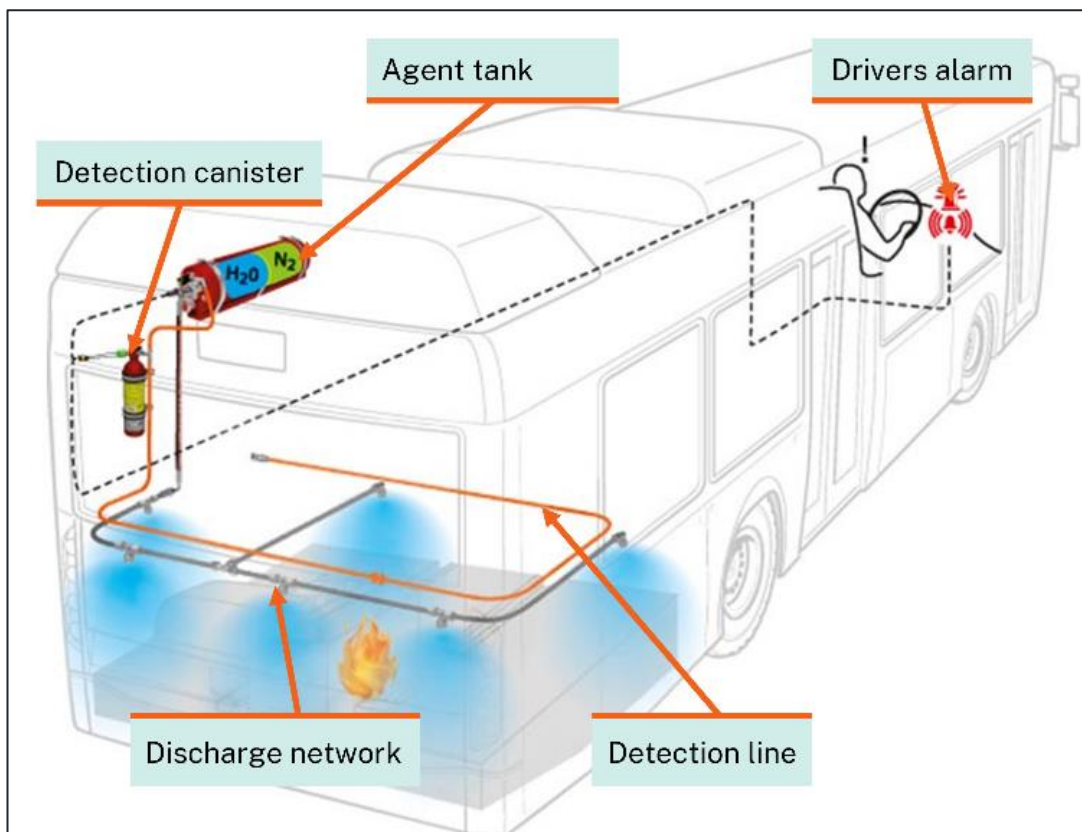
Figure 11: Basic engine bay fire suppression system layout

- 1.46 The main components of the system are the detection canister, detection line network, agent tank and discharge network (Figure 11).

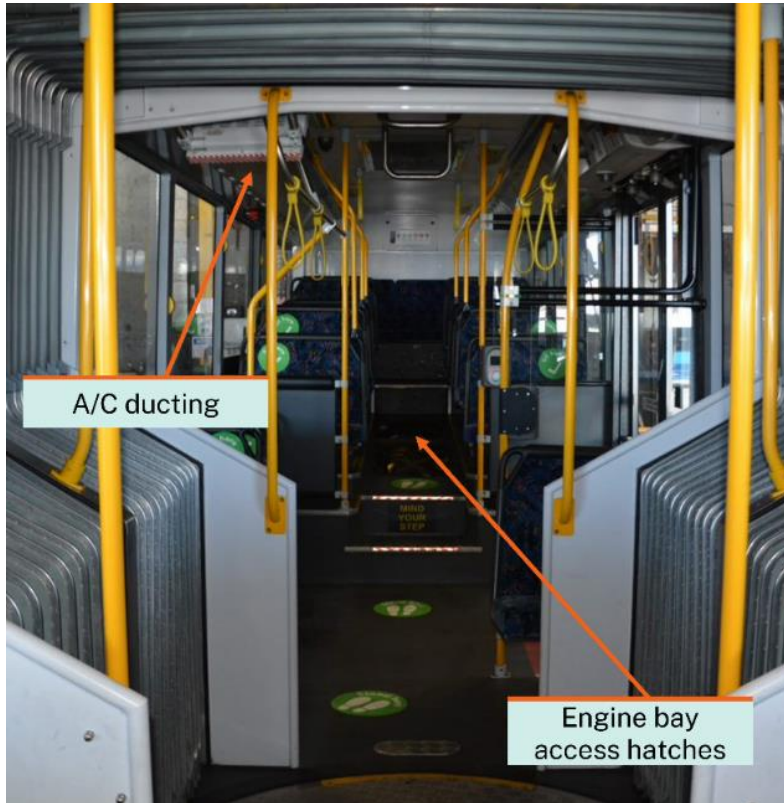
Figure 13: Bus interior

1.54 During the inspection of the bus, the O/S rear interior air conditioning (A/C) duct panels were removed to determine if the fire had penetrated the saloon area (Figure 13).
