Bus Safety Investigation Report

Bus Fire MO9994 — Green Valley, 8 August 2022

Published
March 2024

Investigation Reference I02028

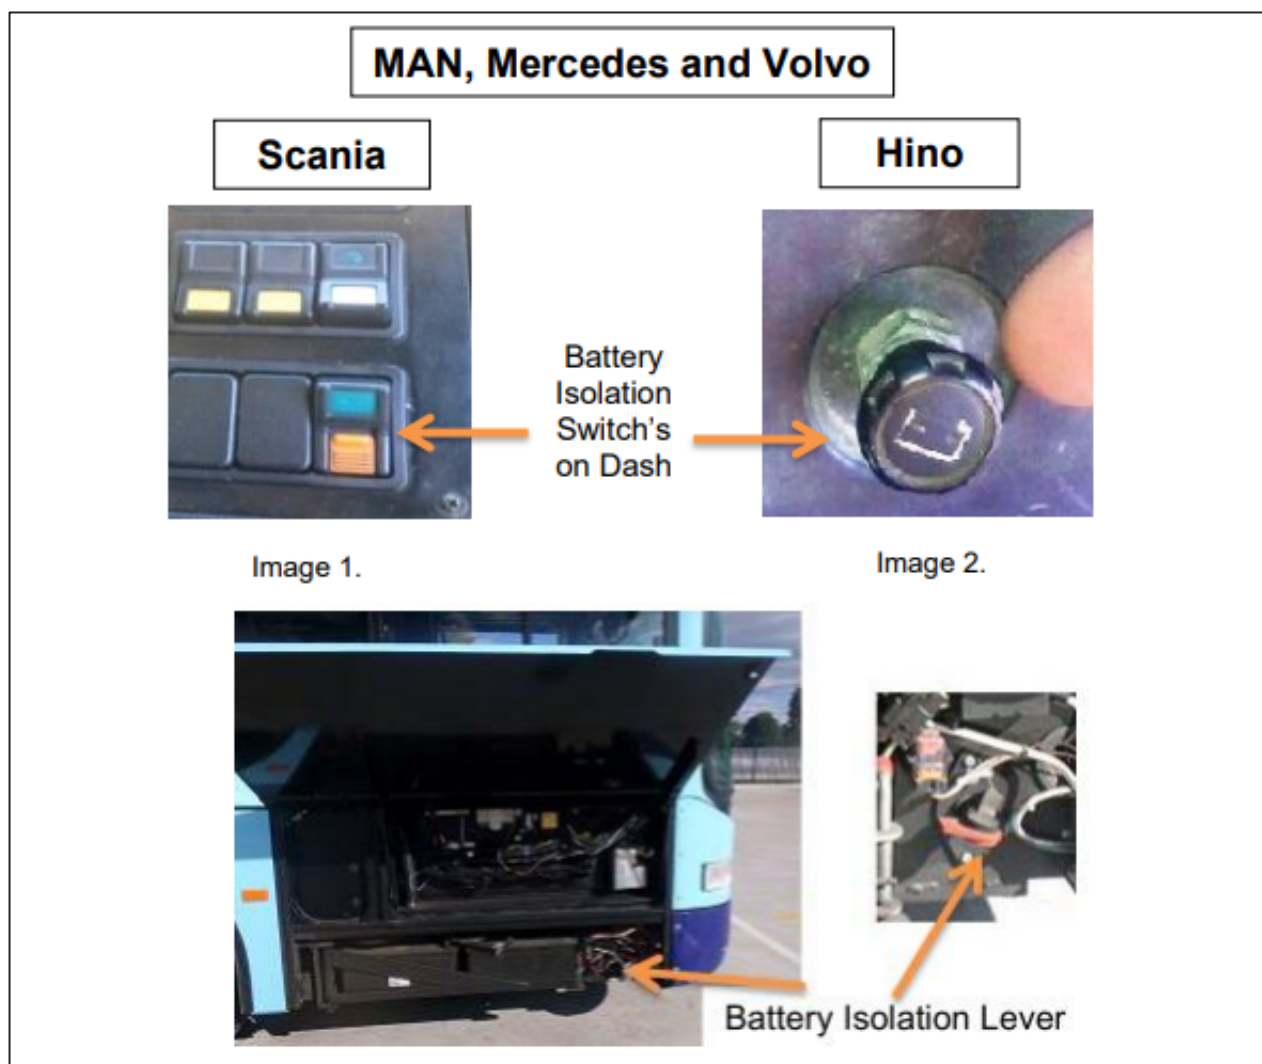
Figure 9: Excerpt from Transit Systems NSW SWP015 – Battery isolation switches

- If safe to do so, fight any flare-up residual fire with the bus fire extinguisher.
- 1.26 The bus fire procedure also instructed a driver to ‘lift hatch under drivers [sic] window and turn off bus electrics using isolation lever as per image 1 & image 2 below’, if safe to do so. The images provided in the Procedure for battery isolation did not show an example of the battery isolation switch fitted to the involved bus model (Figure 9).

- 2.42 TSNSW's Standard Work Procedure (SWP) SWP015 *Emergency Evacuation Procedures for all Buses* illustrated a series of battery isolation switches (Figure 9). TSNSW Driver Guidelines Handbook '*Bus fire*' stated that a driver should 'switch off the battery' (Figure 10) but did not provide information on the location of battery isolation switches or safety consideration of 'if safe to do so', which was contained in SWP015.
- 2.43 While SWP015 and the Driver Guidelines Handbook were designed as driver reference and support material, the provision of recurrent practical, competency-based refresher training, by bus operators, should provide drivers with the skills and knowledge to effectively manage a bus fire/thermal event.
- 2.44 As the Accessory Panel cabinets were locked, the fire commencement site was inaccessible with the onboard portable fire extinguisher.

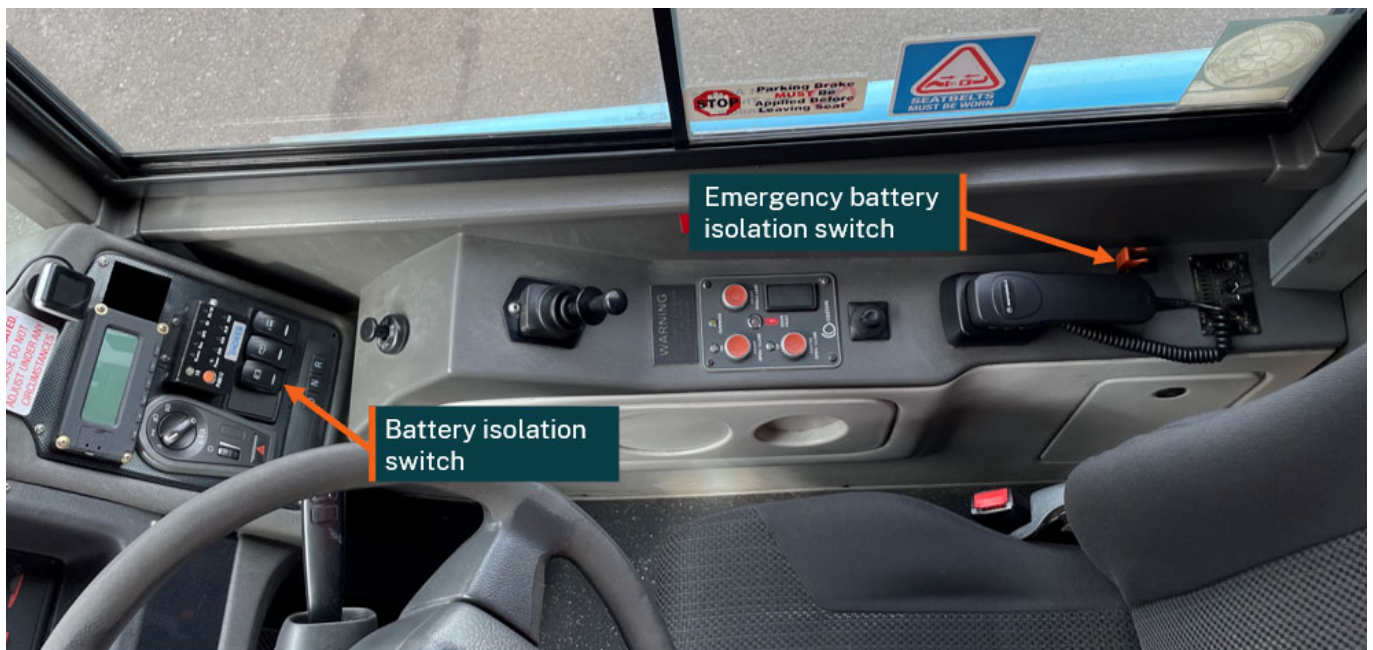
Figure 12: Driver console main battery switches from exemplar bus

- 1.38 The bus involved in the incident was a 2016 Volvo B7RLE, registered in NSW as MO9994, and powered by a Volvo six-cylinder turbo charged diesel engine. It was fitted with a Custom Bus Australia (Custom) CB80 body. MO9994 was procured under TfNSW Bus Panel 2 specifications in July 2016.
- 1.39 MO9994 had a fleet number of 1353 and Vehicle Identification Number of YV3R6R726GA175649. At the time of the fire, the bus had travelled approximately 461,000 kms.
- 1.40 MO9994 had a manually operated battery master switch located on the driver's instrument panel (Figure 12). MO9994 had this manual switch fitted as well as a second emergency isolation switch fitted by the bus body Original Equipment Manufacturer (OEM).

- 2.31 OTSI performed a series of tests, which involved first isolating the one and/or both switches on the driver console (Figure 12), then isolating the mechanical isolation switch next to the fuse box (Figure 13).
- 2.32 The isolation of one, two or all three of these switches had no effect on the continued electrical supply to the bus body circuit (Figure 32, Figure 33). The batteries could only be isolated from the bus body by using tools to remove the associated fuse or physically disconnecting the battery leads.

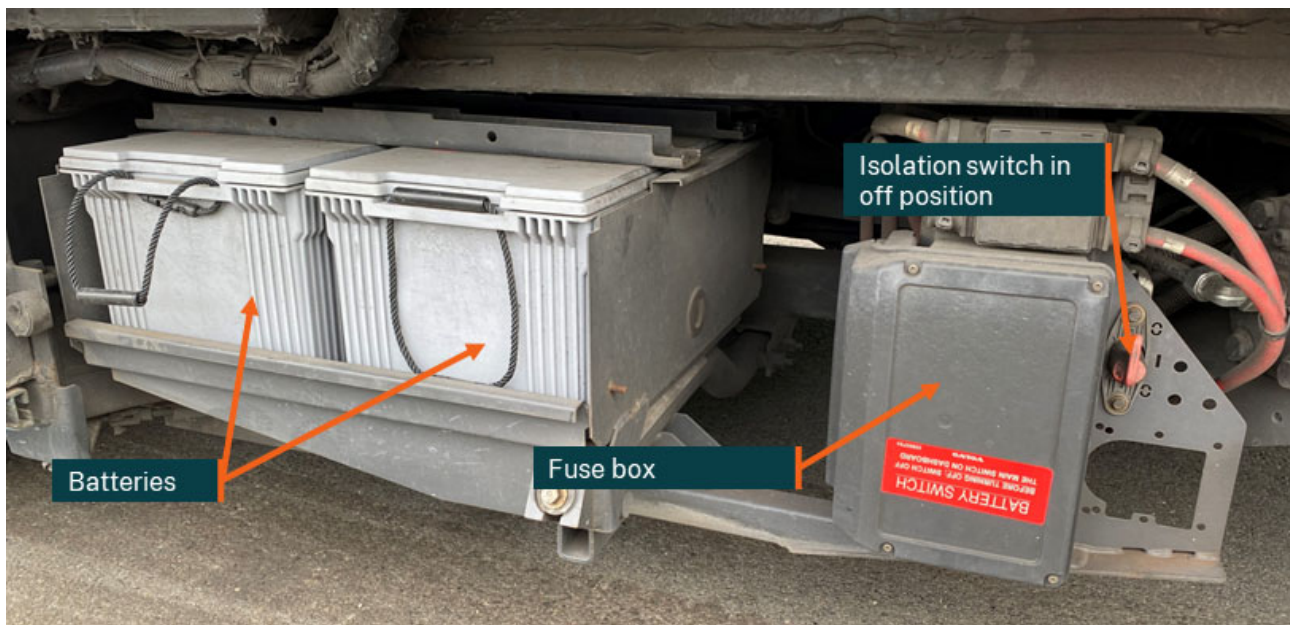
Figure 13: Batteries and fuse box

- 1.41 Electrical power to the bus body was supplied by two 12-volt batteries connected in series, providing 24-volts to the chassis, body, and electrical accessories. The batteries were located in an external swing out compartment located on the chassis, under the driver's compartment floor (Figure 13, Figure 18).
- 1.42 Electrical circuits are protected by fuses against faults, such as a short circuit. A fuse protects a system or equipment from overload and short circuit faults by cutting off the power to them. It achieves this by melting or vaporising the fuse element so that there is no physical connection or conductive path for the current flow through.
- 1.43 A fuse box installed by the chassis OEM, Volvo, was mounted near the battery box (Figure 13).

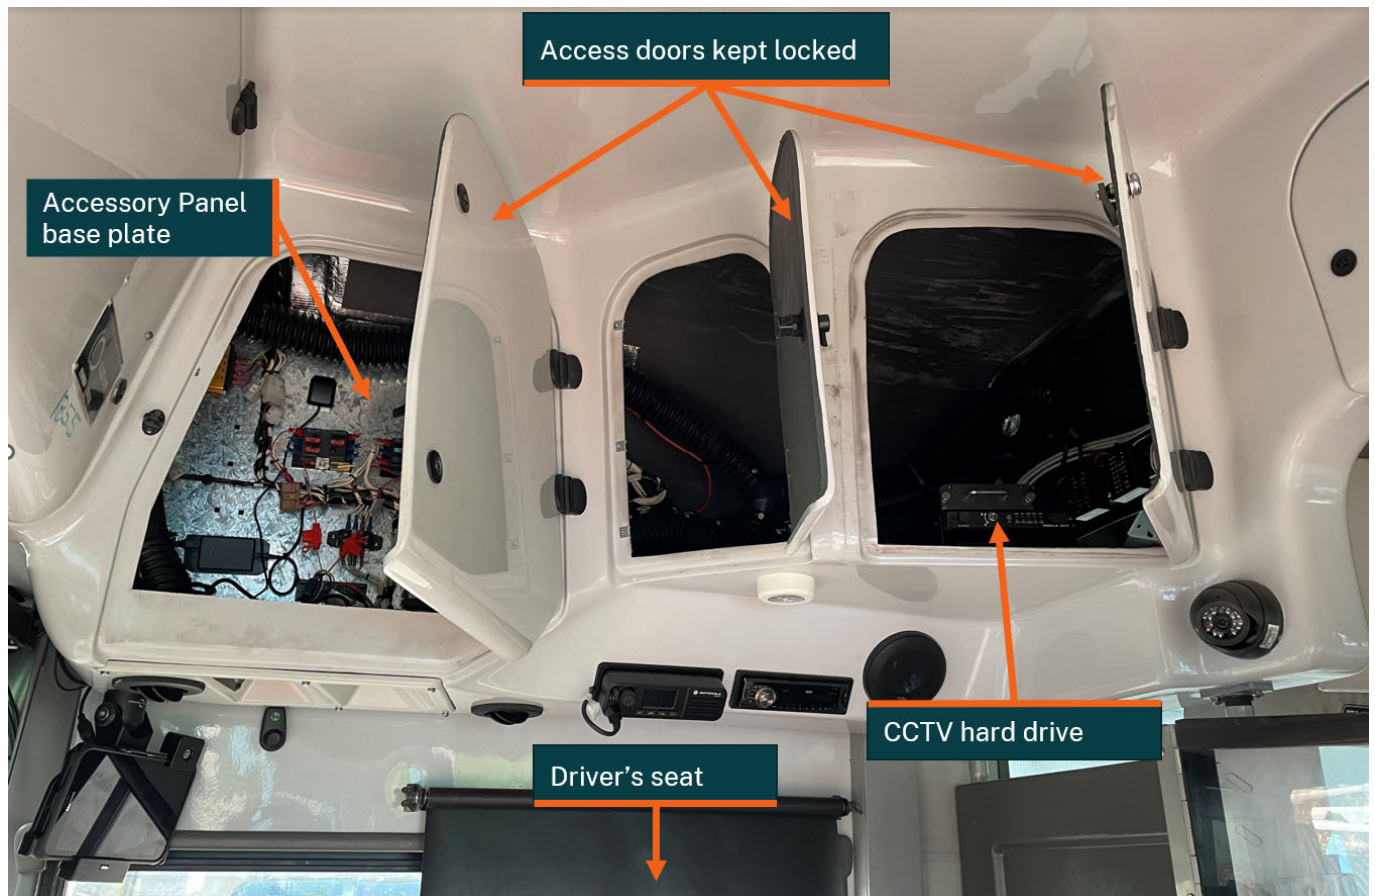
Figure 14: Accessory Panel above driver's seat in exemplar bus MO9992

- 1.44 The Accessory Panel was located inside a compartment above the driver's position, and accessible via three access doors, which were locked by the operator and accessible only for maintenance purposes (Figure 14, Figure 23). The compartment contained items such as the closed circuit television (CCTV) hard drive, two-way radio, FM radio, air conditioning controls, Green Road⁴ system connections and other various electronic components and fuse boards.

- 2.11 OTSI identified several uninsulated terminal posts on the Accessory Panel in the exemplar buses. These unprotected posts increased the risk of an electrical short circuit⁹ when the circuit was live if contact was made with conductive materials.
- 2.12 Electrical arcing was evident on the cable likely connected to the main B+ terminal post of the Accessory Panel located above the driver's position.
- 2.13 OTSI noted that the air conditioning flexible tubing in exemplar bus M09992 was mounted near metal components, including unprotected terminal posts, and associated wires on the Accessory Panel (Figure 23, Figure 24). The flexible tubing was constructed of a continuous wire coil covered in plastic.

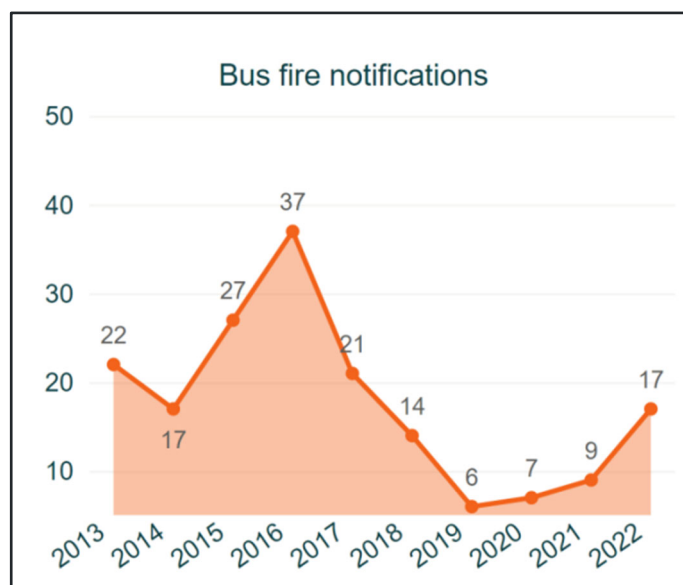
Figure 15: OTSI bus fire notifications 2013-2022

- 1.69 The OTSI Bus Fire Safety Report – *Bus Fires and Thermal Incidents in NSW from 2013 – 2022*,⁸ reports that in the period from 2013 to 2022, OTSI recorded 177 bus fire notifications in NSW (Figure 15).

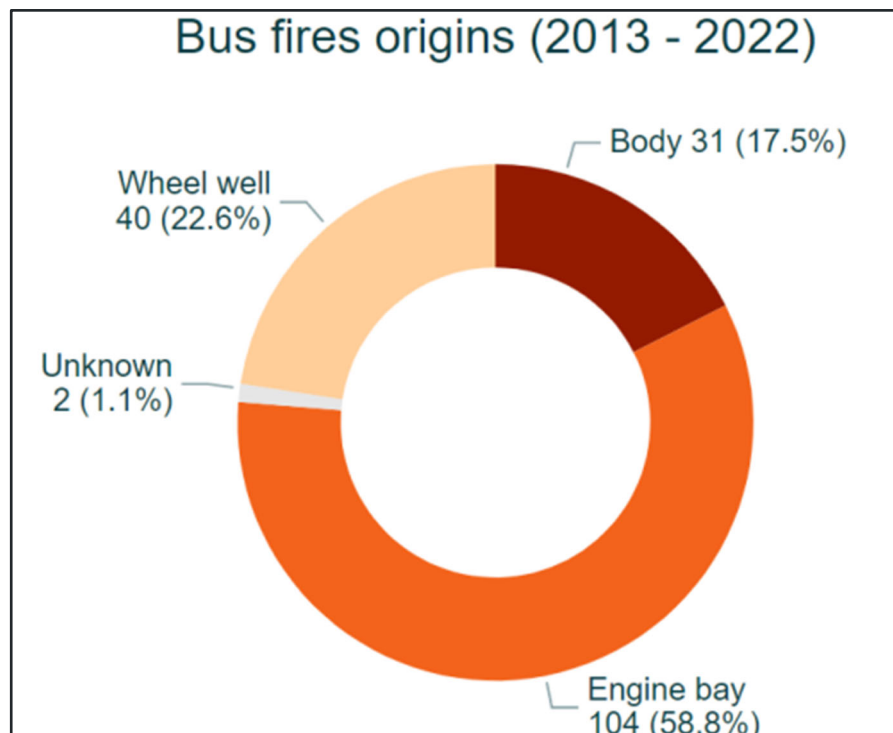
Figure 16: Bus fire origins

1.70 The Bus Fire Safety Report identified that in the 10 years between 2013 and 2022, fires located in the engine bay were the most common (Figure 16), with electrical faults identified as the leading cause (Figure 17).

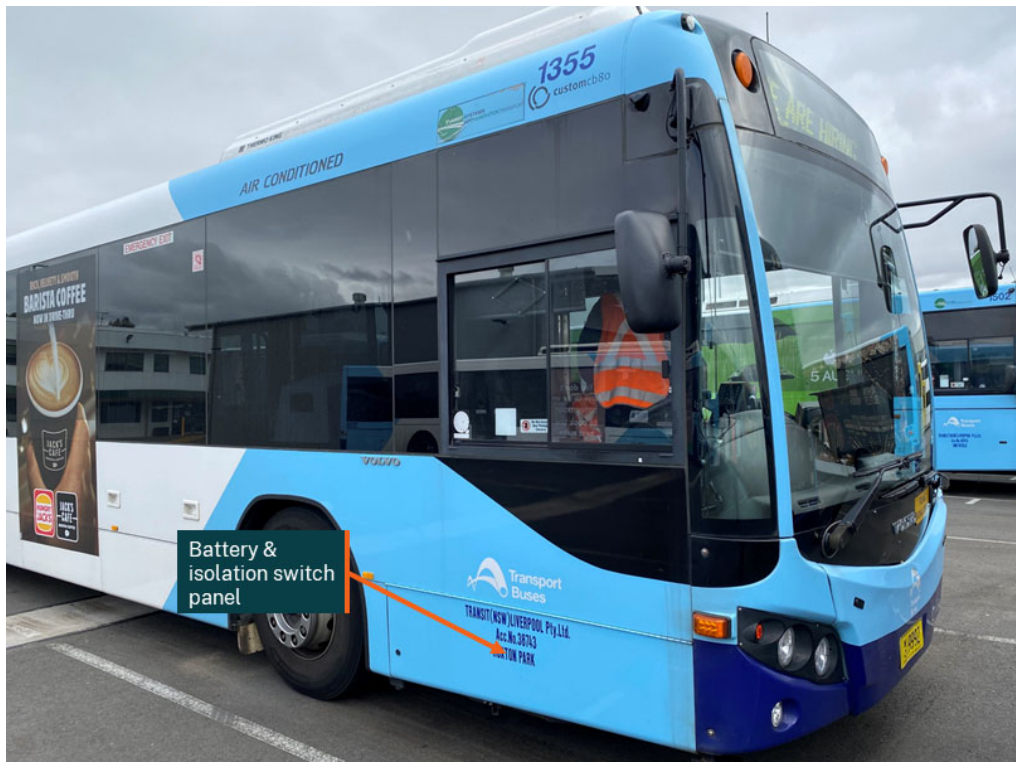
Figure 18: Exemplar bus M09992

- 2.3 Following the incident, OTSI investigators inspected the involved bus, M09994.
- 2.4 The bus operator, Transit Systems NSW (TSNSW), provided exemplar buses, registered M06705 and M09992 (Figure 18), for comparison. This allowed OTSI to better understand the layout of M09994 prior to the fire damage. Representatives from the bus operator and the bus chassis manufacturer, Volvo Bus Australia (Volvo), attended this inspection.
- 2.5 M09994 (body number G7101-01) was part of the delivery of three buses to TSNSW with exemplar buses M06705 (body number G7101-02) and M09992 (body number G7101-03).

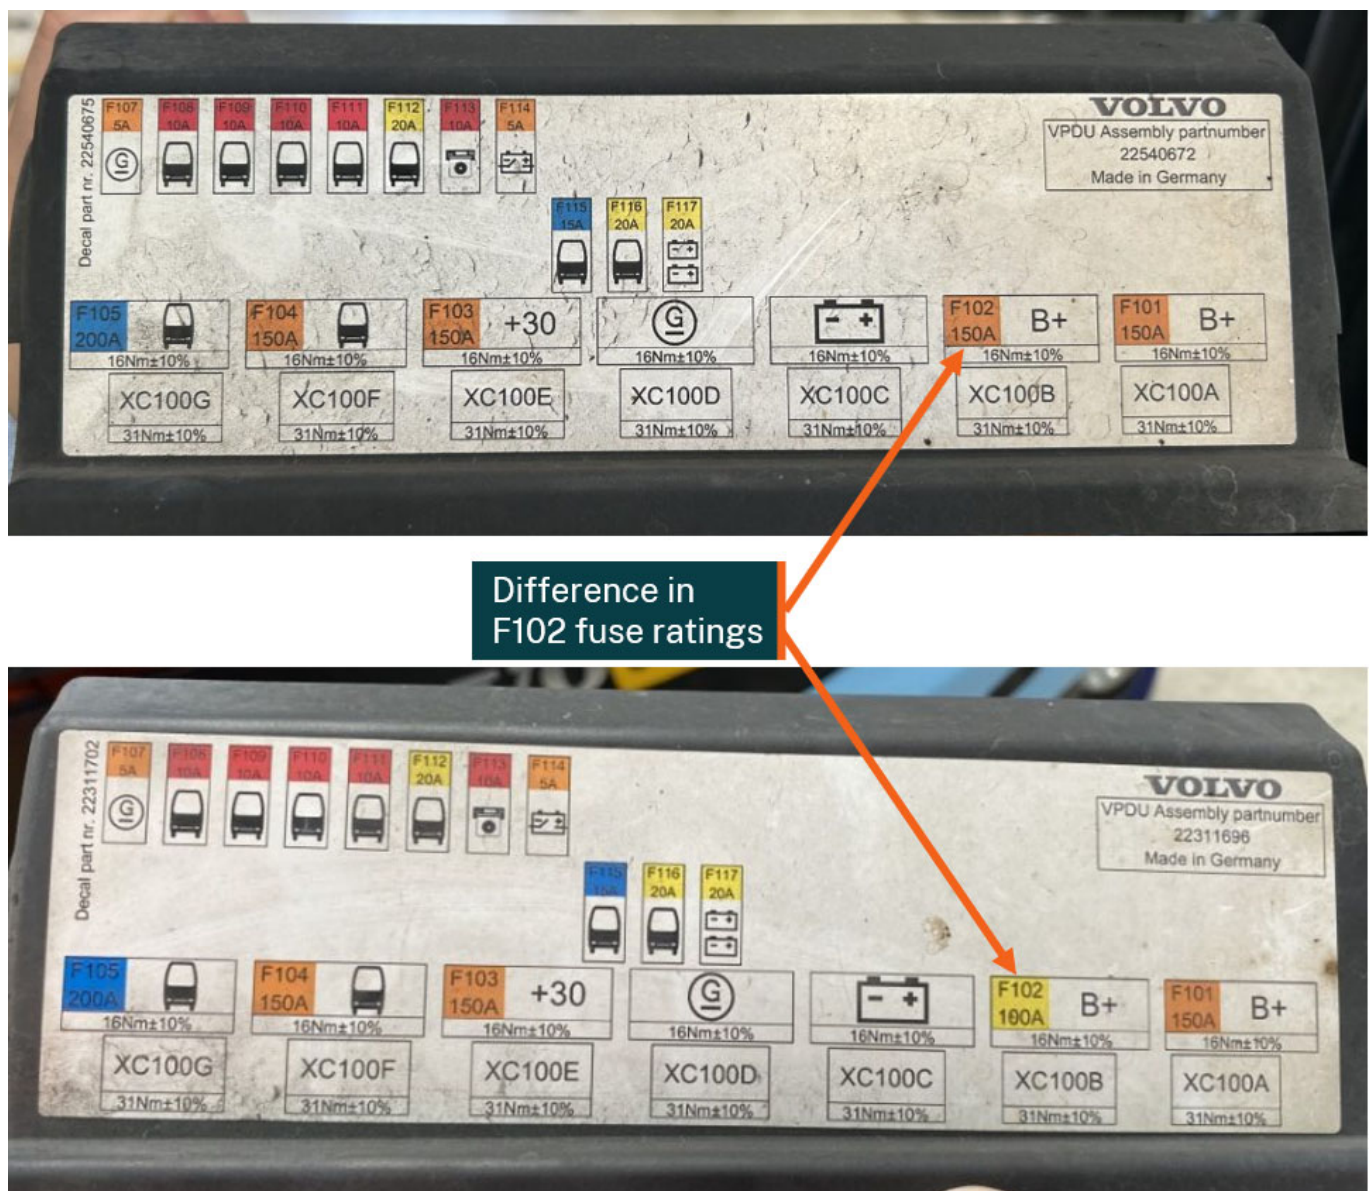
Figure 26: Volvo fuse box layout diagram

- 2.18 MO9994 was built to meet TfNSW Bus Procurement Panel 2 specifications, which did not include reference to any electrical Standard, such as Joint Australian/New Zealand Standard AS/NZS 3000:2018 – *Electrical installations* (known as the Australian/New Zealand Wiring Rules).
- 2.19 Due to the unavailability of supporting evidence, OTSI could not determine the Standard applied for the design and build of the involved CB80 body electrical system.
- 2.20 OTSI reviewed the Volvo fuse box diagrams, located on the inside cover of the fuse boxes on the exemplar buses, and identified that the F102 circuit fuses differed in rating between the two buses, with a 100-amp fuse in one bus and 150-amp in the other, for the same circuit (Figure 26). The fuse box cover for the involved bus was destroyed by fire.

- 2.23 OTSI could not determine a reason for the fuse box diagrams on the two exemplar buses differing to the electrical drawings and fuses fitted on all three buses.
- 2.24 From fuse F102, a 4 B&S¹⁰ (21.11mm²) cable was installed to supply power to the bus body circuit and connected to the Chassis Electrical Centre, located above the offside front wheel arch (Figure 29).

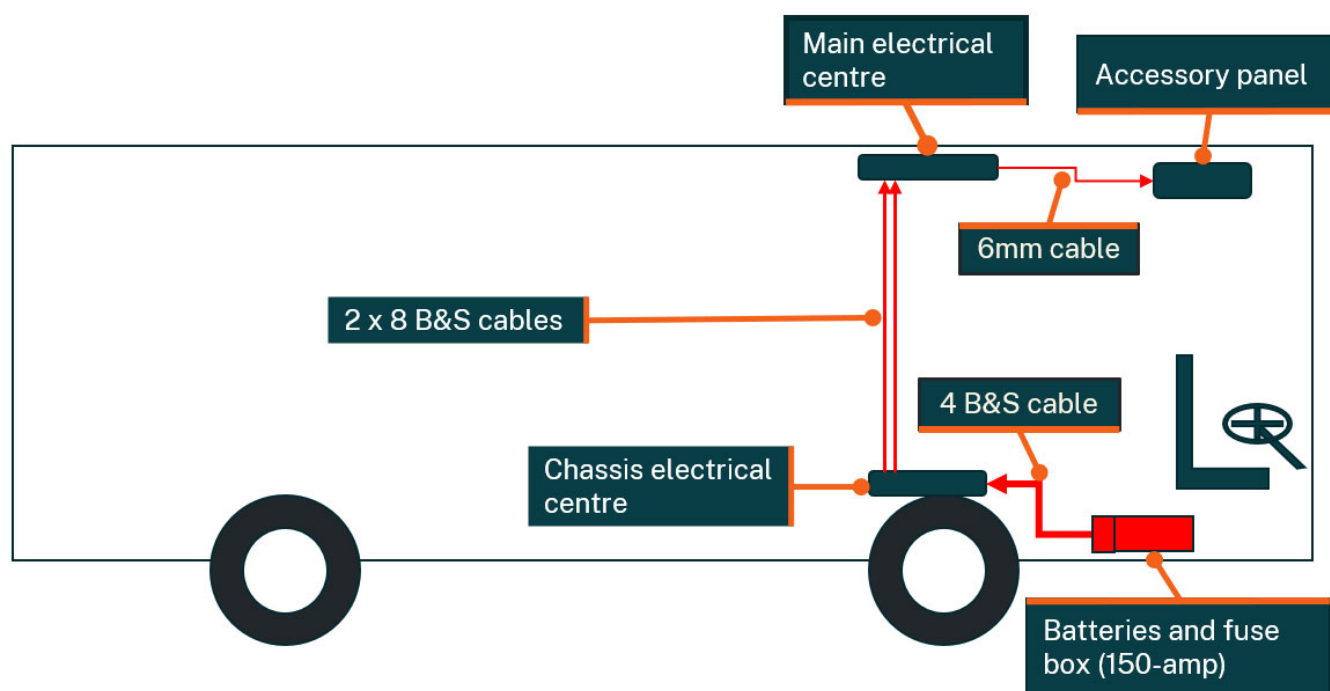
Figure 29: Simplified circuit layout

- 2.26 Power from the Chassis Electrical Centre was configured along two 8 B&S (7.73mm²) cables (continuous rating 50-amps each), to the Main Electrical Centre, located within the air conditioning duct panel directly above the offside front wheel arch (Figure 29). These cables were also connected at an uninsulated metal terminal post in the exemplar buses.
- 2.27 From the Main Electrical Centre, power to the Accessory Panel above the driver's seat, was provided through a single 6 mm cable (continuous rating 27amps). This cable was connected at an uninsulated metal terminal post in the exemplar buses.

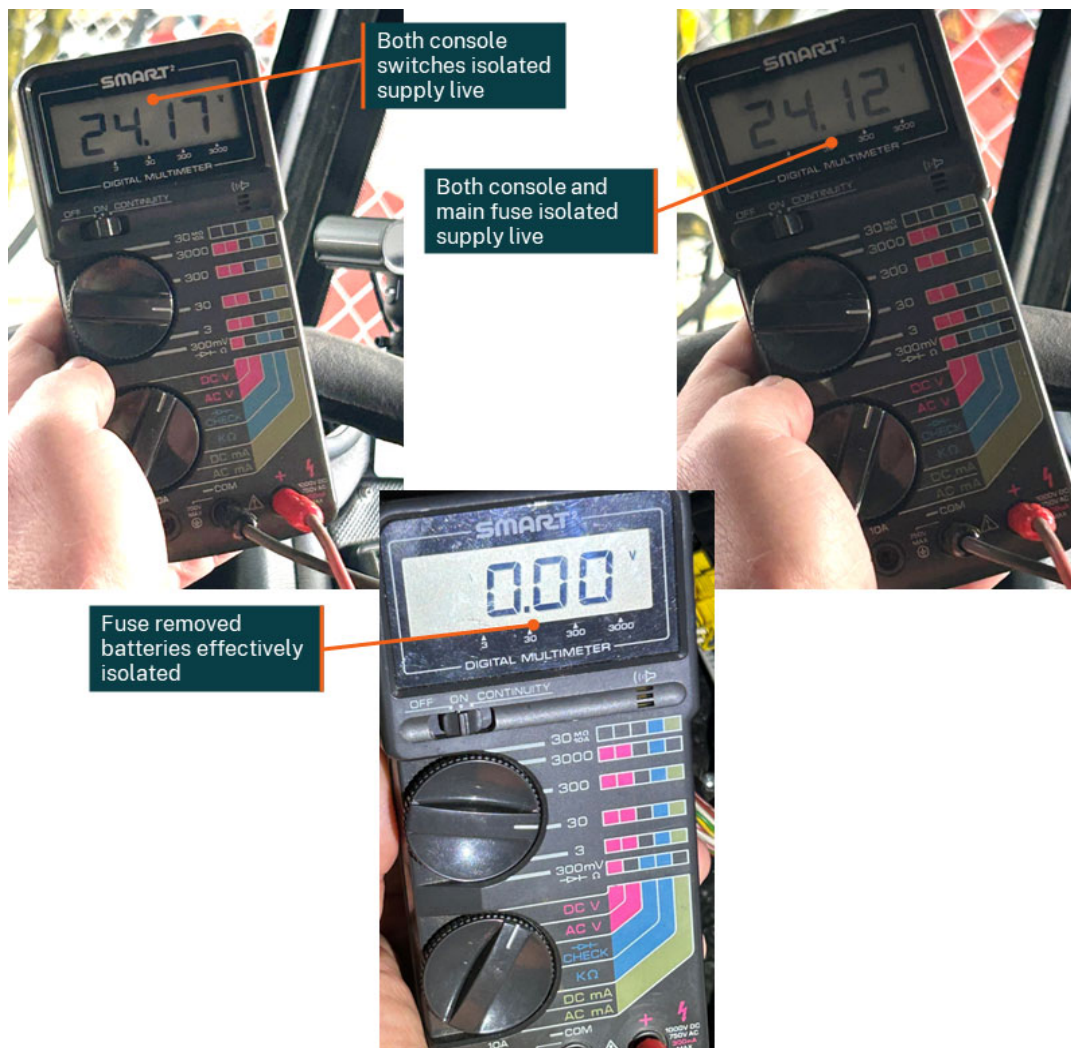
Figure 33: OTSI isolation test results

2.33 By removing electrical current from a circuit, before any surrounding components reach their ignition temperature,¹² it is likely that a fire can be prevented before commencement.
