# Bus Safety Investigation Report

Collision between buses m/o9982 and m/o1531  
Campsie

20 March 2024

Released under the provisions of  
Section 45C (2) of the *Transport Administration Act 1988* and  
Section 46BBA (1) of the *Passenger Transport Act 1990*  
Investigation Reference I02041

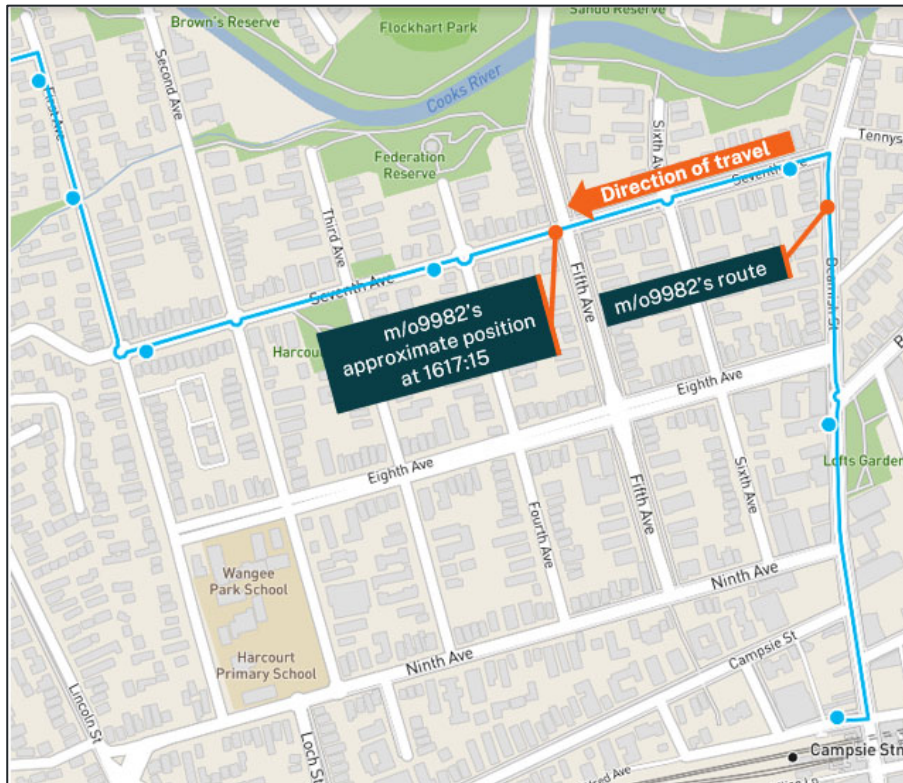
**Figure 5: Map showing route and approximate position of bus m/o9982 at 1617:15**

At that time, bus m/o9982 was travelling ahead at low speed on Seventh Avenue, on Route 942 (Campsie to Lugarno), crossing through the intersection with Fifth Avenue, on a green traffic signal (Figure 5).
