# Ferry Safety Investigation Report

Children overboard at Riverview College Ferry Wharf,  
Riverview, NSW, 16 February 2023

Published  
February 2025

Investigation Reference IO2038

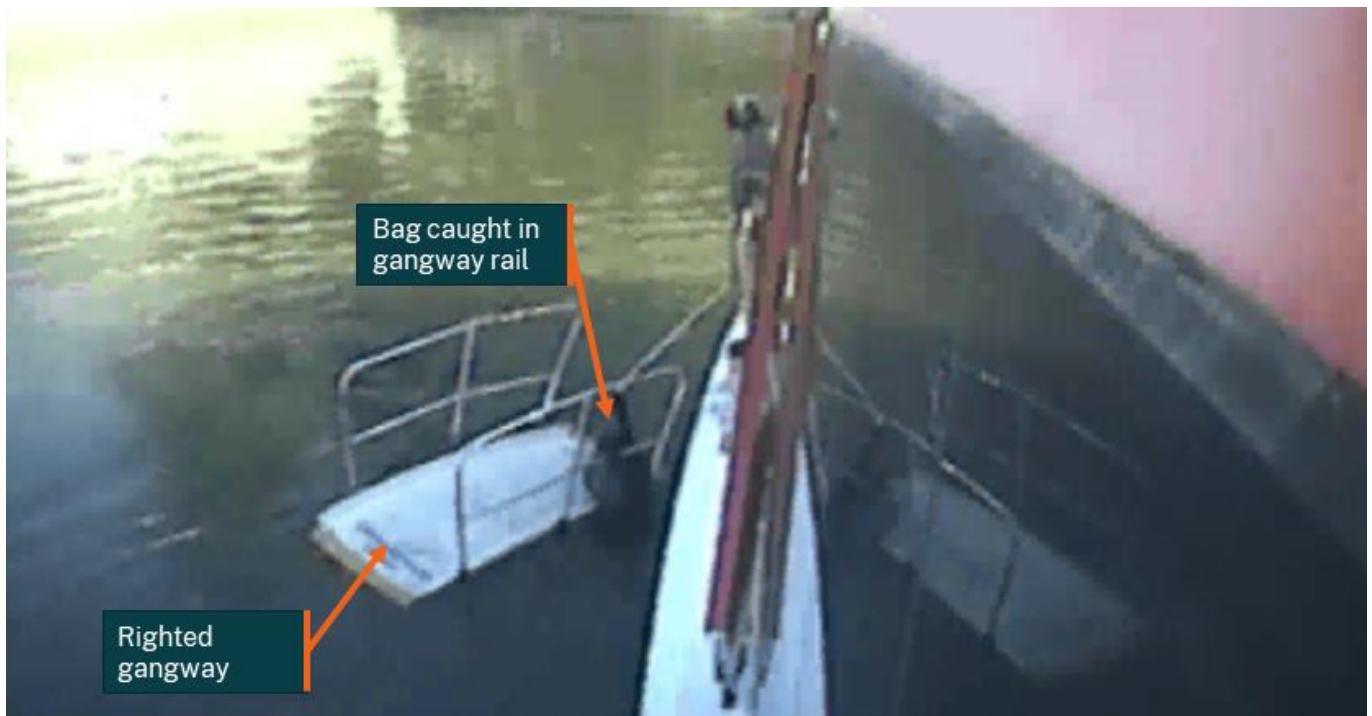
Figure 13: Onboard portside CCTV showing recovery of the gangway and backpack at 0815:53

- 1.27 Following recovery of the three students, the Master manoeuvred the ferry to retrieve the floating gangway. The Deckhand righted the gangway in the water which had a backpack wedged between the gangway handrails. Recovery of the gangway and bag was then carried out by the Deckhand, with the assistance of students onboard. (Figure 13).

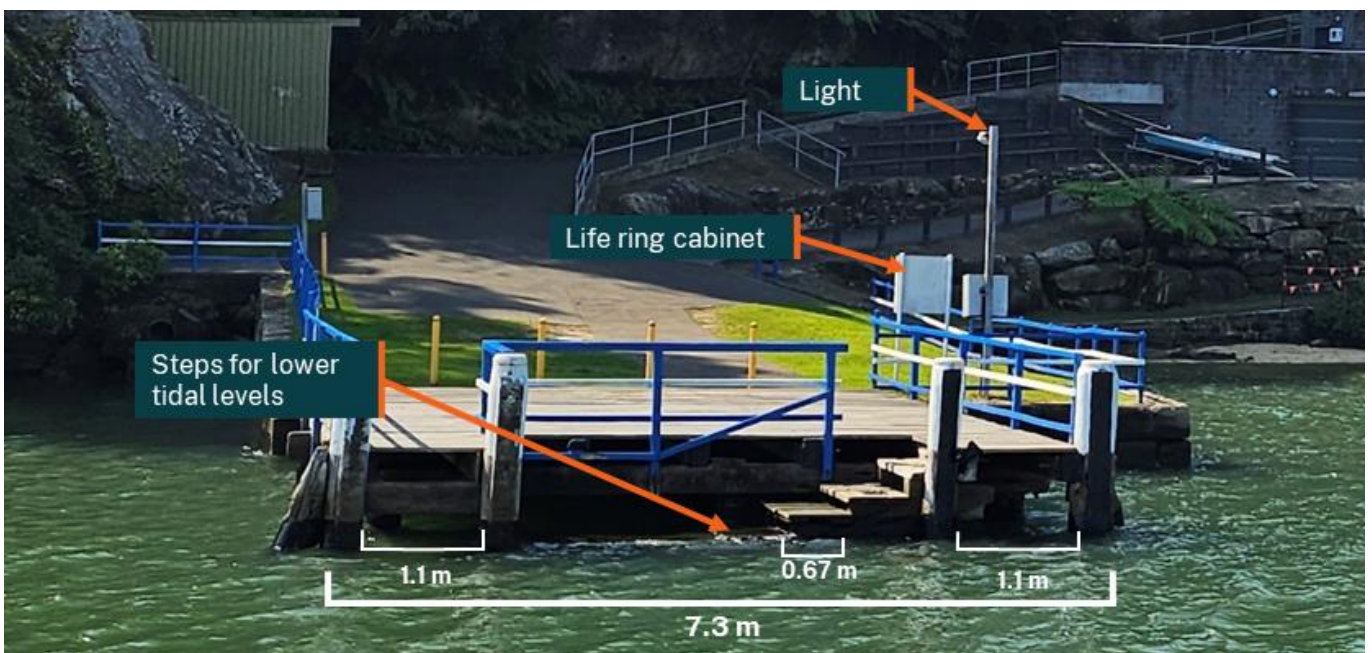
Figure 17: Riverview College Wharf viewed from Lane Cove River

1.41 Riverview College Wharf had two deck level landings of approximately 1.1 m width, located at the Western and Eastern sides of the southern 7.3 m berthing face. The central section of the berthing face included four steps descending to a landing. As there were no mooring cleats or bollards, wharf piles were used to secure vessels. The wharf had a life ring cabinet positioned shoreside on the edge of the rock jetty, and an adjacent overhead light (Figure 17).

1.42 There were four wooden steps, the first approximately 450 mm wide with the remaining three 670 mm wide, leading down to a wooden landing that was approximately 2 m wide (Figure 18). The landing and lower two steps were covered with a Fibre Reinforced Plastic nonslip surface. The steps and lower landing were utilised by ferry crew during lower tidal periods when transferring passengers to and from the vessel. At the time of the incident, the wharf had no nonslip paint, edge markings, person overboard retrieval ladder or lighting at the wharf face.

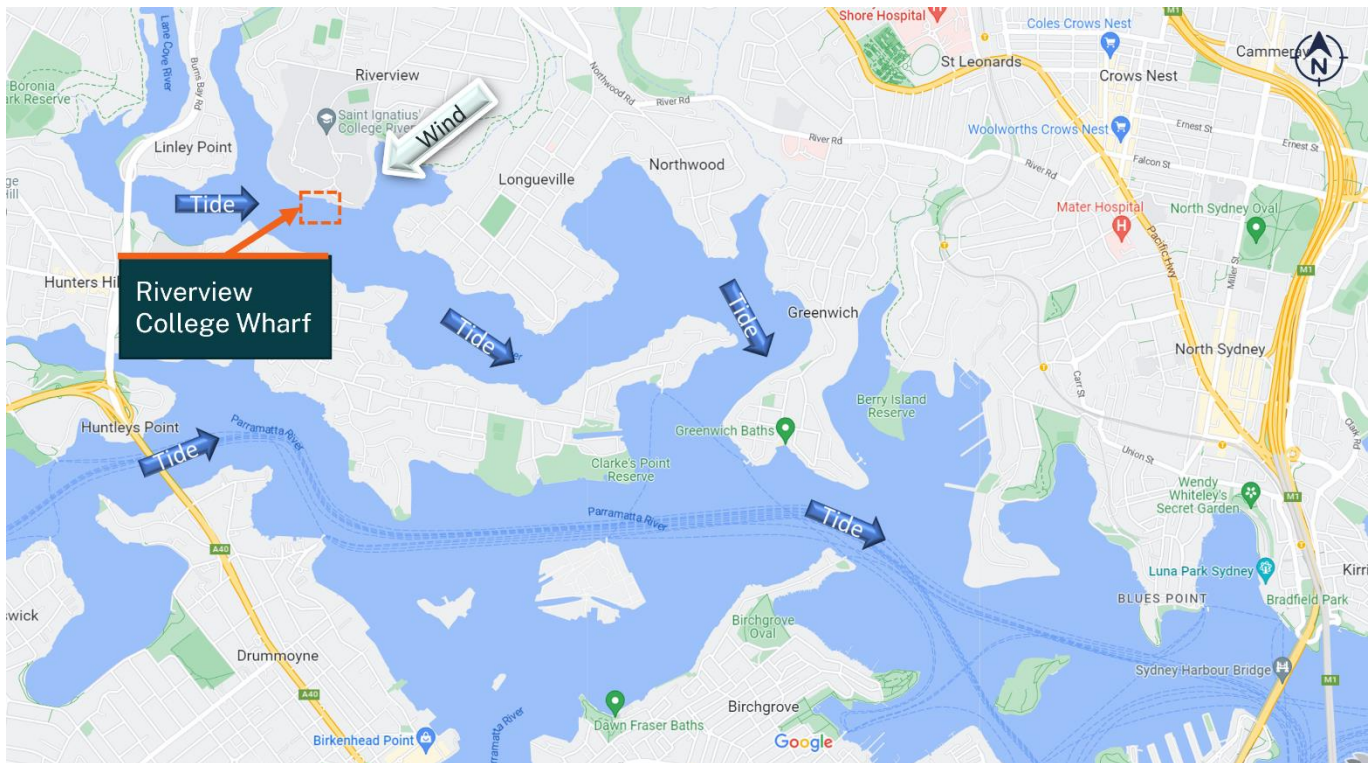
Figure 19: Map showing the location of Riverview College Wharf and environmental conditions at time of incident

- 1.43 The morning of 16 February 2023 was dry and sunny. The Bureau of Meteorology (BOM) recorded a temperature of 22.2°C at 0900 at the Sydney Harbour (Observatory Hill) weather station, about 5.5 km southeast of the incident location. The wind at 0900 was recorded from the northeast at 11 km per hour. The wind direction at the Riverview College Wharf, at the time of the incident, was offshore.
- 1.44 The tide on the day was a high at 0507 of 1.61 m dropping to a low of 0.48 m at 1209. At the time of the incident the tide was ebbing.<sup>8</sup> The tidal direction at Riverview College Wharf was from west to east (Figure 19).

- 1.45 At the time of the incident the Sun was low in the eastern sky, with an approximate altitude of  $19.5^{\circ}$ . While the crew did not report that the sun glare affected their ability to effectively berth the vessel, sun glare was recorded from the locations of onboard forward facing CCTV cameras during berthing and recovery of the students in the water. Neither the tide nor wind were strong. However, both applied a force consistent with influencing the movement of the vessel away from the face of the wharf.

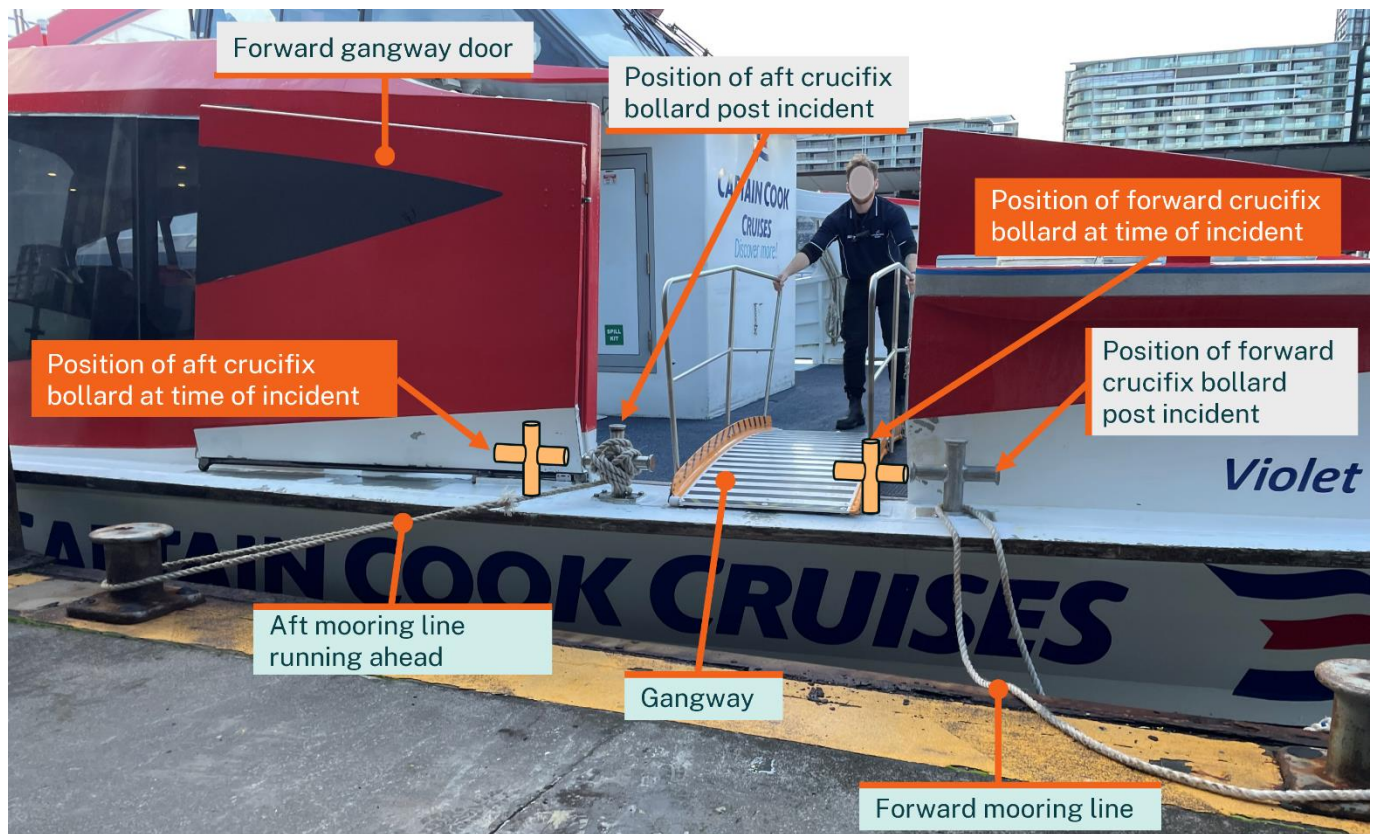
Figure 22: Violet McKenzie crucifix bollard positions on the starboard forward gangway door location

- 1.52 Post incident, on the 12 May 2023, the positions of the crucifix bollards, at the forward gangway doors, were returned to their 'as built' original configuration (Figure 22). This configuration favoured use of the aft crucifix bollards as they were clear of any obstruction, and therefore was easier to berth the vessel running ahead.

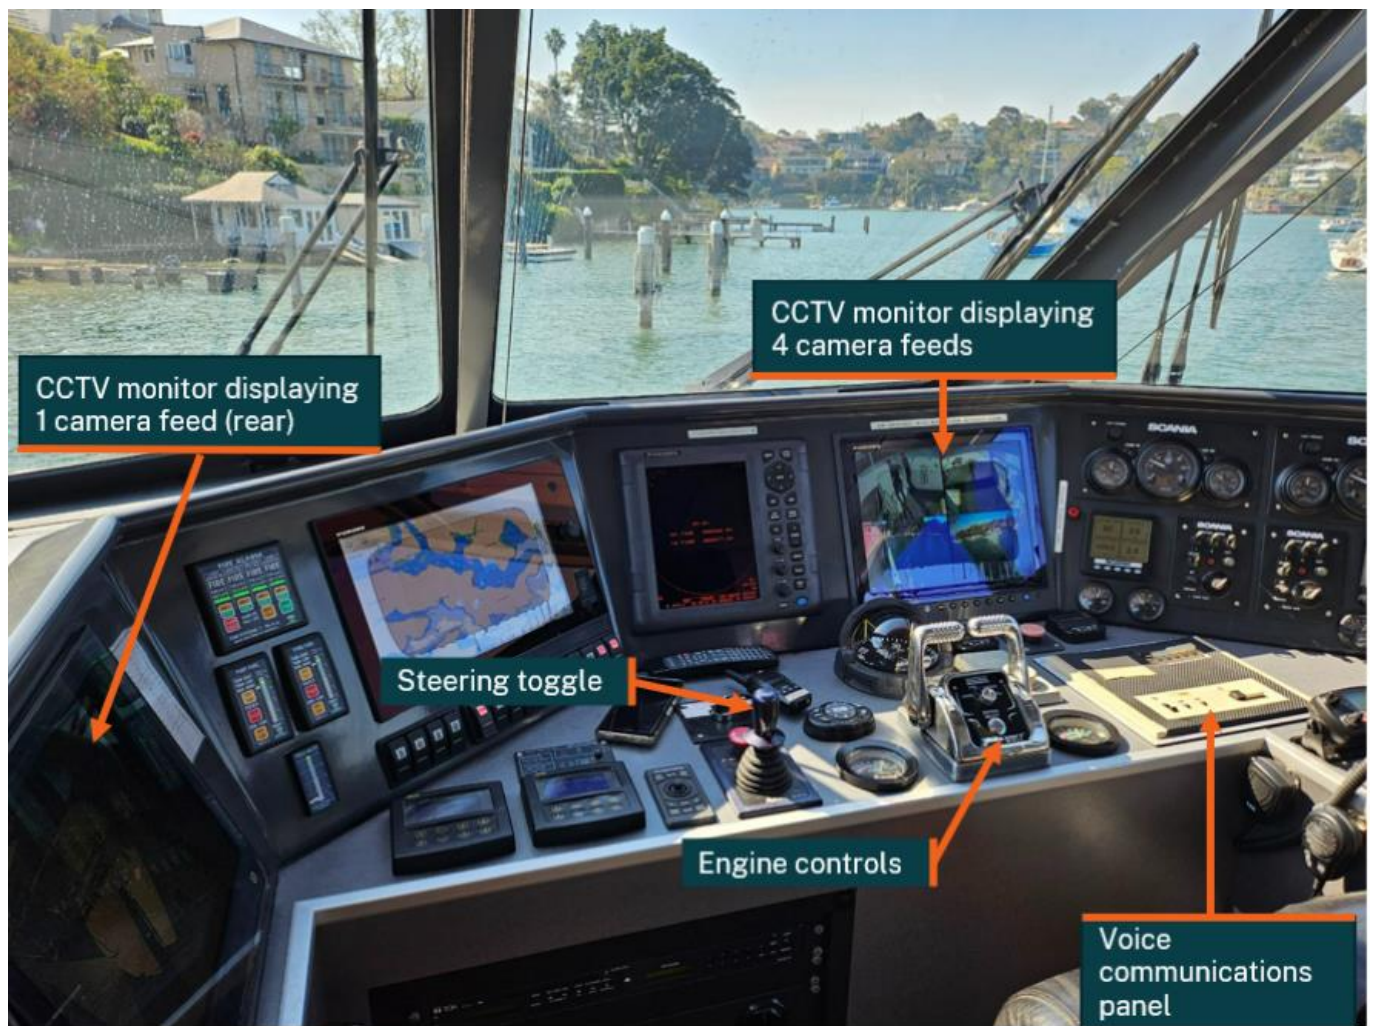
Figure 24: Super Rocket Class wheelhouse layout

- 1.54 The voice communications panel in the wheelhouse was located adjacent to the engine controls and below a CCTV monitor displaying four onboard camera feeds (Figure 24).
- 1.55 On the Super Rocket Class vessels, there was limited direct visibility from the Master's position in the wheelhouse to view the forward deck and gangway door areas. Due to direct visibility limitations the Super Rocket Class vessels, including *Violet McKenzie*, had several CCTV cameras to assist the Master in monitoring the working deck and sections of the vessel that could not be seen from the wheelhouse position. The cameras streamed images to monitors located in the wheelhouse (Figure 24).

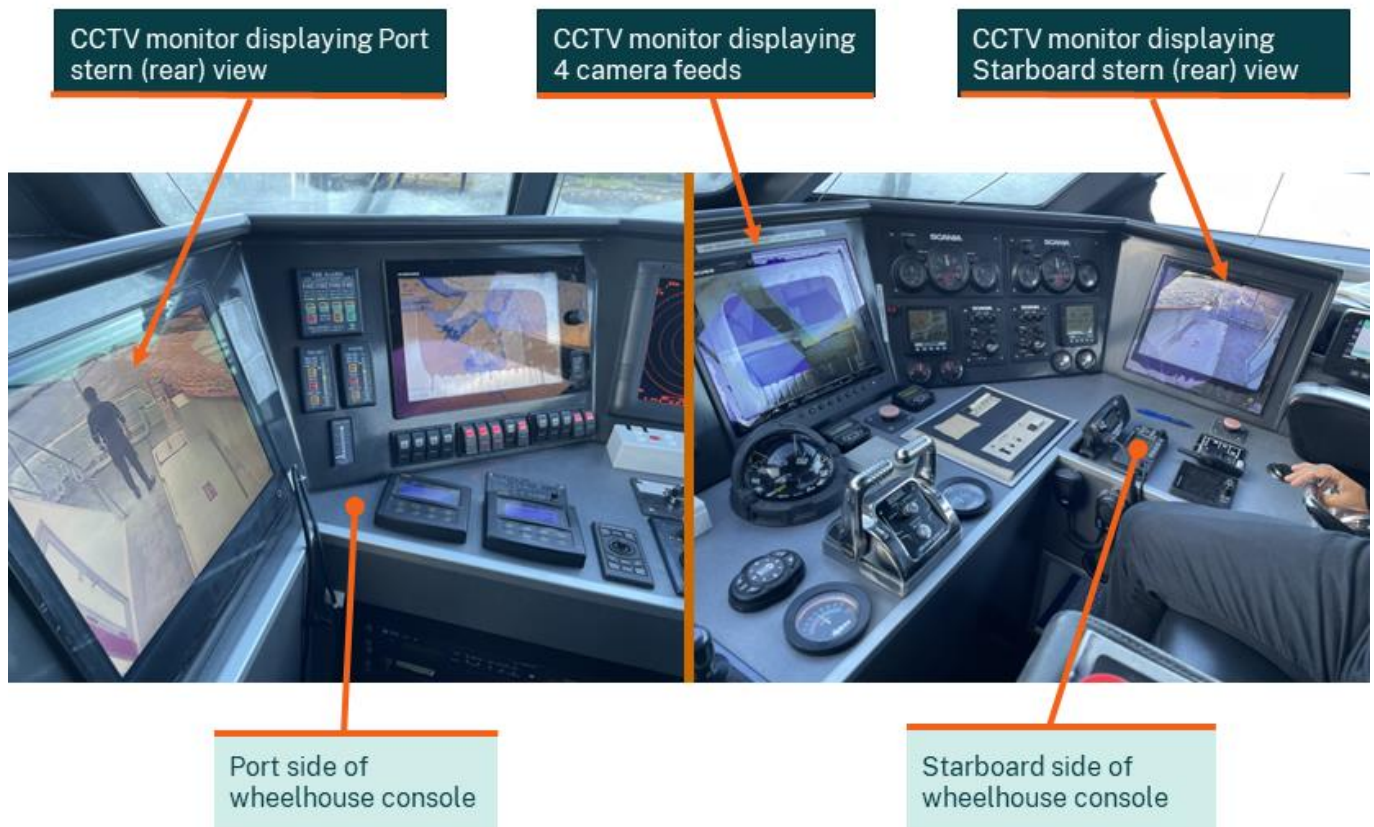
Figure 25: Port and Starboard side wheelhouse console CCTV monitor layout

- 1.56 One monitor on Super Rocket Class vessels was usually set to simultaneously display four CCTV camera feeds. A single camera feed could also be displayed full screen. It was reported that the CCTV cameras usually displayed on this monitor were from both port and starboard forward gangway decks, and views towards the stern of the vessel, along either side. These CCTV cameras did not provide a view of the port side of the ferry where it interacted with the wharf. However, that CCTV view was available.
- 1.57 There were also two CCTV monitors located on the port and starboard side of the wheelhouse, these monitors were set to display camera feeds from their respective port and starboard sides of the rear passenger deck (Figure 25).

2.27 Violet McKenzie's CCTV cameras provided limited visibility to the Master. In addition, not all of the CCTV camera streams were shown to the Master on the wheelhouse console monitors. Of note in this incident the default monitor setting did not provide a view of the port side of the vessel where it interacted with the wharf (Figure 3 on page 10). The selection of CCTV camera views to be displayed at the wheelhouse console could be changed using a computer mouse located near the floor of the wheelhouse. That interaction could lead to the detriment of maintaining a proper lookout during a ferry journey or at the time of berthing operations.

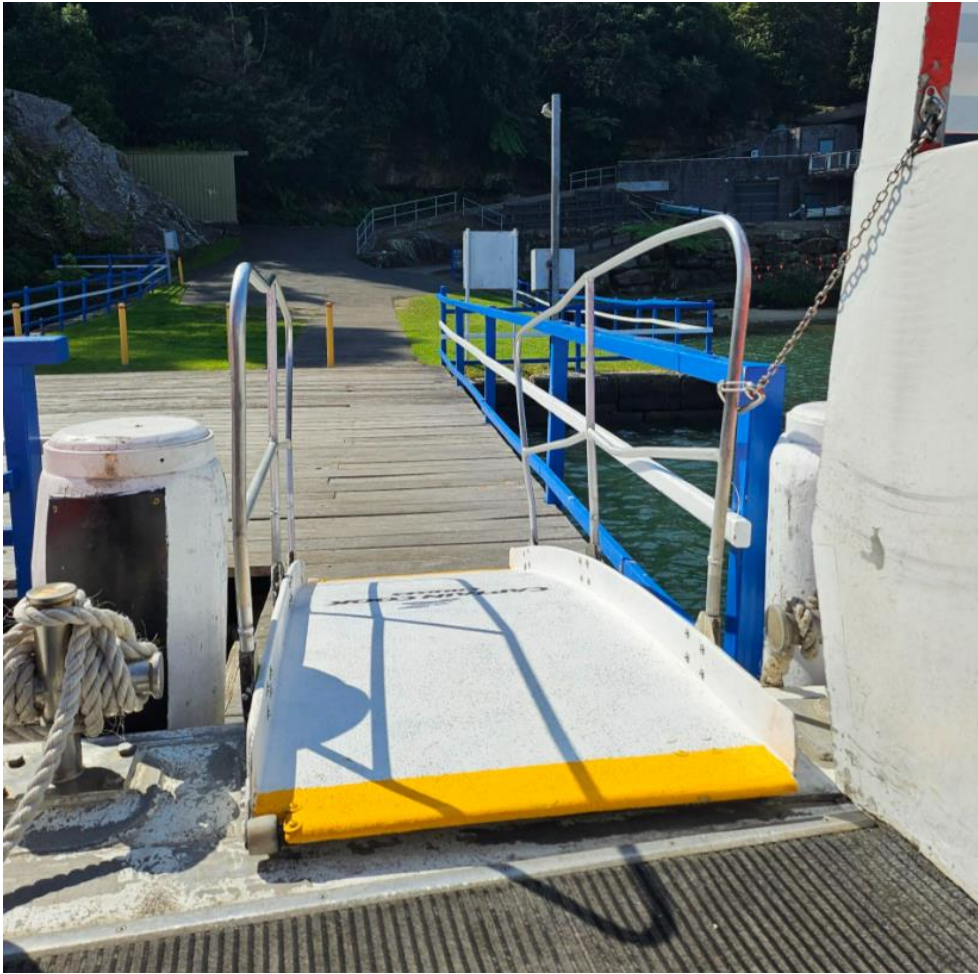
Figure 27: Gangway design involved in incident

- 1.60 The gangway carried onboard the vessel and used on the Lane Cove River service was 850 mm wide and 2.4 m long. It weighed approximately 25 kg and was constructed of fibreglass, with aluminium handrails.
- 1.61 There was a chain attached to the handrail on one side, to clip the gangway to the vessel when in place for passenger embarkation/disembarkation (Figure 27).

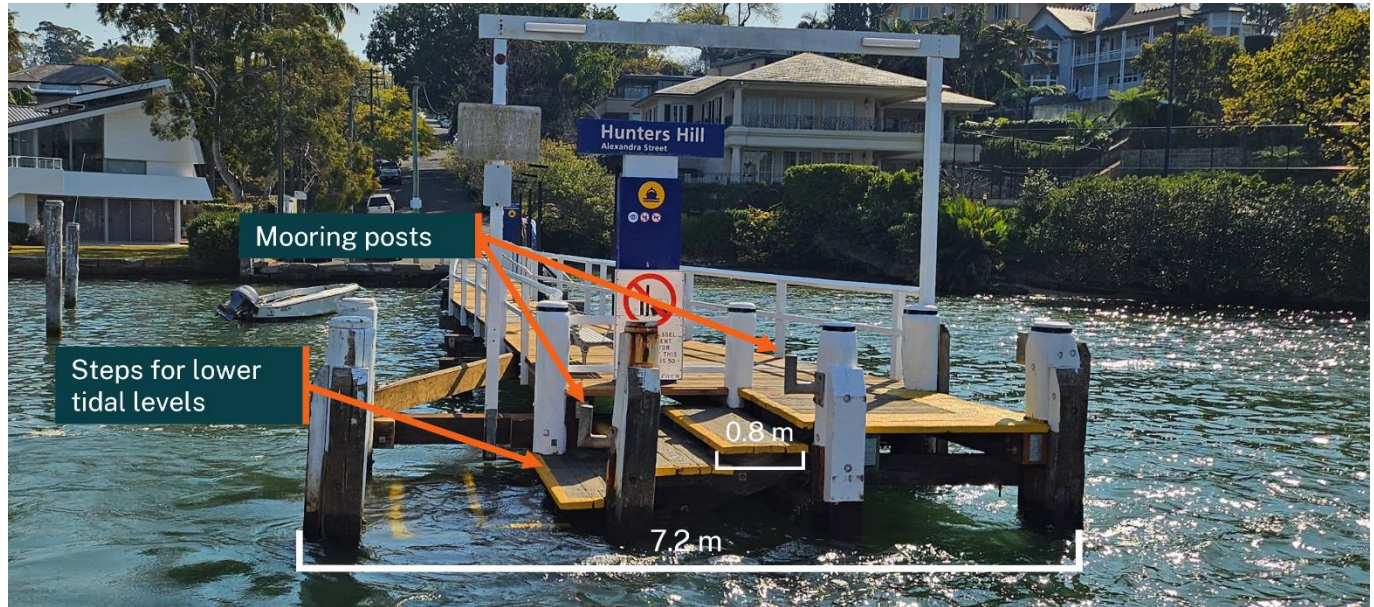
**Figure 36: Hunters Hill Wharf – fixed structure**

1.163 Hunters Hill Wharf had a berthing face of approximately 7.2 m. Hunters Hill Wharf (Figure 36) included mooring posts<sup>31</sup> for vessels and had nonslip paint and defined edge markings on the deck and steps.

1.164 Hunters Hill Wharf did not have a recovery ladder for persons in the water to utilise. The 0.8 m depth steps were narrower than the gangways utilised by CCC, this increased the risk of the gangway becoming unstable during operations.

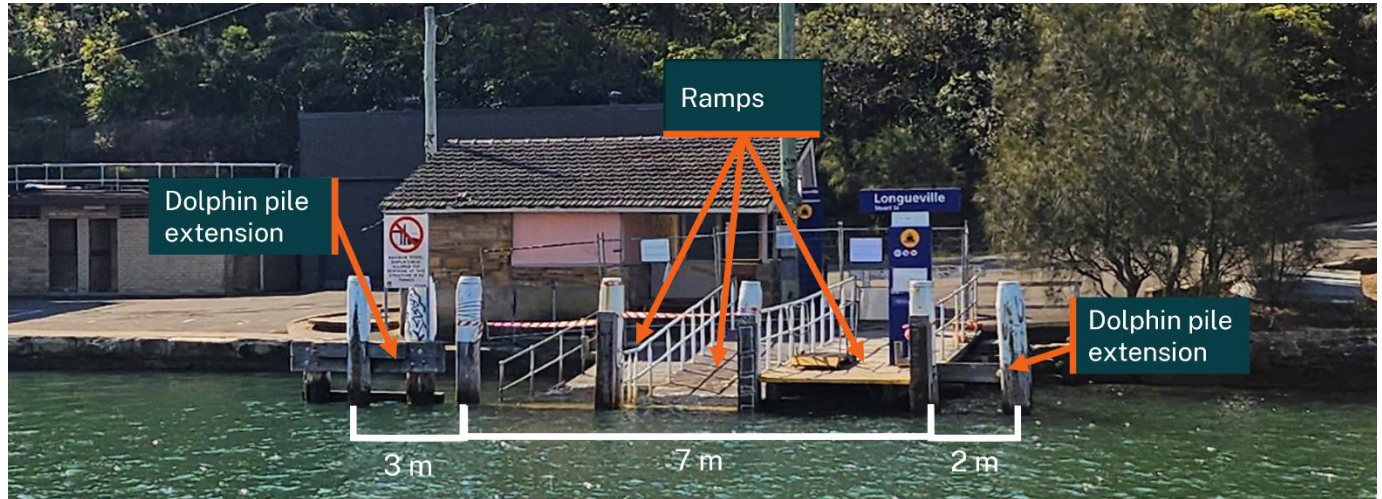
**Figure 37: Longueville Wharf – fixed structure**

1.165 Longueville Wharf was similarly built of timber on a base of timber piles. It differed from the other four wharves on the river as far as it utilised three separate ramps of different height to address various tidal heights (Figure 37). Higher tidal levels were challenging due to highest ramp being significantly lower than a 24 m ferry's deck. This wharf had a berthing face of approximately 12 m due to an additional two dolphin<sup>32</sup> type pile structures at either side of the wharf face.

1.167 At higher tides such as those above 1.8 m, the three ramps could become inundated with water and not allow access to the ferry without actual movement through water. Attempts to use the wharf in these conditions decreased safety and resulted in steep angles of gangway incline.

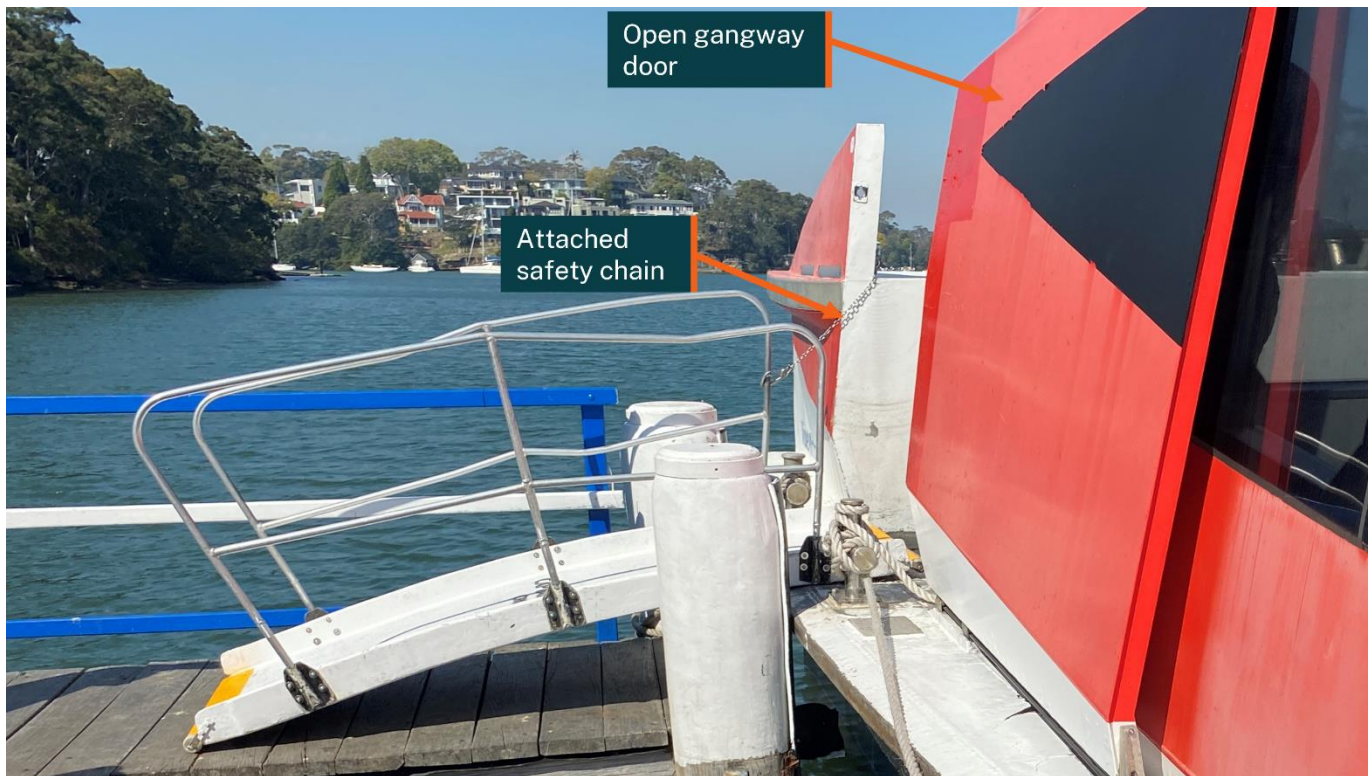
Figure 41: Gangway with safety chain attached

<sup>33</sup> The safety chain was intended to reduce the likelihood of the gangway moving and falling in the water from the ferry.

- 2.12 On the day of the incident, it was noted that the safety chain was not attached from vessel to gangway. It was also noted that during the berthing and POB recovery operations, the passengers were not kept clear of the forward working deck. On both occasions, the port cabin door remained open which allowed students to gather around the open gangway area. The lack of control of students on the working deck, permitted the student 19 to step into the open gangway door and jump into the water while the Deckhand went to obtain the recovery ladder.

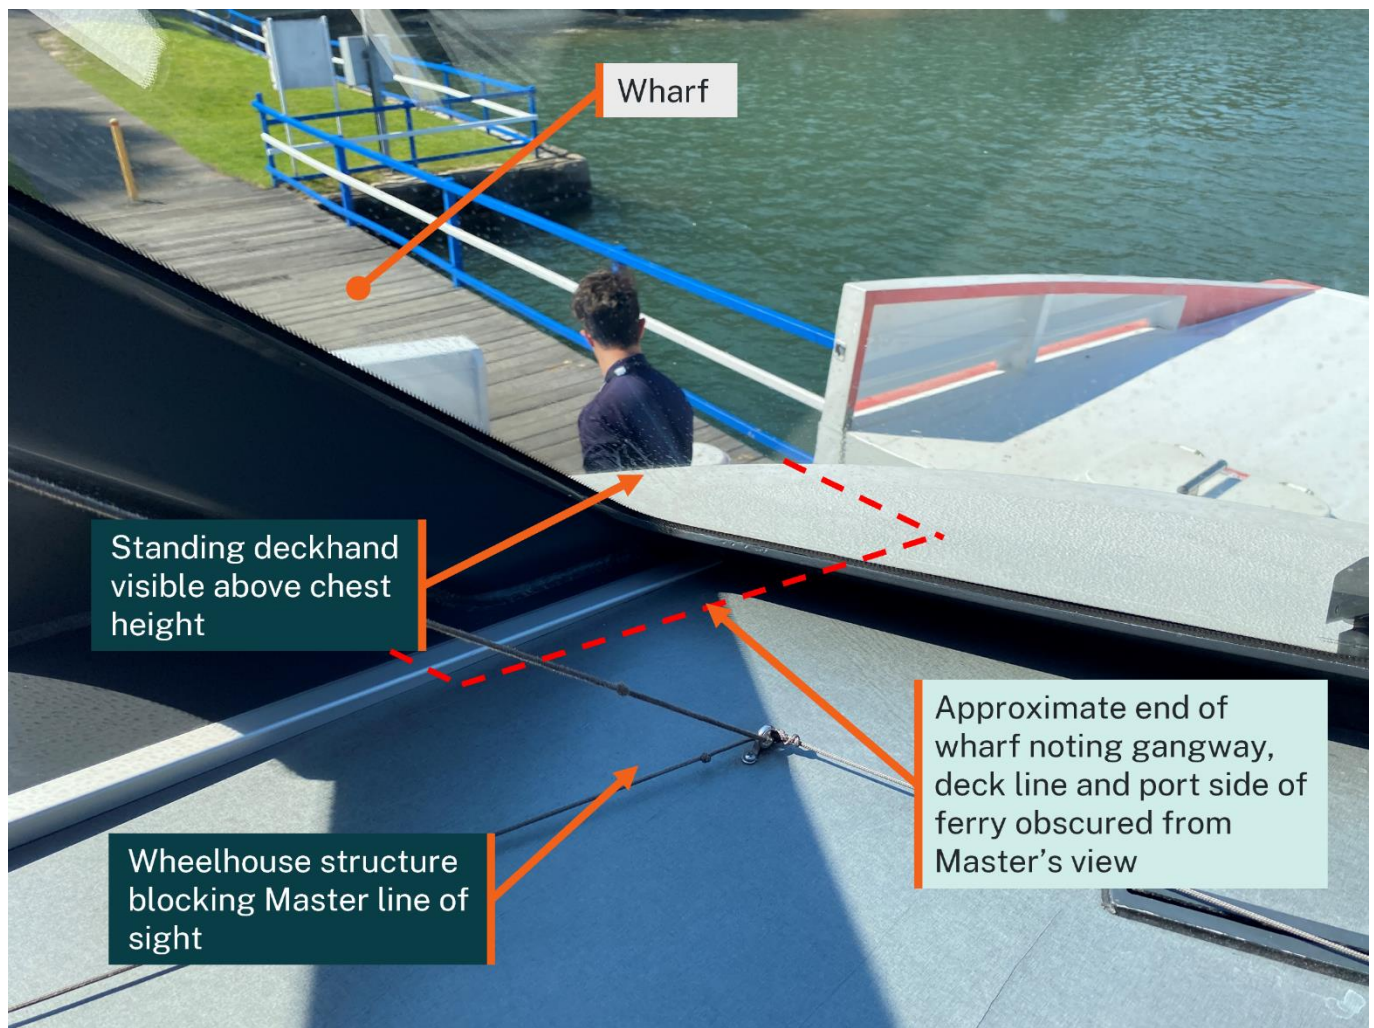
Figure 42: View of working deck from Master's position

- 2.26 The line of sight restrictions resulted in the Master having to rely on CCTV and their Deckhand to assist and warn (via hand signals and voice communication) the Master of potential hazards. Such hazards included the ferry not maintaining a stable position against the wharf resulting in the potential for the gangway falling into the water.

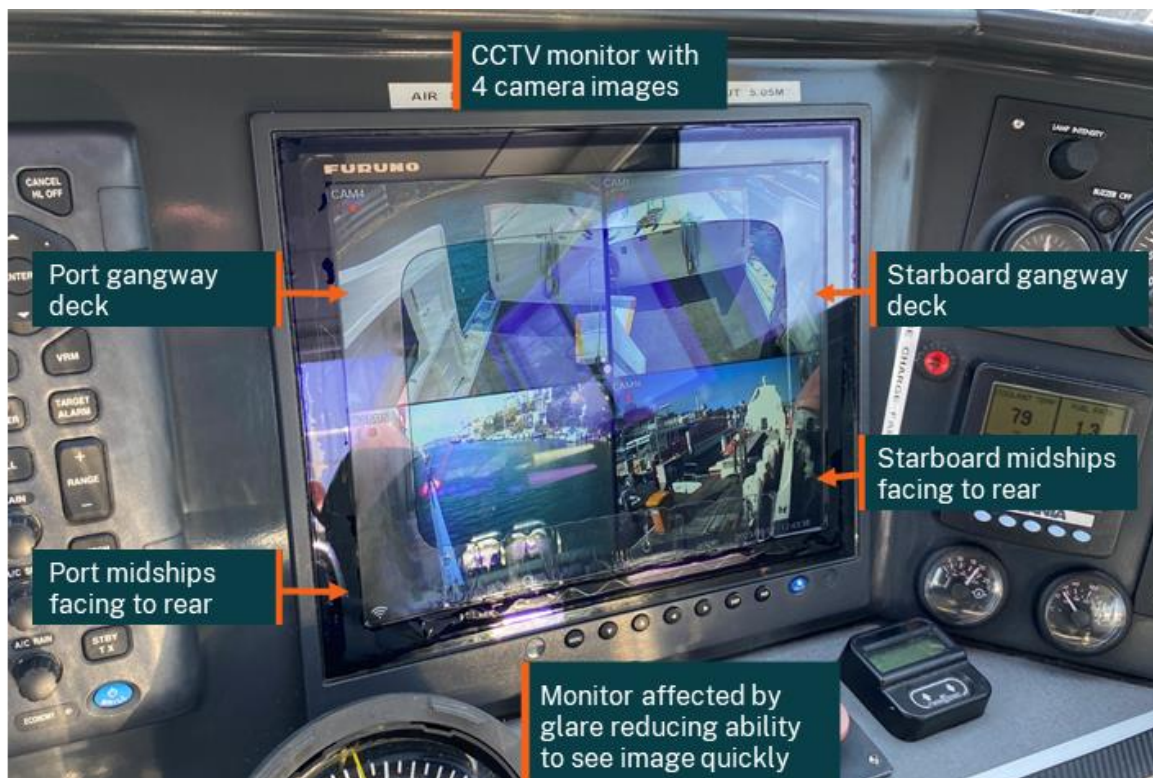
Figure 43: CCTV monitor showing images from 4 cameras with reflections from other sources

2.28 When a Master utilised any CCTV monitor, their concentration was focused on the monitor, and away from the forward working deck where the berthing and gangway operations were undertaken. Several challenges could arise in using the CCTV monitors as configured at the time of the incident. These challenges included glare affecting the clarity of the monitor's image during daylight, hindering the Master's ability to quickly glance at it (Figure 43). In addition, the partitioning of the monitor into 4 small camera streams potentially further increased the amount of concentration and time a Master utilised when viewing the monitor.

- 2.29 Without direct visual reference cues of the vessel's position relative to the wharf, a Master could lose situational awareness when attempting to monitor operations looking at screens located inside the wheelhouse. The likelihood of distraction also increased as a Master attempted to carry out multiple tasks requiring a change of focus on multiple items. While utilising the CCTV screen, a Master's attention was focused away from the gangway location. When a Master focused their attention on the internal CCTV screens, they risked of a reduction of their situational awareness to external factors. At such a time, a potential loss of situational awareness increased the likelihood that external factors (wash from passing vessels, high wind gusts, vessel position, gangway monitoring, passenger crowding etc.) could potentially affect the berthing process before the Master recognised and reacted to their existence.

- 2.32 As highlighted above, the default set up of camera angles shown on the CCTV screens were such that none of the images clearly showed the vessel position in relation to gangway and wharf interface. OTSI observed that two large CCTV monitors on the wheelhouse console displayed rearward facing images (Figure 25). These images, while beneficial in providing visibility during a reversing manoeuvre, could not assist the Master during berthing and gangway operations.
- 2.33 As a consequence of those limitations the Master primarily relied on a less reliable control of communication from the Deckhand regarding the safe securement of the gangway and vessel to the wharf.

- 2.31 OTSI noted that while the CCTV screens potentially aided a Master in monitoring the berthing process and transfer of passengers, their use was not without risk. A clear line of sight to the gangway would have removed the need for aids such as CCTV during the gangway operation and likely improved crew teamwork.

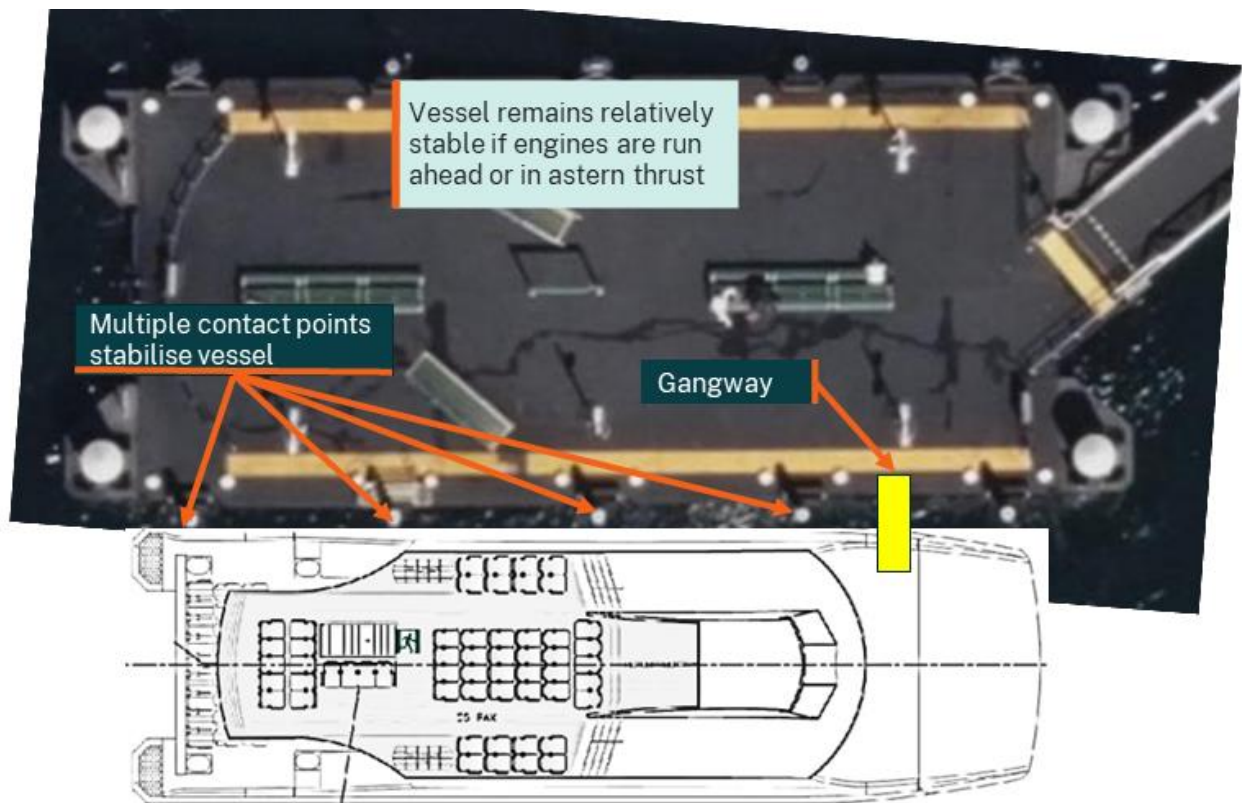
Figure 44: Image showing vessel alongside a large floating pontoon type wharf

- 2.49 Passenger ferry transport incorporates several associated risks to safety. To ensure a successful and safe service, these risks must first be identified then managed. One of the most significant risks encountered in passenger ferry operations is during the boarding and disembarkation of passenger at wharves.
- 2.50 A significant influence on passenger transfer safety is the vessel/wharf interface, how well a vessel/wharf interact with one another. A large wharf berthing face and level deck height offer increased stable options for gangway placement and superior surface area for a vessel to lay alongside. The larger surface offered by the berthing face improves vessel stability with the engines engaged in ahead or astern (Figure 44).

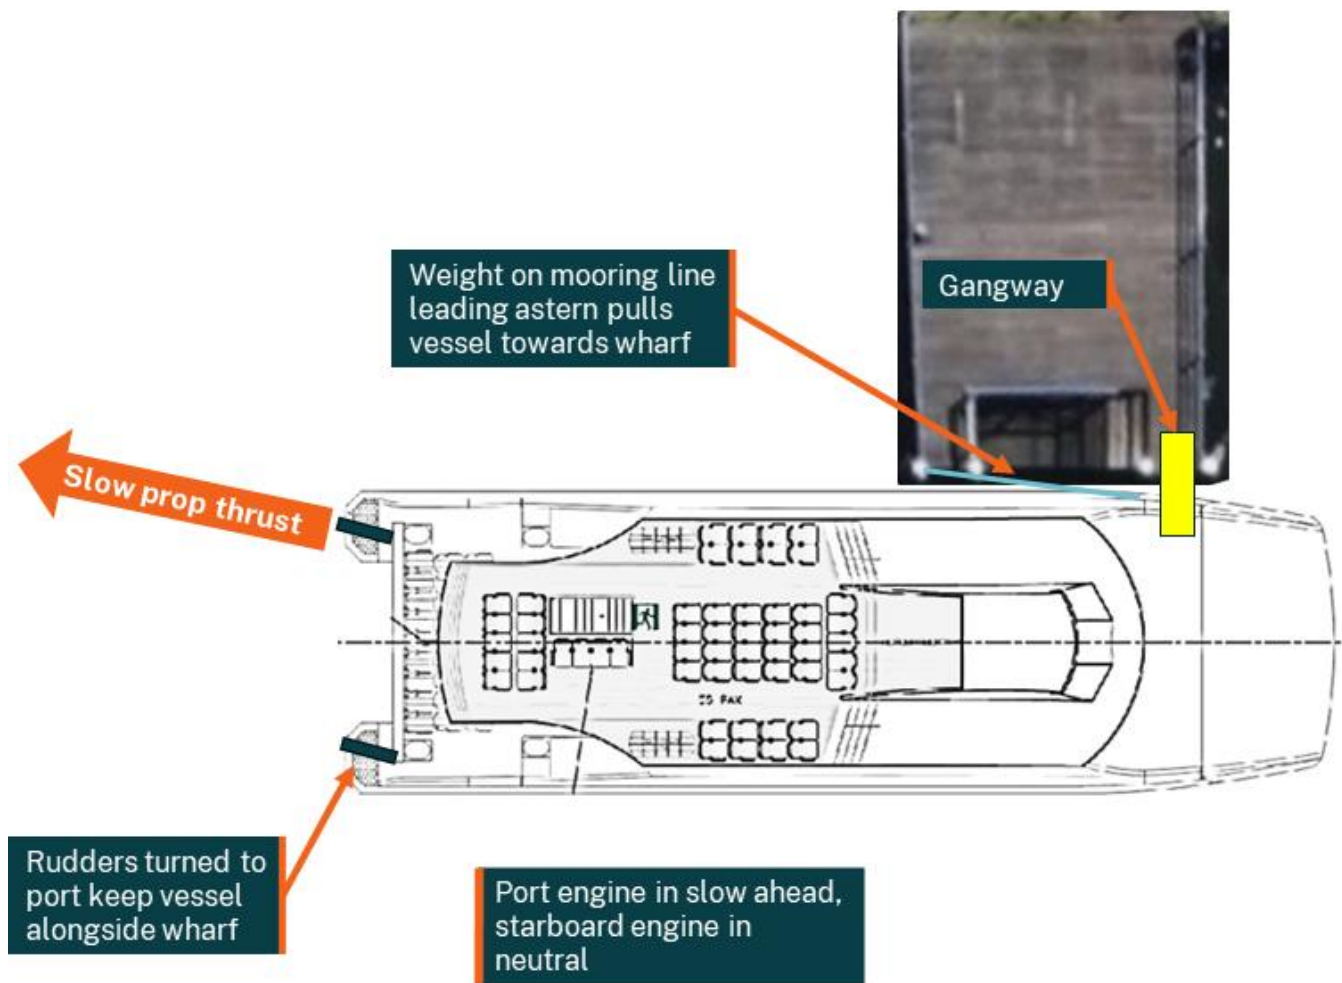
Figure 45: Image showing vessel berthed alongside wharf, using engine thrust and rudders to stay alongside running ahead

- 2.51 As wharf berthing face length decreases, the amount of vessel that can be supported by the wharf is also reduced. The reduced support provided by the wharf requires a Master to utilise engine thrust to stabilise the vessel alongside the wharf. When a Master engages forward thrust (running ahead), the vessel is pulled alongside the wharf by the mooring line deployed by their crew. Any subsequent movements by the vessel can be corrected by small movements of the steering (Figure 45).

- 2.52 In calm to moderate conditions, common practise in the marine industry is to engage one engine ahead, to maintain the vessel position alongside a wharf. When one engine is utilised a reduced force on the mooring line occurs, lessening the likelihood of it breaking and reducing wear. If conditions (tide and wind) require both engines to maintain position, a Master will often instruct crew to place a second line on the wharf to maintain position.

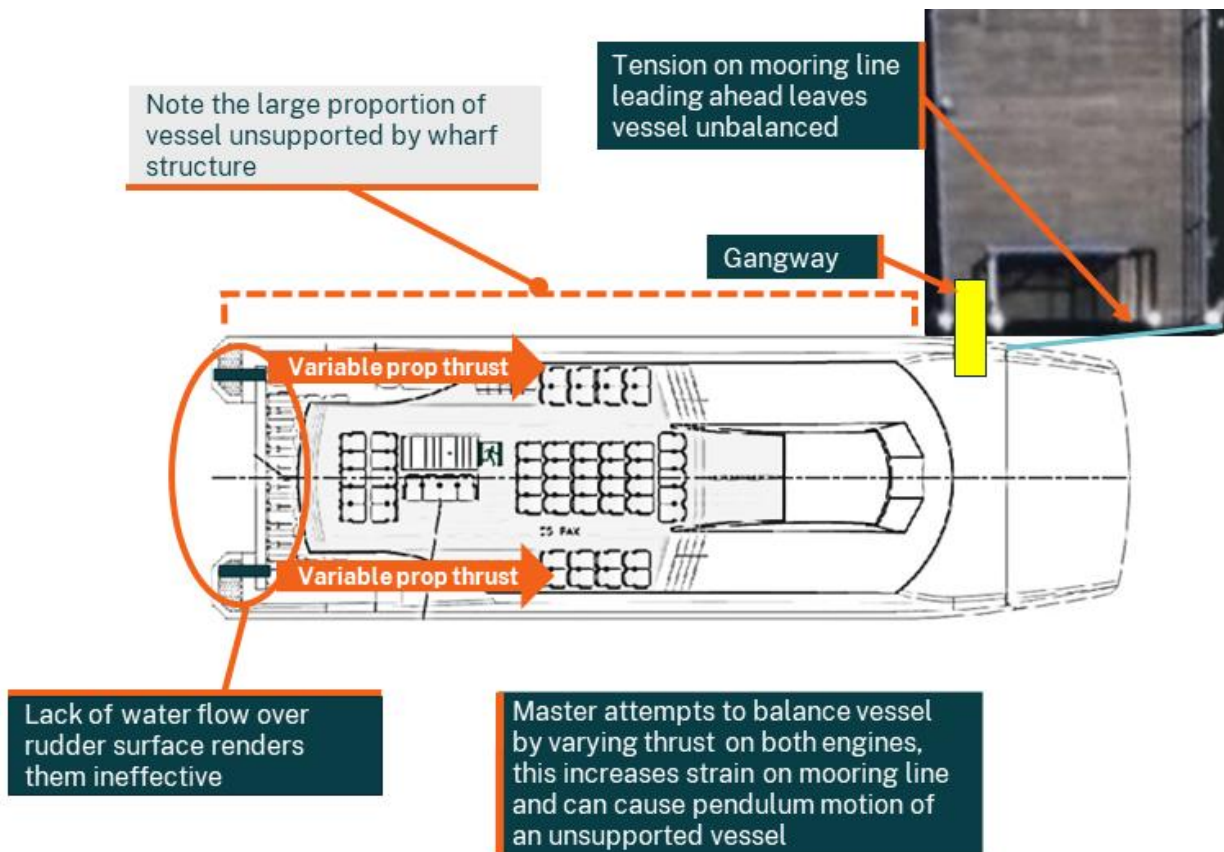
Figure 46: Image showing vessel running engine thrust astern and pulling back on a mooring line

- 2.55 The Masters that ran astern would approach a wharf as normal, and then engage the engines astern (in reverse) and lay back on a mooring line. The Master would then vary reverse thrust on either engine to maintain vessel angle and wharf position (Figure 46). The reverse thrust pushed water flow away from the rudders, rendering them ineffective. Crew had favoured this approach as the placement of the crucifix bollards on the ferries at the time of the incident were easier for the Deckhand to secure the mooring line (Figure 22 on page 28).

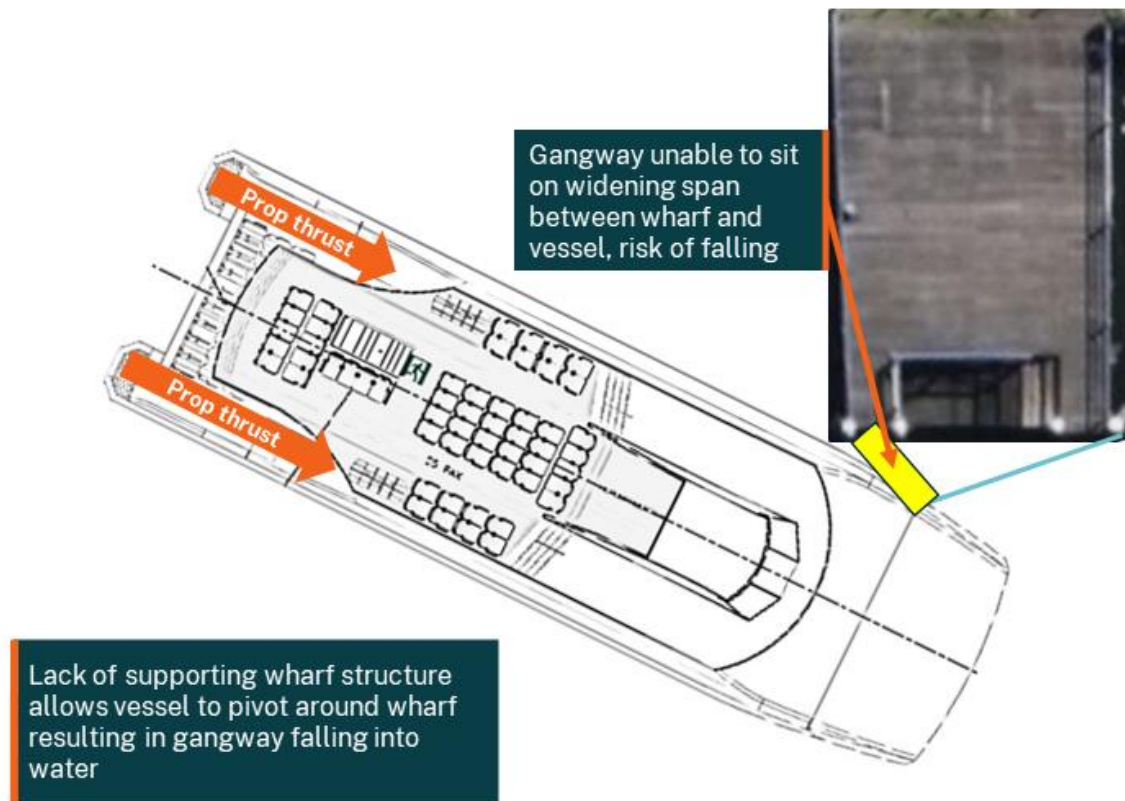
**Figure 47: Image showing vessel with thrust engaged astern, directing water flow away from rudders rendering them ineffectual**

- 2.57 When a Master increased or varied astern thrust, an unsupported stern was likely to swing like a pendulum, resulting in the Master further increasing or varying thrust to compensate. Varying the engine thrust would result in a mooring line alternately stretching and contracting (Figure 47).

- 2.59 When a bow moves away from the vicinity of the wharf, a gangway could quickly become unstable and eventually fall off either the wharf or vessel (Figure 47).

- 2.60 A Master requires significant concentration to maintain a vessel in position considering the result of external and internal forces acting on it. If the Master fails to respond effectively to the vessel's pendulum motion, a risk of the gangway becoming dislodged significantly increases. On the day of the incident, both wind and tide, while not strong, acted upon the vessel to move it away from the wharf (Figure 48 on page 71). These factors highlight that the practice of running astern presented significant challenges to maintain safe vessel berthing for gangway operations on small wharves.

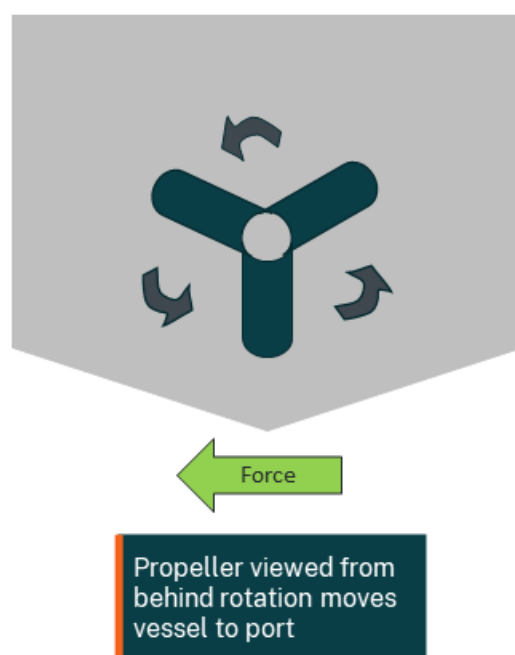
Figure 49: Transverse thrust effect

- 2.64 The direction of propeller rotation created a sideways force known as transverse thrust, commonly referred to as ‘propeller action or walking’ in the maritime industry. Transverse propeller thrust has the effect of placing a sideways force on the propeller shaft moving the propeller (and stern of a vessel) in the direction of propeller rotation. When that effect is viewed from behind a vessel a propeller turning in an anticlockwise rotation will move a vessel stern to port (Figure 49: Transverse thrust effect).

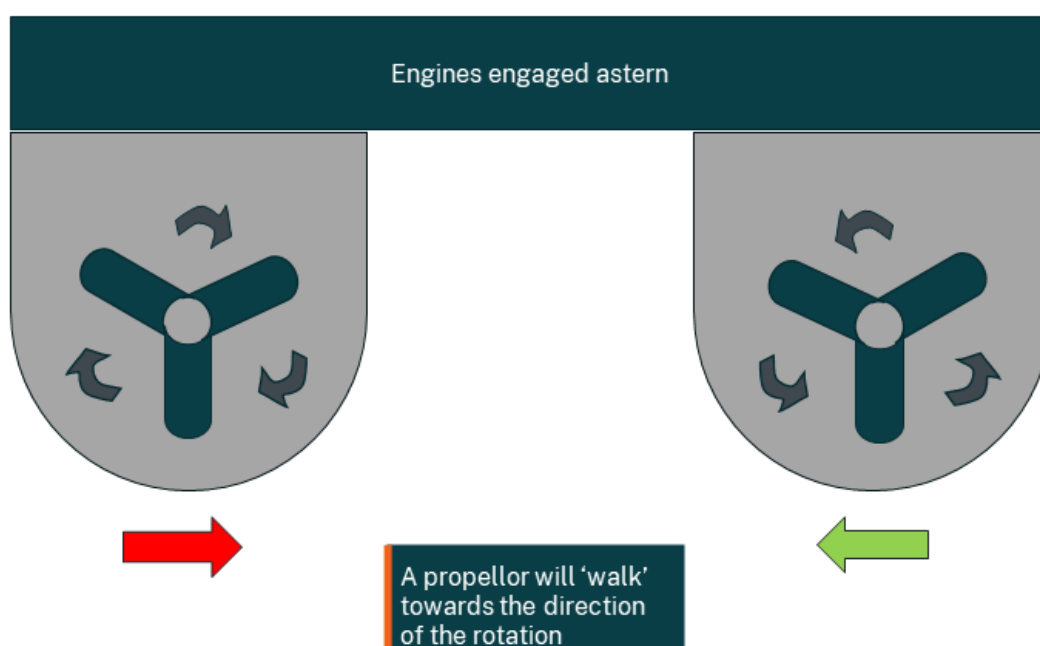
Figure 50: Catamaran in astern viewed from behind

2.65 *Violet McKenzie* was a catamaran (twin Hull) vessel and had two propellers: one at the rear of each hull. When viewed from behind and engaged in astern thrust, the propellers turned inwards in opposite directions, with the transverse forces in balance if the propeller speeds were the same. The resulting transverse force from the propellers would vary, dependant on the speed each propeller rotated. Successful management of the net transverse force presented a challenge for the Master to manoeuvre using astern thrust.

- 2.66 When *Violet McKenzie*'s Master attempted to keep the ferry in position at Riverview Wharf, the tide, wind, propeller action and lack of supporting wharf structure destabilised the ferry, with it slowly moving away from the wharf.
