# Ferry Safety Investigation Report

Children overboard at Riverview College Ferry Wharf,  
Riverview, NSW, 16 February 2023

Published  
February 2025

Investigation Reference IO2038

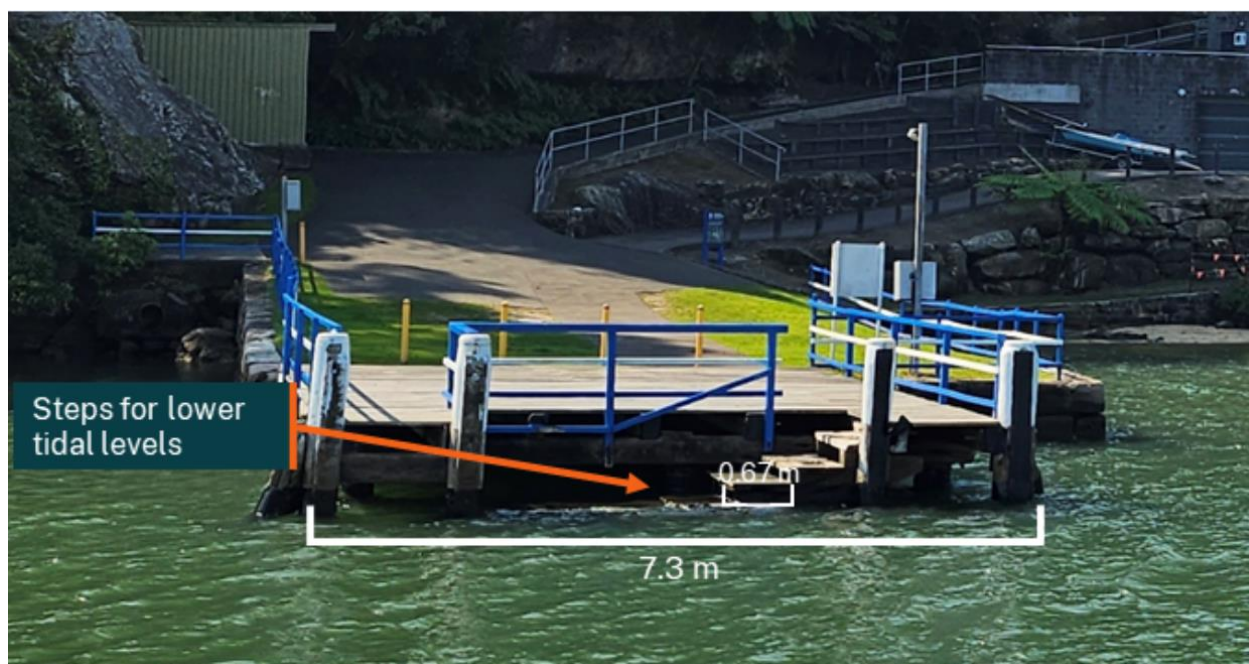
**Figure 51: Involved wharf layout at time of incident**

2.77 At the time of the incident, the involved wharf did not have several safety features, such as a ladder for emergency egress from the water, clearly marked visual delineations of the steps/wharf face and mooring points for vessels to secure on (Figure 51).

- 2.78 While the absence of these items did not contribute to the incident or influence the recovery of the students from the water, there were identified safety improvement opportunities which OTSI discussed with the wharf owner, Saint Ignatius' College, Riverview, after the incident.
