Light Rail Safety Investigation Report

Fractures of Urbos 3 LRV underframes — Sydney Inner
West Light Rail Line, 27 October 2021

Fractures of Urbos 3 light rail vehicle underframes Sydney Inner West Light Rail Line

Investigation Reference I02011

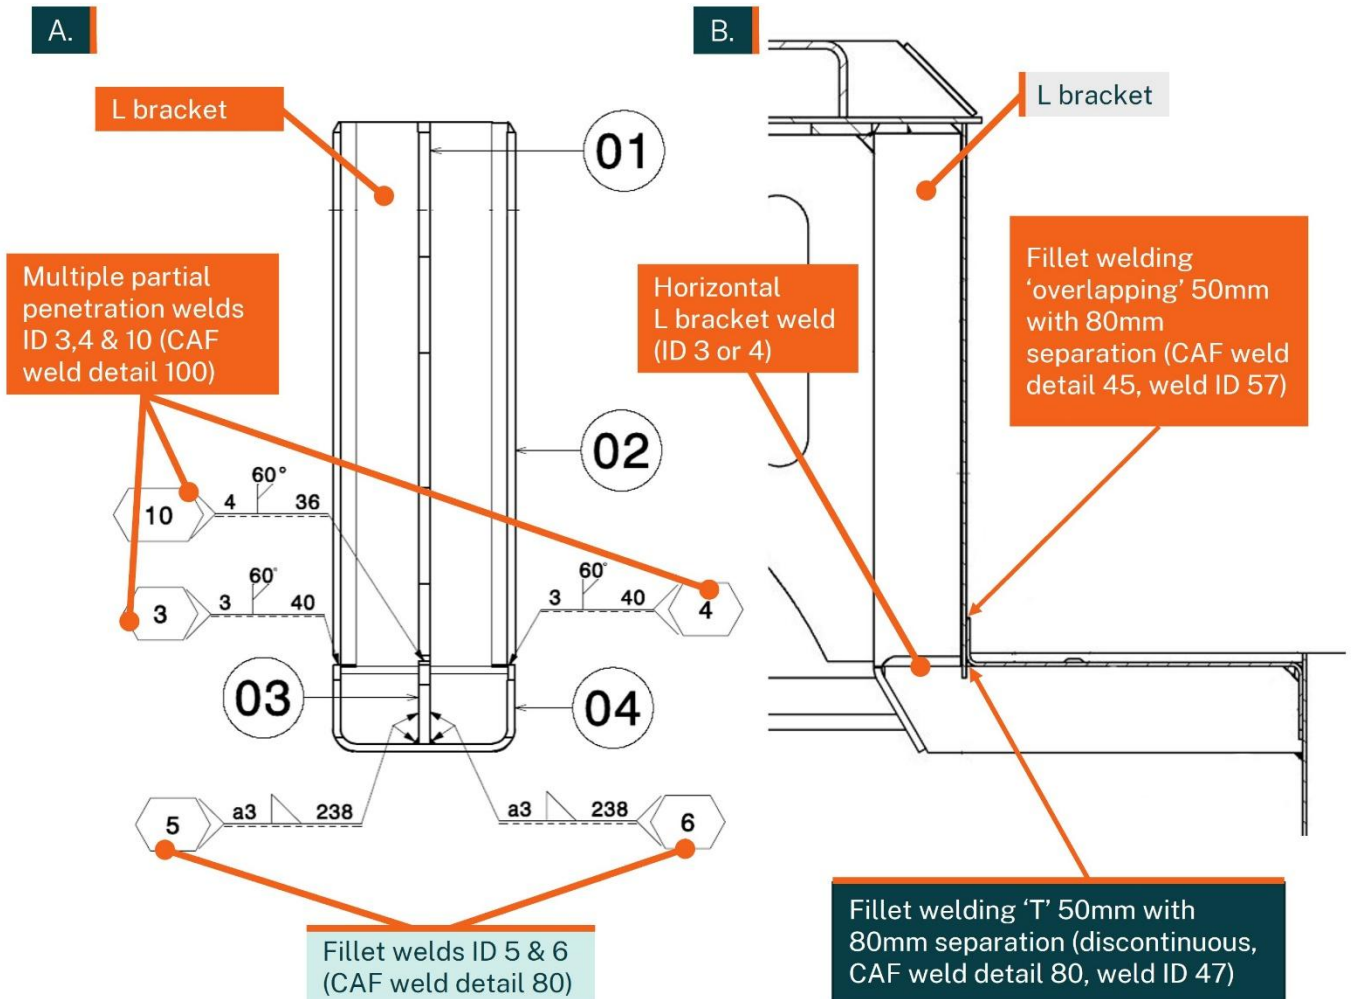
Figure 14: Bogie box L bracket weld construction details

1.46 The major principal stress of the bogie box in welded material was identified as weld ID 47 (Figure 14 - B). That location being near the coincidence of the upper vertical bogie box sheet interface with the lower shelf (fracture location #3), and the corner of the L bracket structure (fracture location #2) (Figure 4). Details of the L bracket design and welding fabrication obtained from CAF are also depicted in Figure 14.

Details of the L bracket weld construction and assembly within the bogie box sheeting. Image A – front view shows weld identification numbers 3, 4, 5, 6 and 10 along with the weld category details that CAF applied in their FEA assessment of the underframe design. Image B – side view shows the L bracket in an assembled position against the bogie box sheeting noting the fillet 'T' weld category detail 80 for weld ID 47 provided by CAF at that weld location and the L bracket horizontal weld ID 3 & 4.
Source: CAF, annotated by OTSI

- 1.65 According to CAF weld certification documents, the L bracket welds (Figure 14 – A) were subject to a visual inspection on the outside surface of the L bracket as they were in the fully assembled state. The visual inspection process at that stage of construction could not view the inside of the L bracket channel where a check of internal welding and plate alignment could have been undertaken. A visual inspection of the central upper bogie box sheet interface with the lower shelf weld (fracture location #3) was also not possible where the L bracket was welded against that section of the bogie box sheeting.

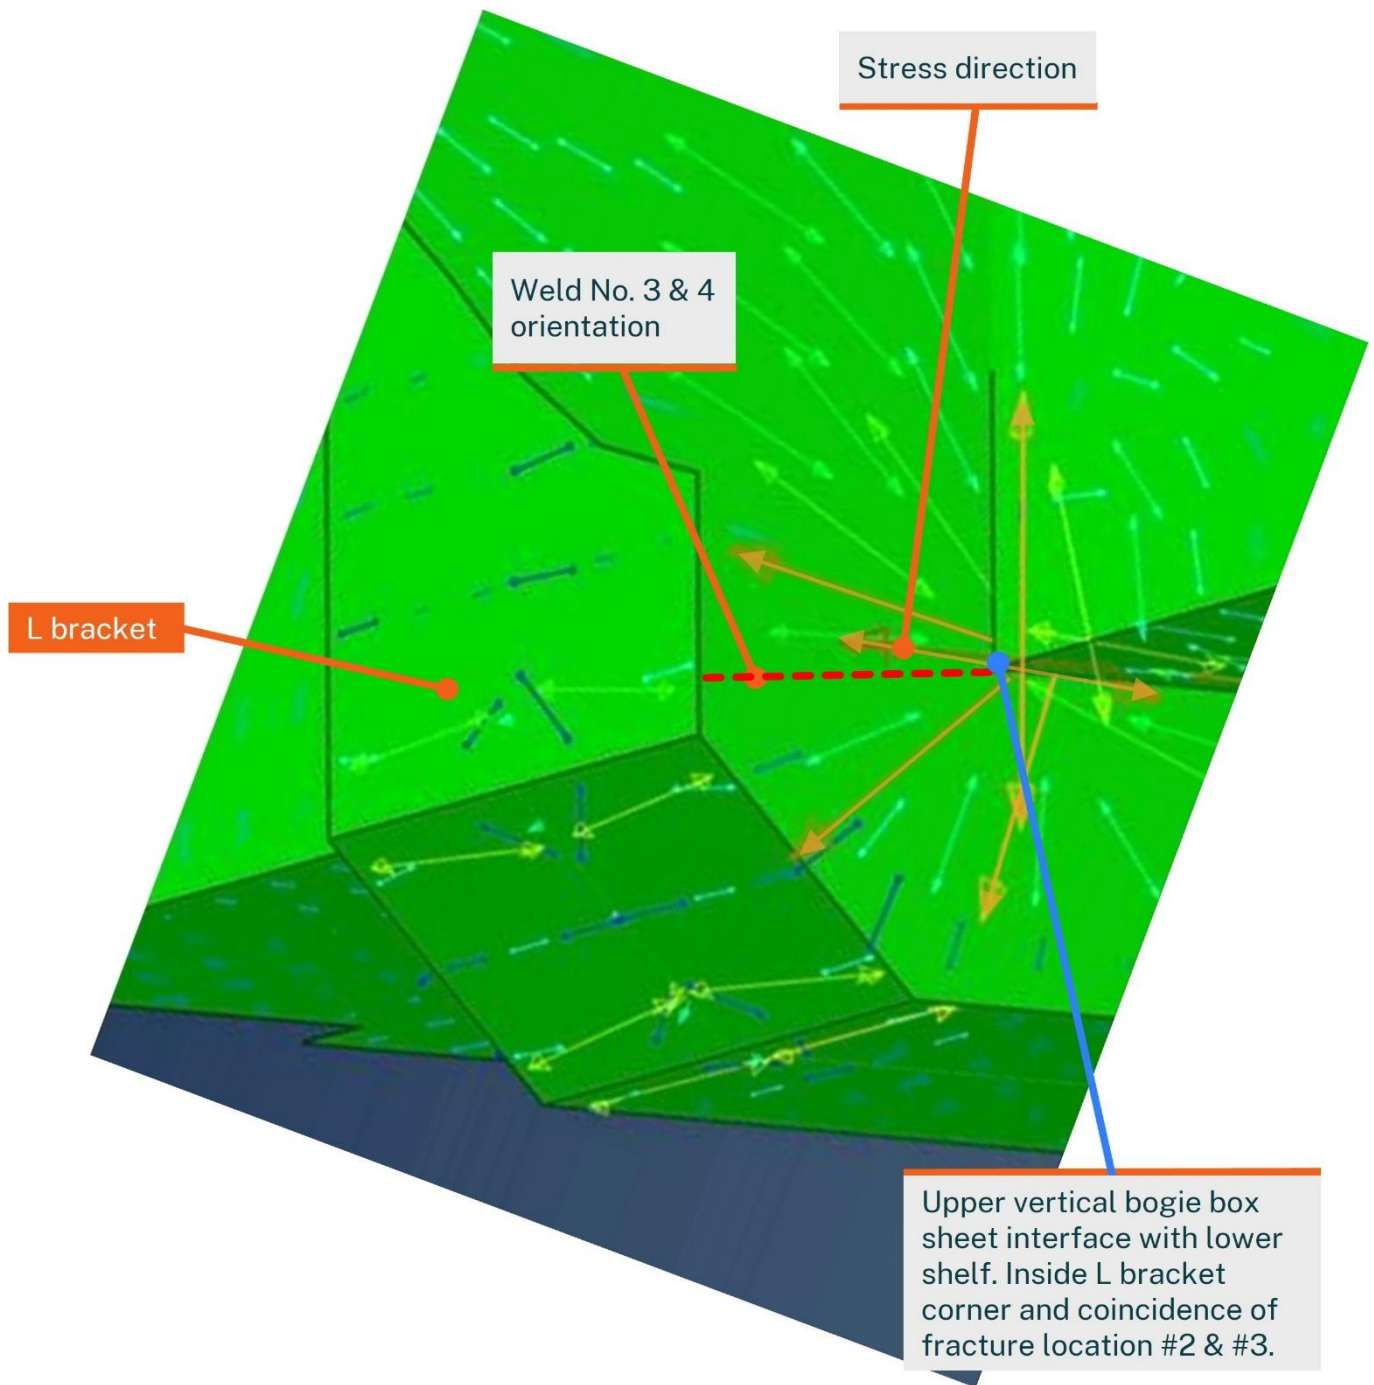
Figure 16: CAF bogie box L bracket FEA force direction plot

1.48 The FEA assessment detailed the direction of stress (and corresponding force) acting along the weld ID's 3 and 4 as shown in Figure 16. CAF assessed the direction of maximum stress as 57.7 N/mm² acting through those welds to be longitudinal and hence a selection of the weld detail category of 100 was made. The same assessment methodology was applied by CAF to select the other bogie box weld detail categories, including the bogie box sheeting weld ID 47 being a weld detail category 80 with a direction of stress as longitudinal.

CAF stress/force direction FEA plot of bogie box at the L bracket location for vertical fatigue load case. Stress direction plot showing principal stress directions for bogie box L bracket (orange arrows) and orientation of welding IDs 3 and 4 (red dotted line, weld IDs referenced in Figure 14 on page 29) where fracture location #2 was identified. Orientation of the L bracket weld ID's were parallel to the stress direction indicated by the orange arrows with the stress direction radiating out from the inside L bracket corner where fracture location #2 was identified and on the inside of the bogie box sheeting, where fracture location #3 was identified at the upper vertical bogie box sheet interface with the bogie box lower shelf.

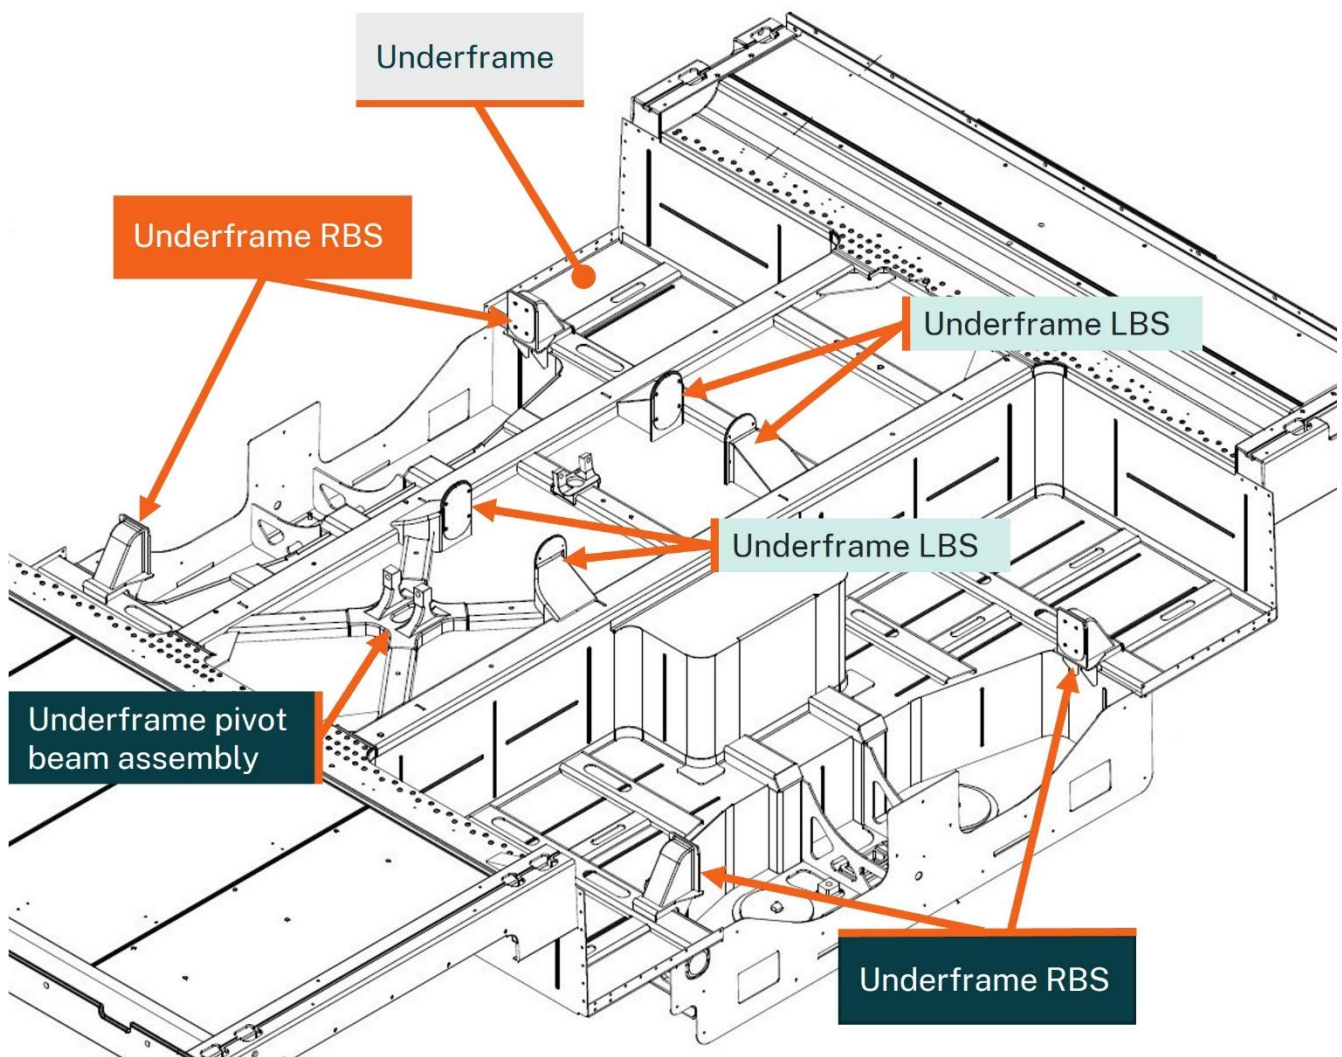
Figure 20: Underframe RBS, LBS and pivot beam details

- The 'IS' TMP instruction covering a **bogie inspection** did not specifically require a check of the underframe RBS condition in the same way it required a check of the LBS underframe condition. No fractures were identified in the LBS underframe area (Figure 20 on page 44).

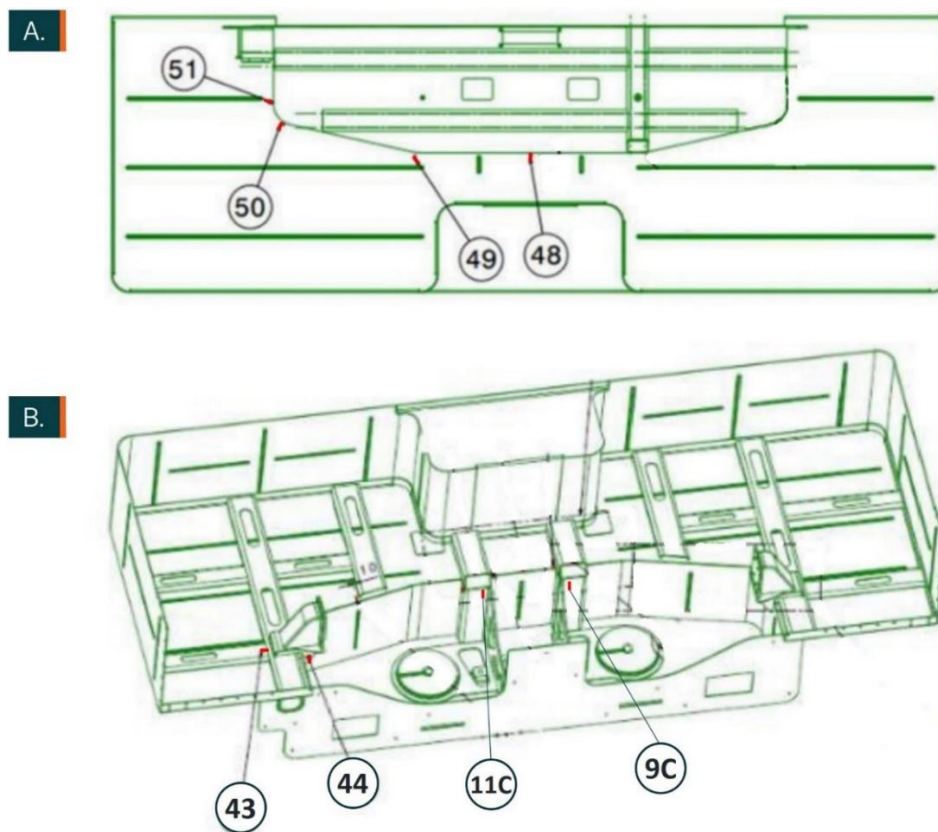
Figure 26: Original design - bogie box central frame strain gauge locations

1.135 Strain gauges were positioned at strategic locations on the underframe bogie box (Figure 26). Strain values from those gauges permitted the calculation of cumulative fatigue damage results⁷² for the Configuration A, B and C RBS clearance test runs. Values of the cumulative fatigue damage were assessed against the weld detail category 36 and weld detail category 80.⁷³ A number of the cumulative fatigue damage results were above the acceptable 30-year limit (values shown in red identifying a ratio greater than 1) (Table 4). CAF identified the highest results to be within the central frame (bogie box and RBS underframe structure). The location of those gauges that exceeded the acceptable 30-year limit were in the vicinity of fracture locations #2, #3 and #4. The exceedance values in the vicinity of fracture locations #3 and #4 were measured at all RBS clearance configurations (Configuration A, B and C). The calculative cumulative damages at each gauge were indicative of an LRV with fractures and would not be indicative of the original LRV design vehicle without fractures.

Central frame bogie box strain gauge locations where the cumulative fatigue damage results of dynamic testing on the original Urbos 3 design was undertaken by CAF. Image A: RHS bogie box top view of strain gauge locations 48, 49, 50 and 51. Image B RHS bogie box inverted view of strain gauge locations 9C, 11C, 43 and 44. Cumulative fatigue results are referenced in Table 4 on page 60.

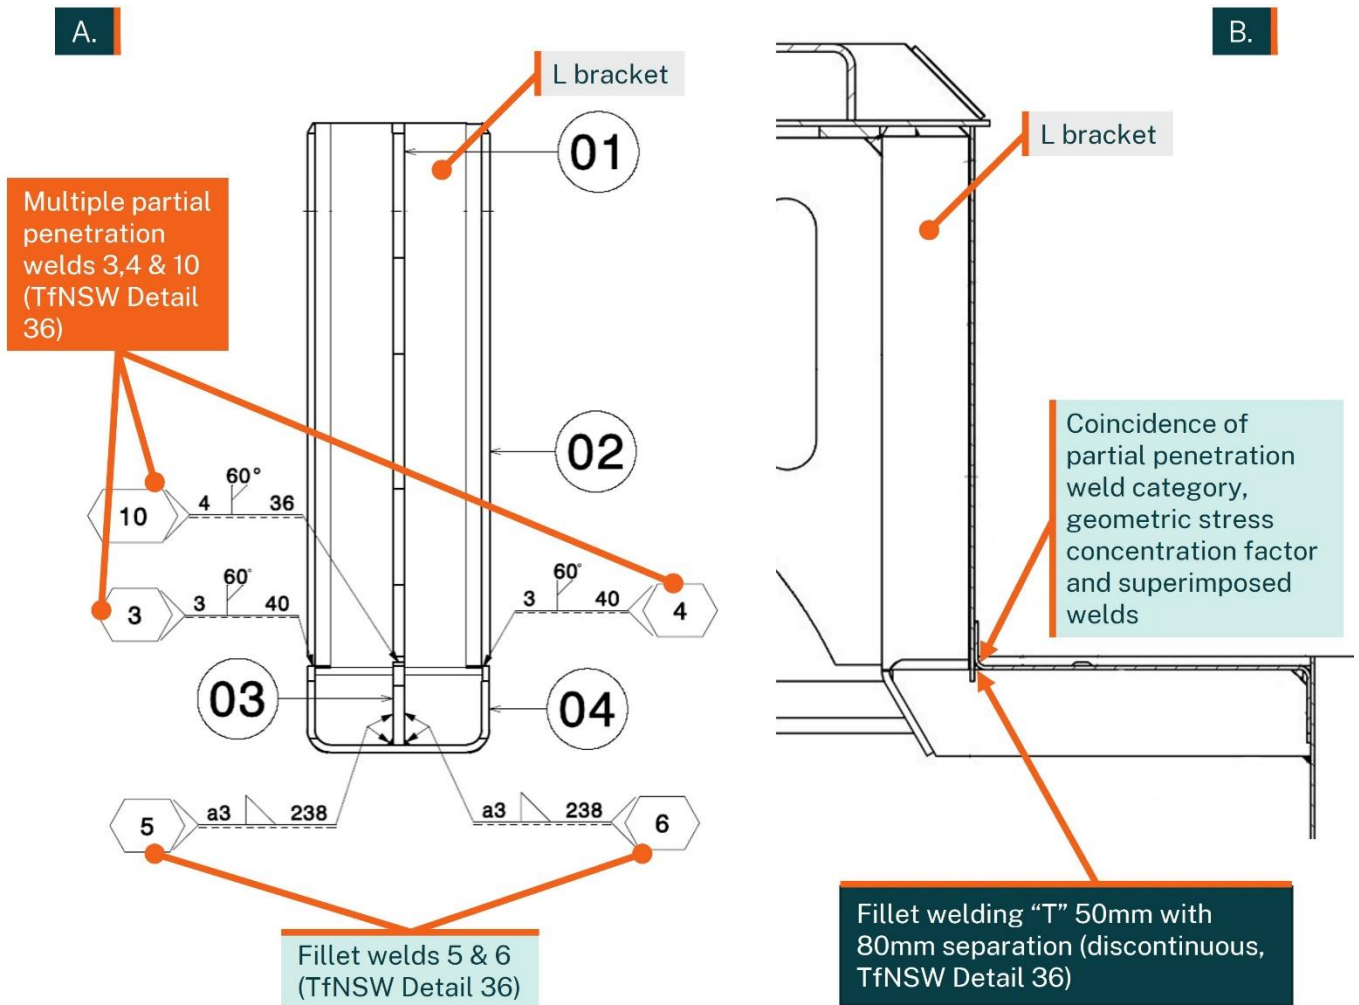
Figure 27: Original design - L bracket welds with TfNSW assessed weld detail categories

- A number of the bogie box L bracket welds, in the vicinity of fracture location #2, were assessed as weld detail category 36 (Figure 27 on page 63). The weld detail category differed to that used by CAF in their fatigue calculation assessment, with CAF using the weld detail category of 80 (see *CAF design and maintenance requirement documentation* paragraph 1.46 and 1.47). In addition, TfNSW noted a geometric complexity of the L bracket right angle and weld construction, assessing a geometric stress concentration factor (Kt) of 2 being appropriate to apply against the level of stress at the coincidence of welds within the L bracket.

Image A details a front view L bracket assembly drawing with weld identification numbers 3, 4, 5, 6 and 10. Corresponding TfNSW weld detail categories are labelled. Image B identifies a side view assembly drawing of the L bracket and bogie box sheeting (in cross section) noting the fillet discontinuous 'T' welding and coincidence of partial penetration welds at the L bracket corner and bogie box sheeting corner construction.

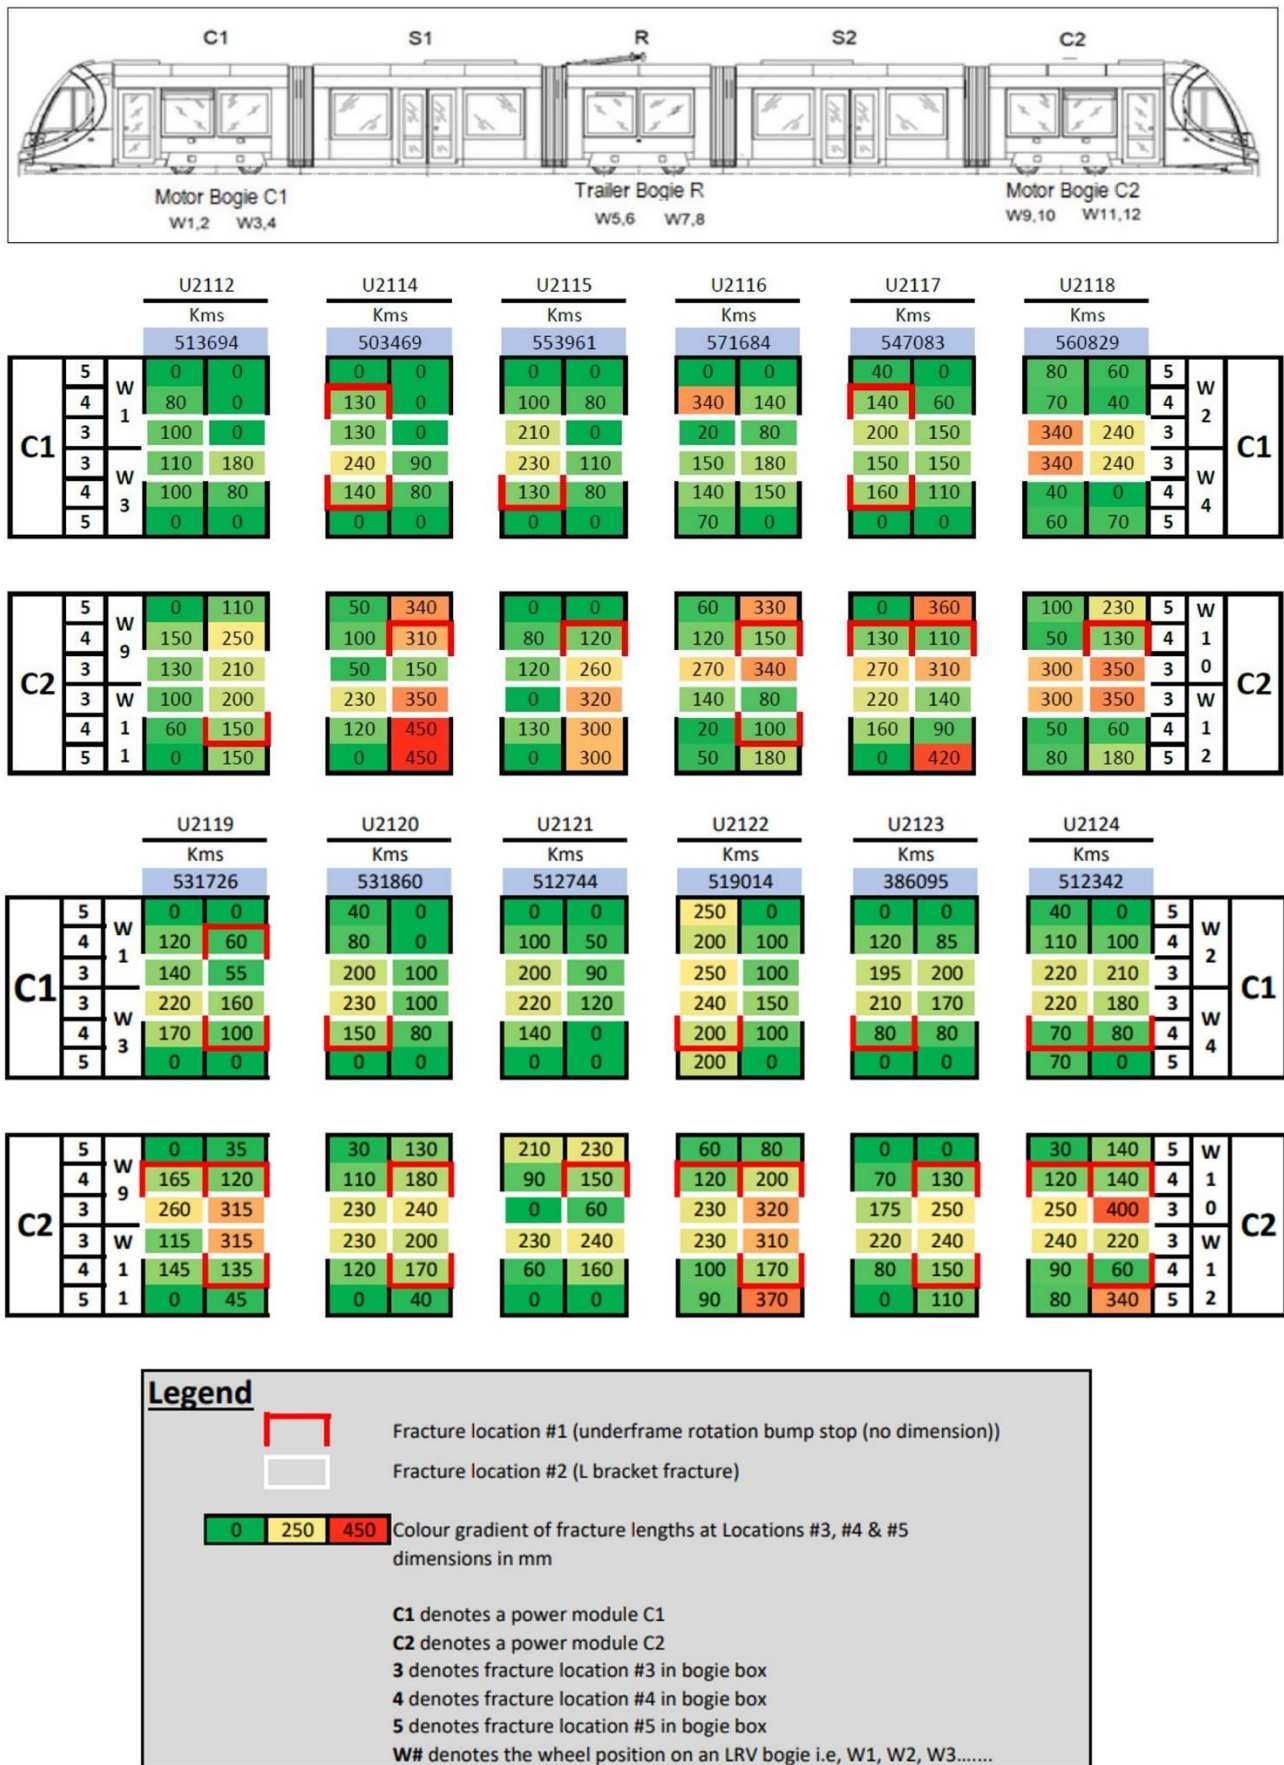
Figure 35: Urbos 3 unit fracture locations, measurements and kms travelled

- No fractures of the underframe RBS attachment to the underframe reinforcement member were detected at the horizontal and rear welds (Location #1.1).

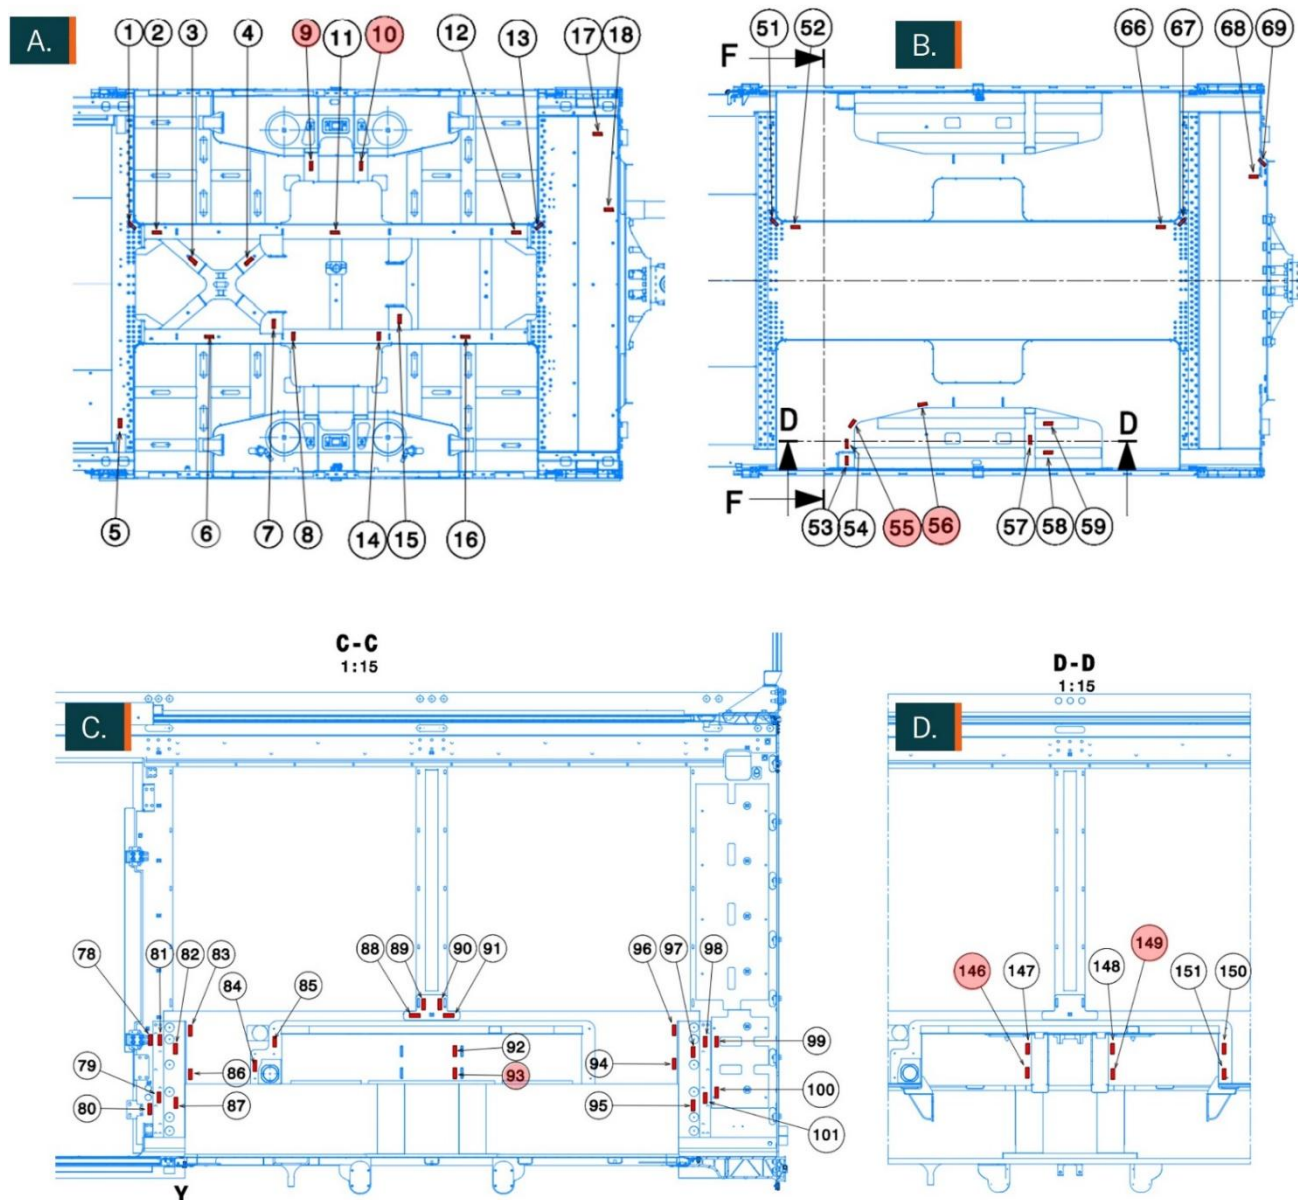
Figure 36: Strain gauge placement locations for Urbos 3 static strain measurement

- location #2 relevant gauges IDs 9 & 10
- location #3 relevant gauges IDs 56, 93, 146, 149
- location #4 relevant gauges IDs 55.

Figure A: Strain gauge positions of interest being 9 & 10, in proximity to fracture location #2,

Figure B: Strain gauge positions of interest being 55 & 56, in proximity to fracture locations #3 & #4.

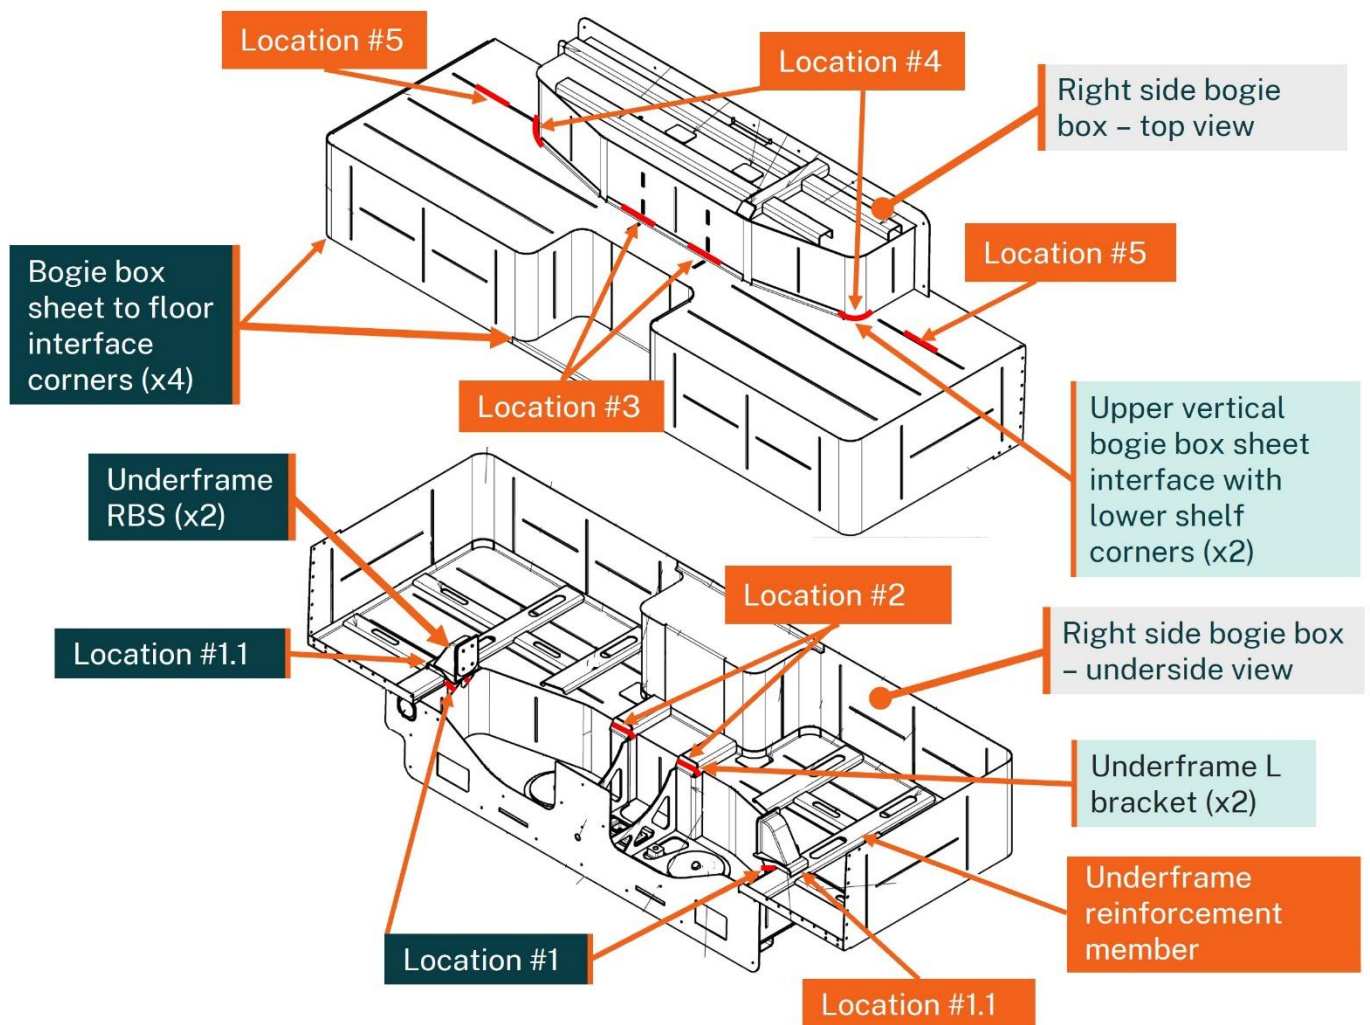
Figure 40: Underframe bogie box fracture locations

Table 5 identifies OTSI fracture locations (Figure 40) against CAF strain gauge location numbers with reference to the original design (Figure 41) and the modified design (Figure 42 and Figure 43). Red values identify where the ratio exceeded the cumulative 30-year fatigue assessment. Green values identify the ratio below 1 that met the cumulative 30-year fatigue assessment.
