**Office of Transport Safety Investigations**

## **BUS SAFETY REPORT**

**BUS FIRES IN NEW SOUTH WALES IN 2017**

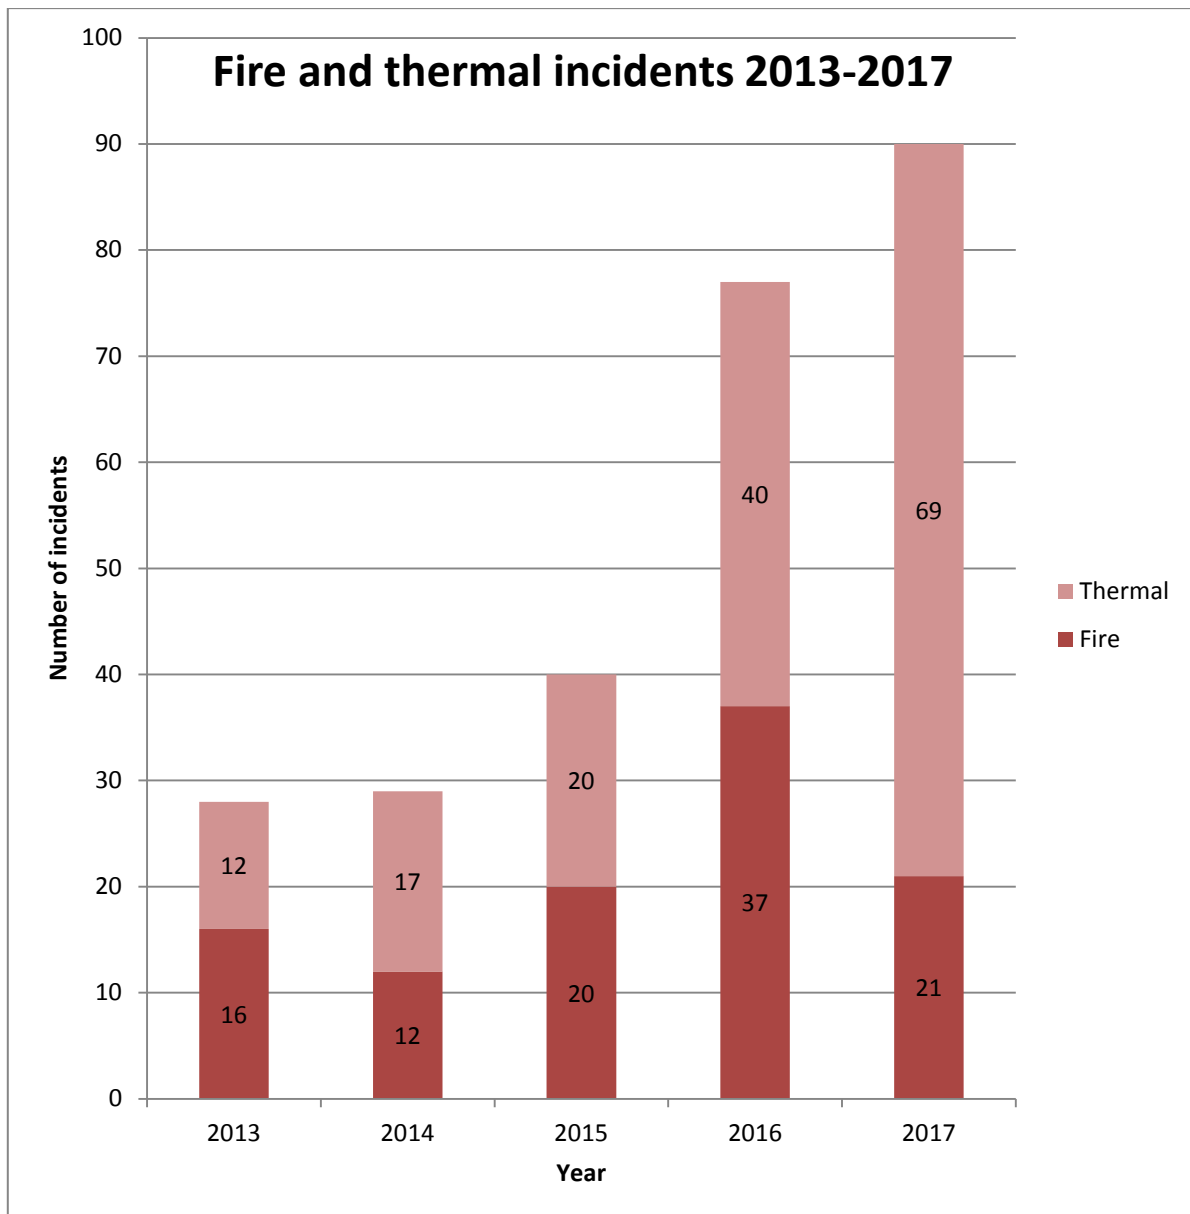
In 2017 there were a total of 90 reported incidents: 21 fire incidents and 69 thermal incidents. This was an increase in total incidents of 16% from 2016 (see *Figure 1*).

**Figure 1: Number of fire and thermal incidents 2013-2017**

It should be noted that there was a significant decrease of 43% in fire incidents, from 37 fire incidents in 2016 to 21 fire incidents in 2017.

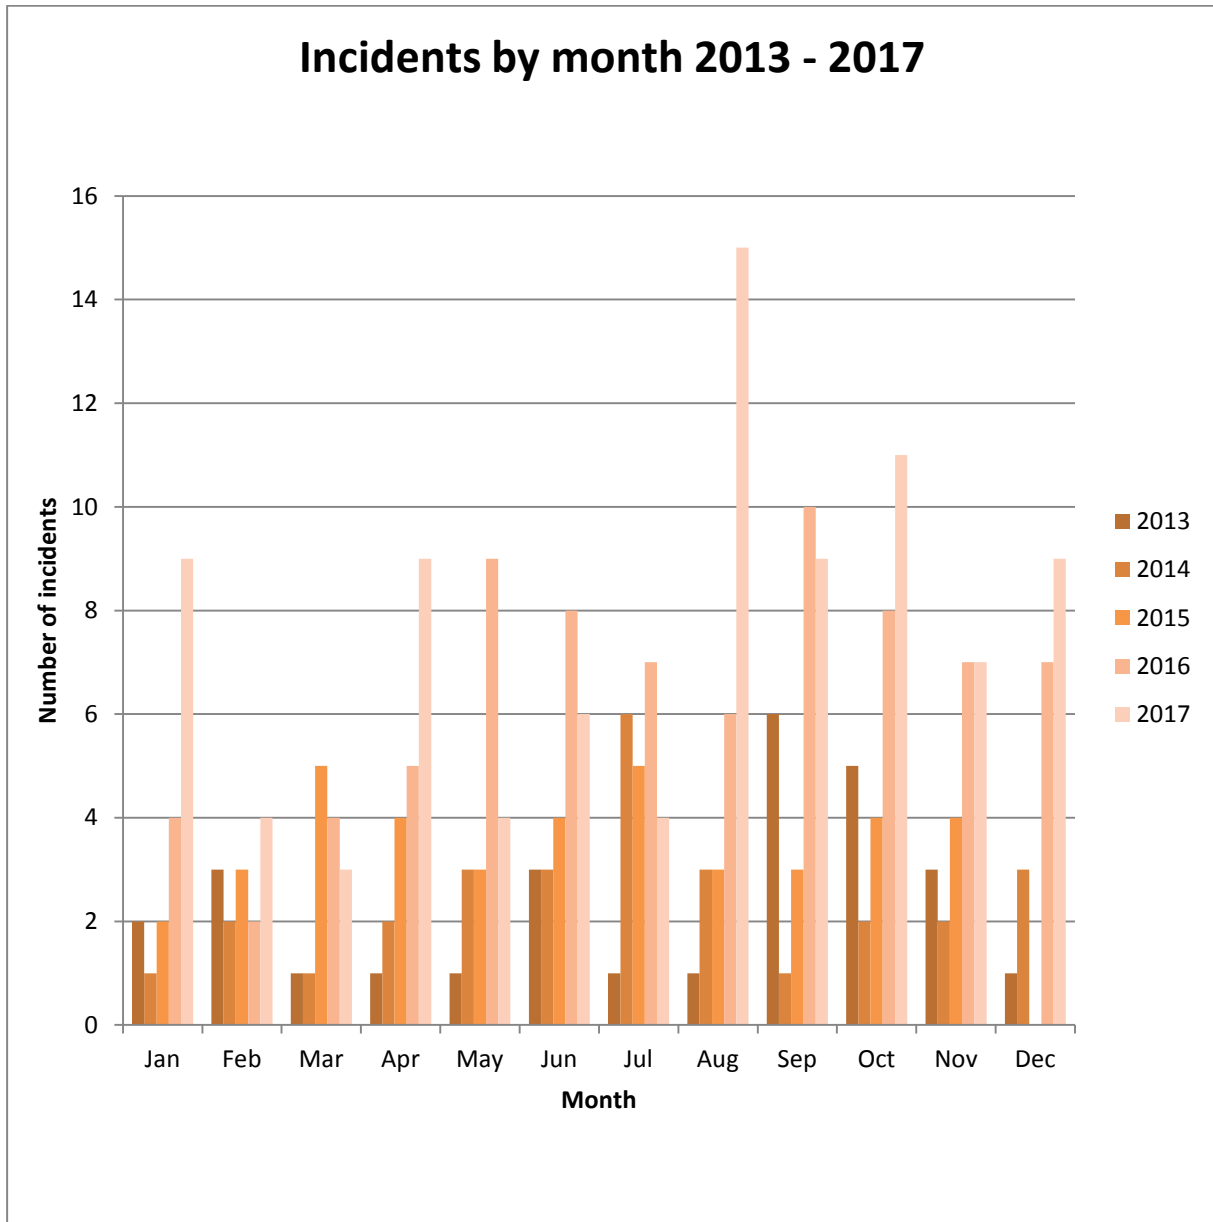
The 90 incidents reported in 2017 were distributed through the year, as shown in *Figure 2*. On average there was a fire or thermal incident reported every 4 days. Brief details of each incident are recorded at *Appendix A*.

**Figure 2: Incidents by month 2013-2017**

Although there was a large spike in incidents in August 2017, a record month for incidents, there was no apparent trend in the month by month incidents.

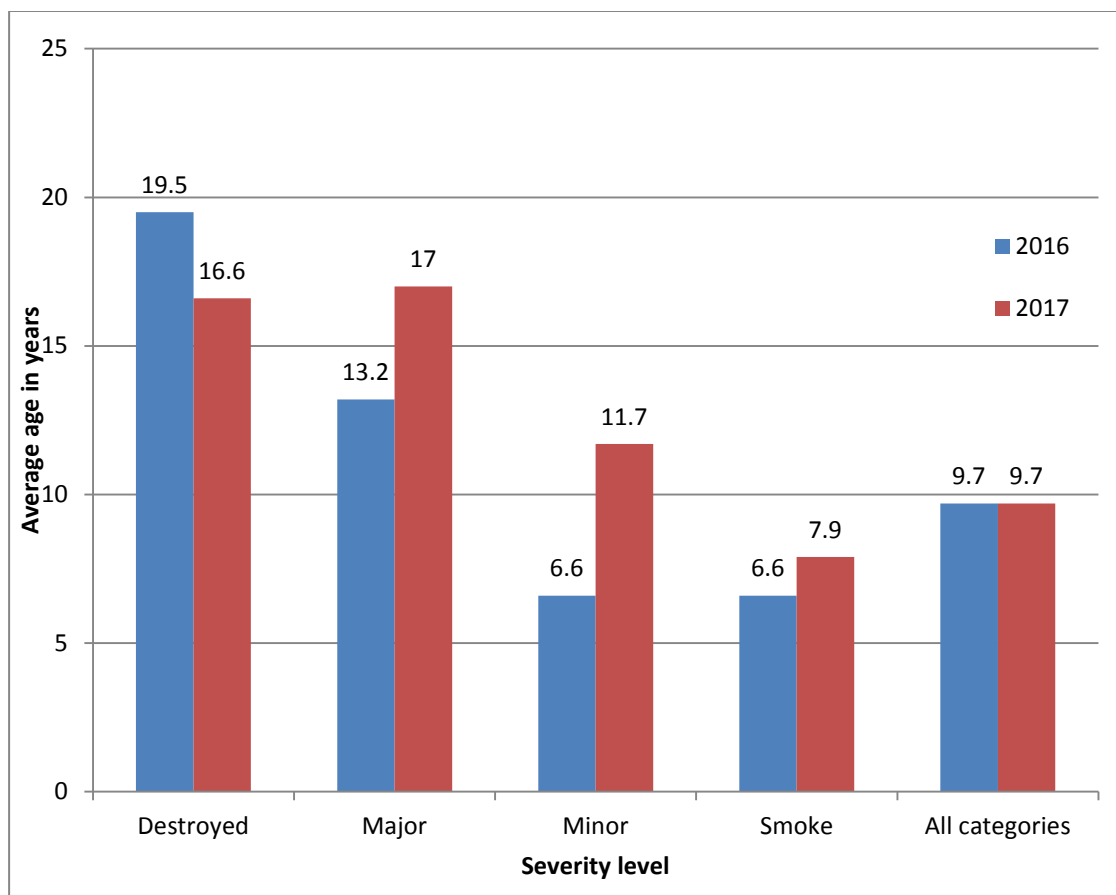
The severity level and the average age of buses involved in incidents in 2016 and 2017 is shown below in *Figure 6*. This shows that, like 2016, older buses sustained a greater level of damage than newer buses.

**Figure 6: The severity level and the average age of the bus**

The 5 destroyed vehicles ranged in year of manufacture from 1995 to 2004. The 7 vehicles that sustained major damage ranged in year of manufacture from 1993 to 2011. The average age for buses in the destroyed category was 16.6 years. In 2016 it was 19.5 years. The average age for buses in the minor damage category was 7.9 years. In 2016 it was 6.6 years. The average age of buses involved in all levels of fire and thermal incidents was 9.7 years, the same average as 2016.

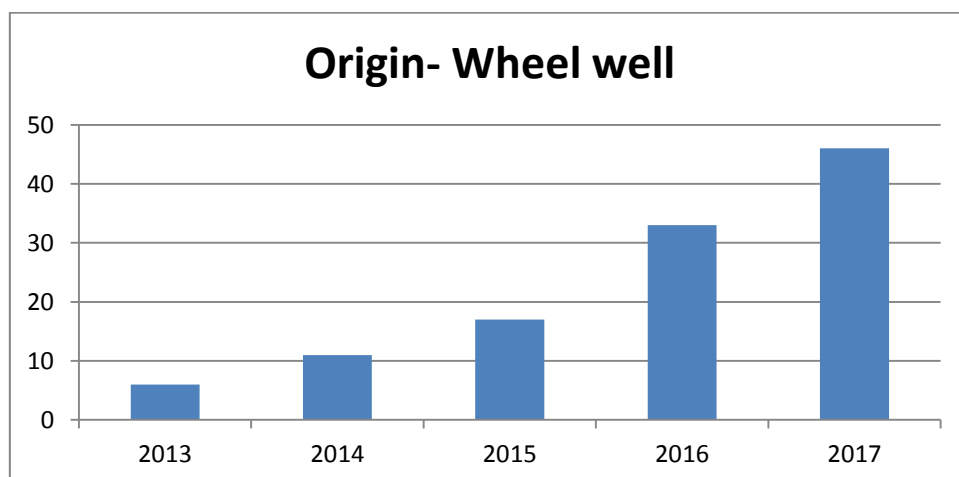
In 2017, 46 incidents (52%) were located around the wheel well. It should be noted that the majority of these incidents (91%) resulted in smoke damage only. OTSI believes that it is likely the increasing trend of wheel-well thermal incidents is due mainly to an increase in reporting. However, these precursor incidents should not be ignored as one wheel-well fire destroyed a bus at Thornton in October 2017. There has been a steady increase in wheel well incidents from 2013 to 2017 (see *Figure 11*).

**Figure 11: Number of wheel well incidents 2013-17**

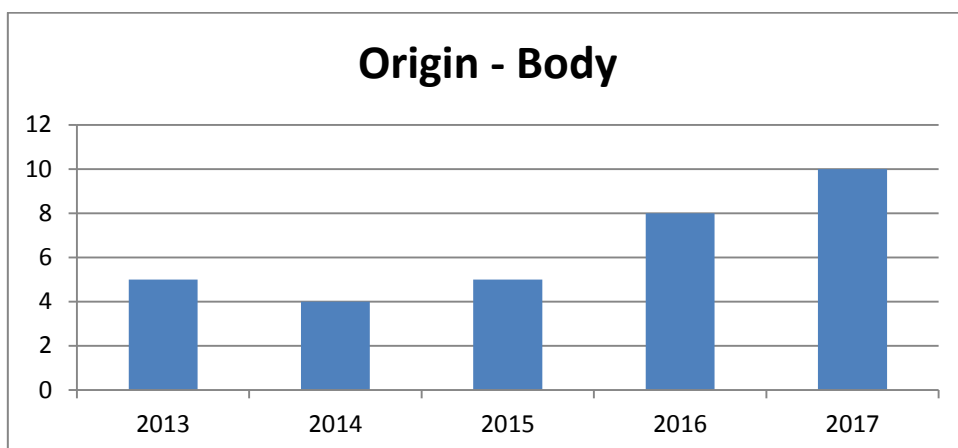
A smaller number of incidents originated both inside and outside the body of the bus or coach. There has been an increase in body incidents from 2013 to 2017 (see *Figure 13*).

**Figure 13: Number of body incidents 2013-17**

The cause of body incidents was all due to electrical malfunction or failure (100%). The 10 electrical incidents had a wide variety of origins: battery compartment, battery cables, ignition switches, wiper motor, and a mirror control unit.

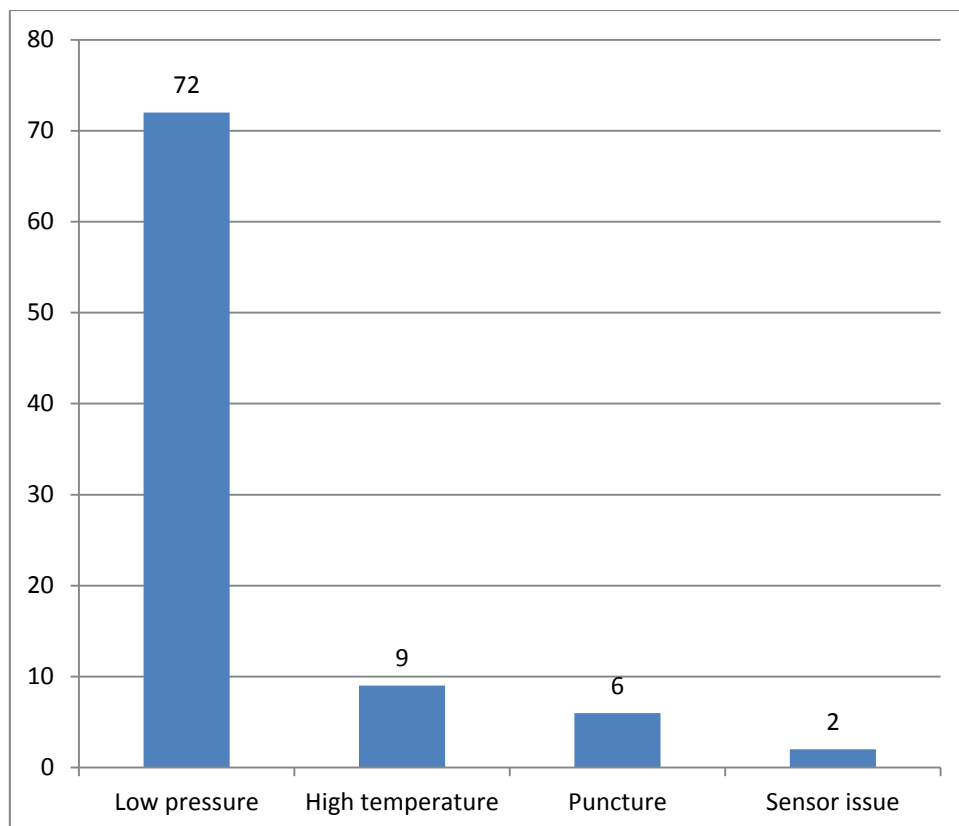
The 19 operators reported having a total of 4439 buses, with 1738 of these buses were fitted with TPMS (39%). The numbers of the activations are provided in *Figure 20* below. It should be noted that this number does not reflect all activations as many operators did not keep records of activation numbers. It is hoped that improved record keeping by operators will make the data more comprehensive in future years.

**Figure 20: Tyre pressure monitoring system activations**

Many bus operators now have tyre pressure monitoring systems fitted. A large number were fitted as part of the EBFS system installation. These systems continuously monitor tyre pressure and temperature data which is transmitted from wireless, valve-stem mounted tyre sensors. A dash-mounted screen provides a visual and audible alert for rapid deflation, under inflation, high pressure and excessive heat conditions.
