Office of Transport Safety Investigations

BUS SAFETY REPORT

BUS FIRES IN NEW SOUTH WALES IN 2018

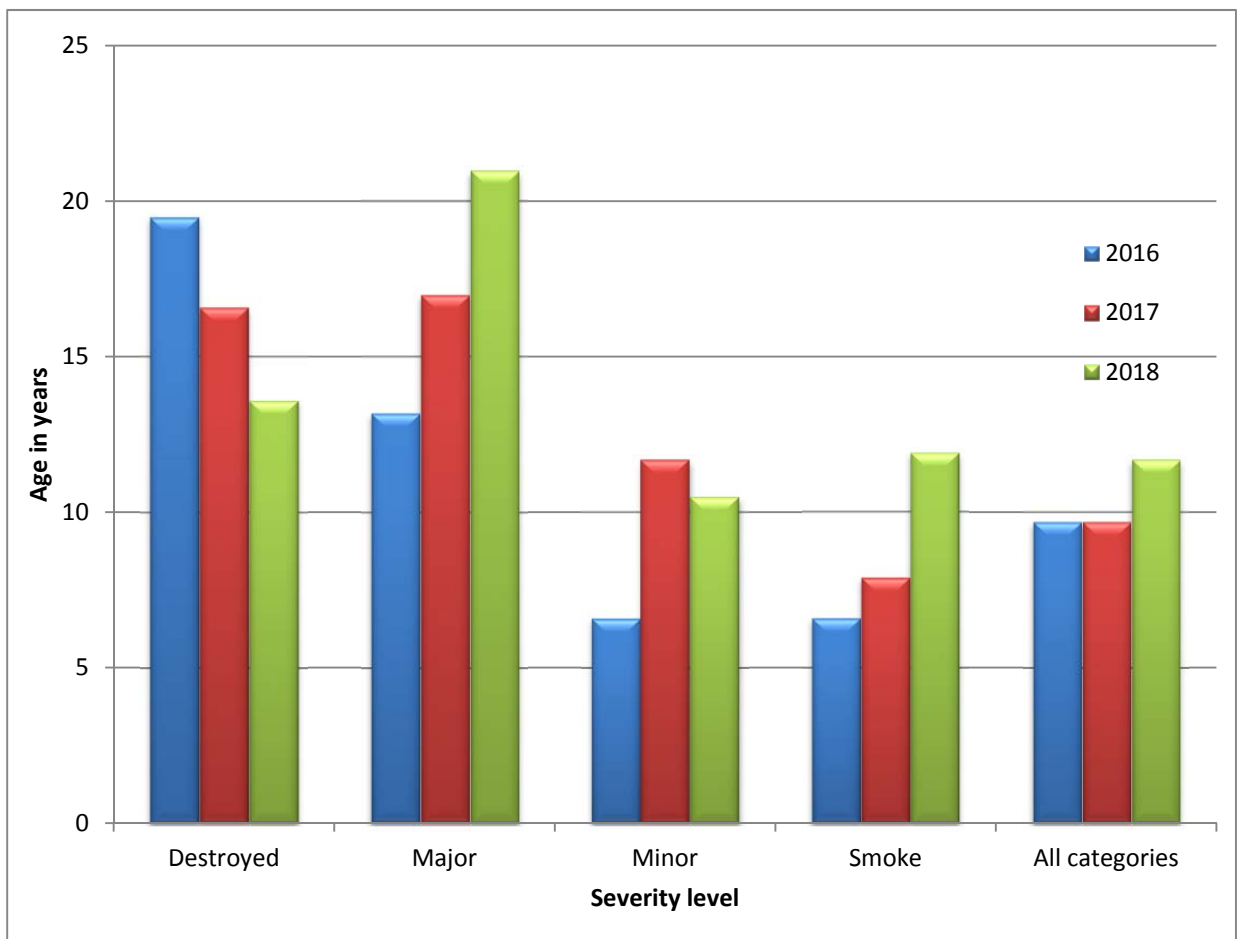
The three destroyed buses ranged in year of manufacture from 1992 to 2013 and the bus that sustained major damage was manufactured in 1997. The average age for buses in the destroyed category in 2016 was 19.5 years, in 2017 was 16.6 years, and in 2018 was 13.6 years. The average age for buses in the minor damage category in 2016 was 6.6 years, 2017 was 11.7 years and in 2018 was 10.5 years. The average age of buses involved in all levels of fire and thermal incidents was 11.7 years, an increase of three from previous years.

The severity level and the average age of buses involved in incidents in 2016, 2017 and 2018 are shown below in *Figure 6*.

Figure 6: The severity level and the average age of the bus

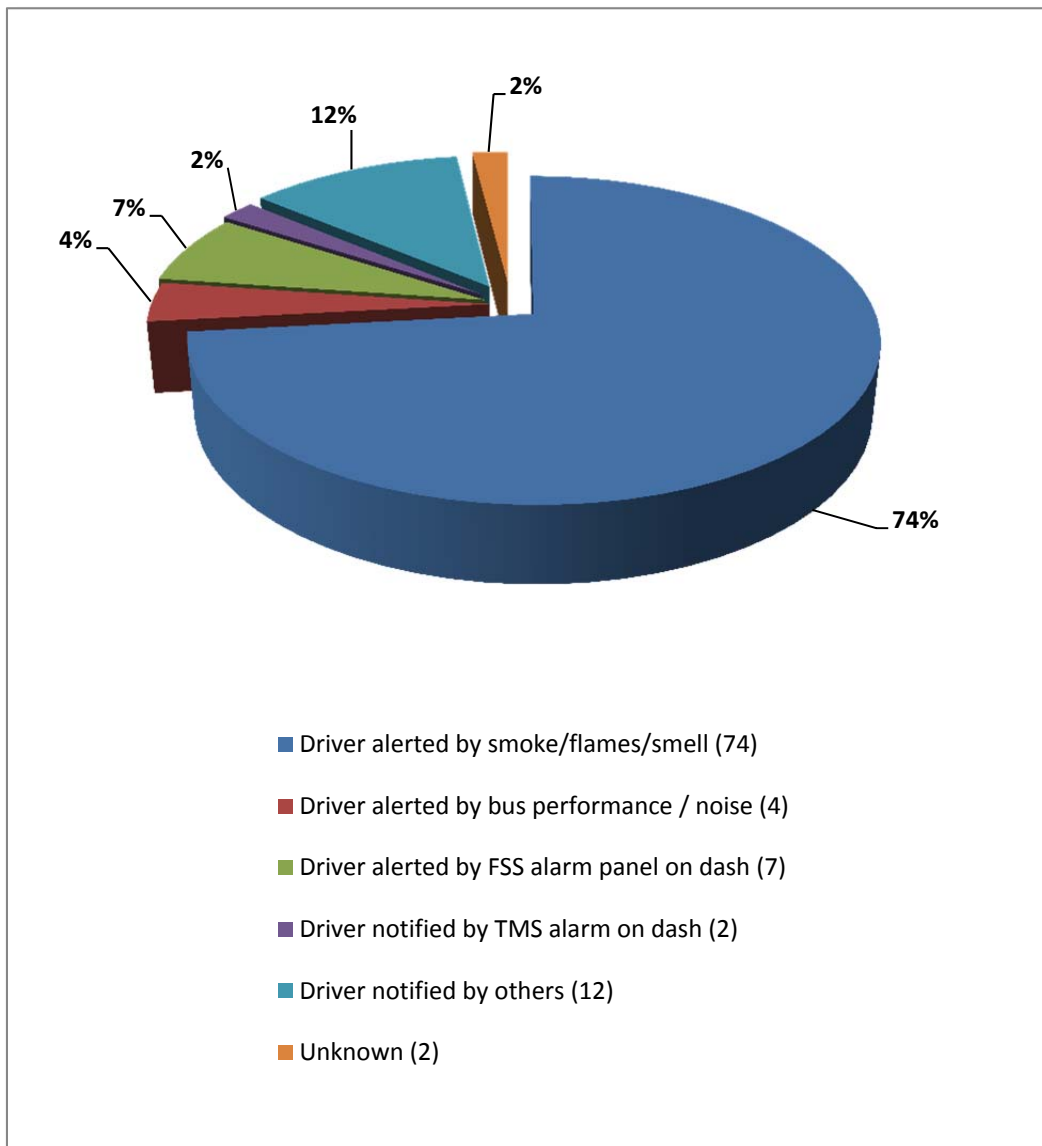
The data for the detection of incidents in 2018 are shown in Figure 17.

Figure 17: Detection of incidents 2018

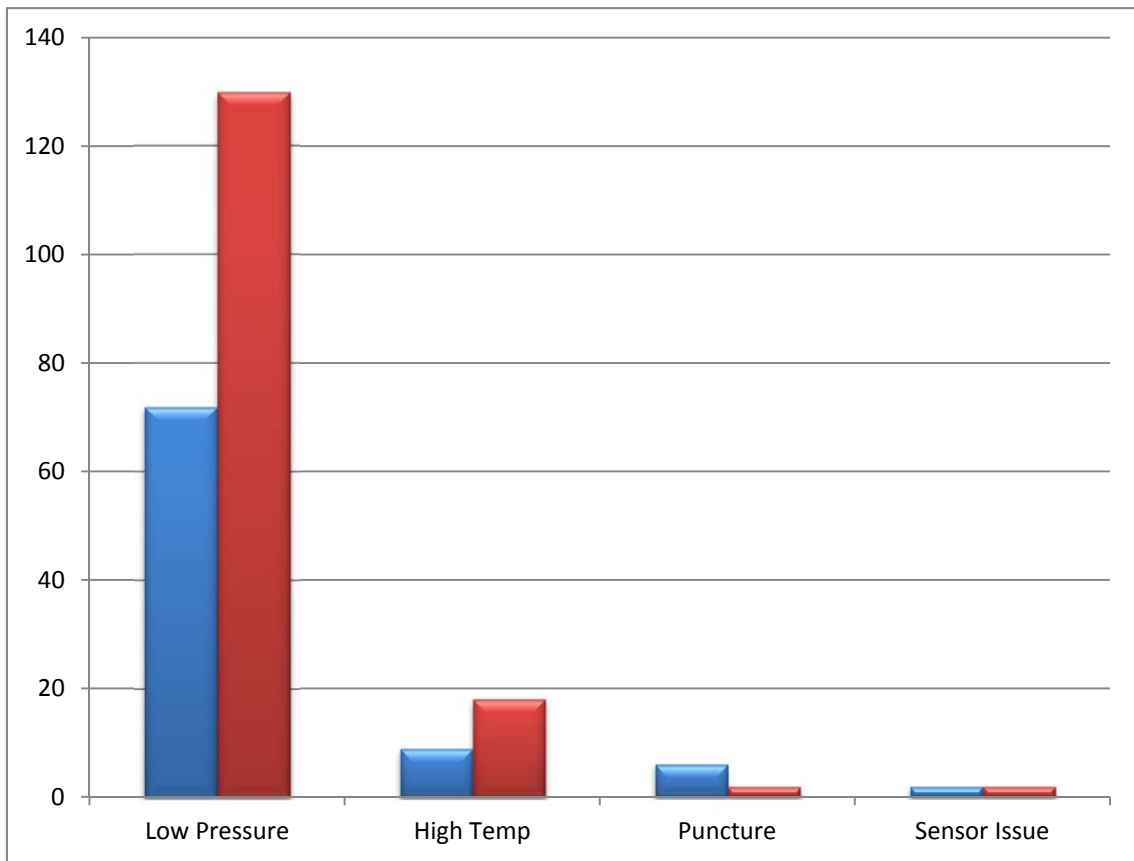
The 19 operators reported having a total of 1211 buses fitted with TMS. The numbers of the activations are provided in Figure 20 below. It should be noted that this number does not reflect all activations as many operators did not keep records of activation numbers. It is hoped that improved record keeping by operators will make the data more comprehensive in future years.

Figure 20: TMS activations 2018
