BUS SAFETY INVESTIGATION REPORT

AN INVESTIGATION INTO BUS FIRES IN NSW 2005 - 2012

Investigation Reference 04601

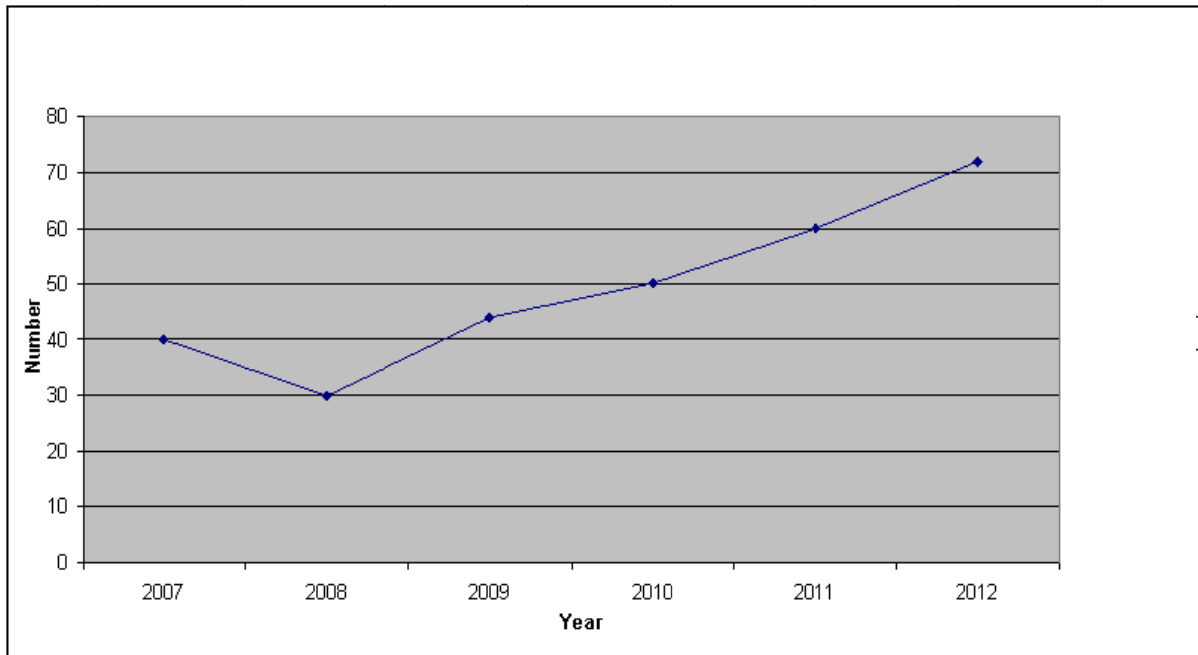
Figure 1: Bus fire insurance claims

Data on the number of claims due to bus fires over the last five years shows a steady annual increase of approximately 20%, or 15% when growth in the fleet is taken into account (see *Figure 1*).⁷
