**Office of Transport Safety Investigations**

## **BUS SAFETY REPORT**

**BUS FIRES IN NEW SOUTH WALES IN 2018**

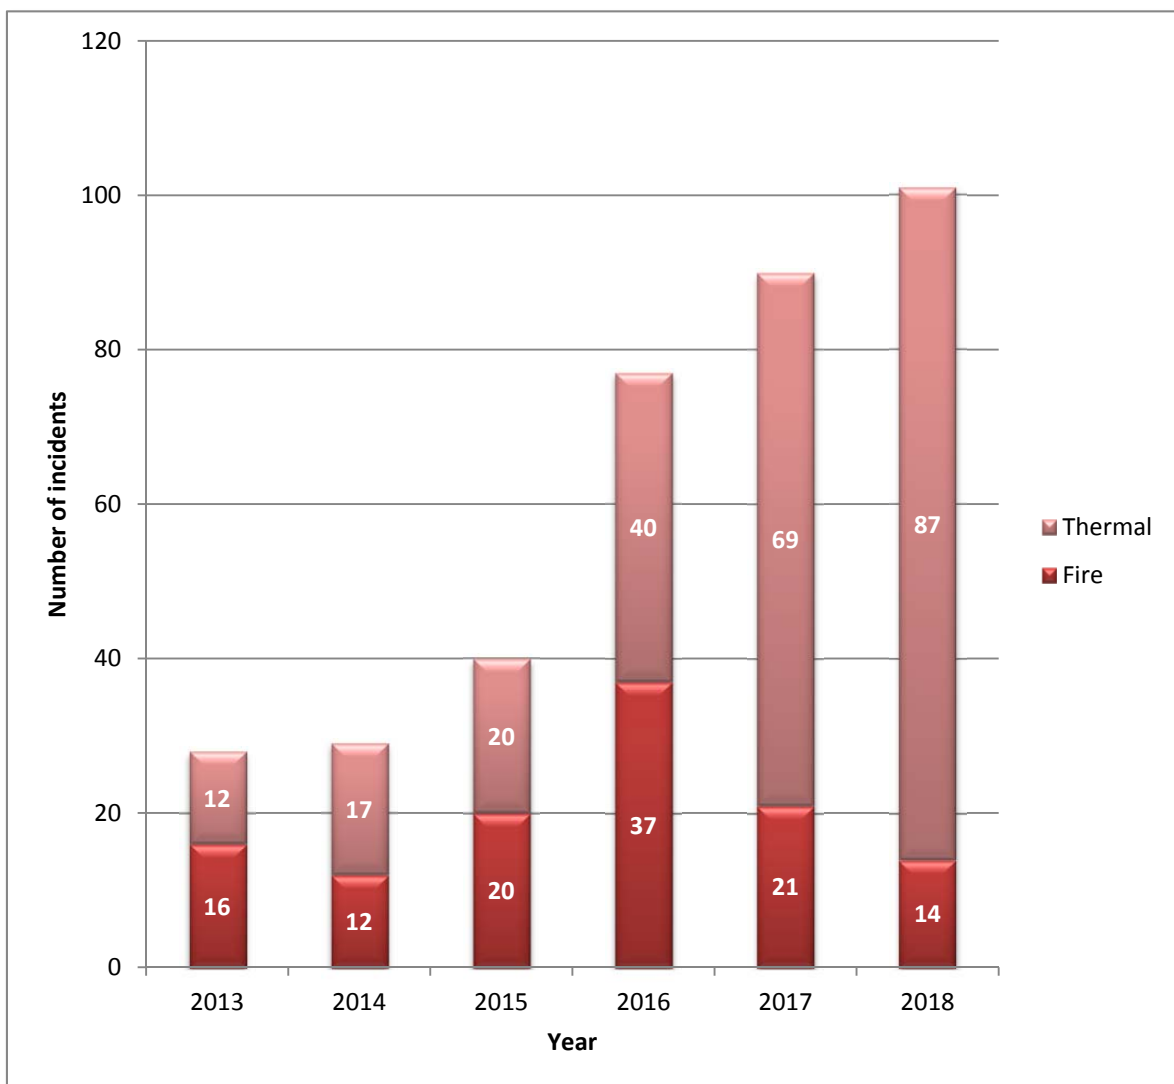
In 2018 there were a total of 101 reported incidents: 14 fire incidents and 87 thermal incidents. This was an increase in total incidents of 12% from 2017 (Figure 1).

**Figure 1: Number of fire and thermal incidents 2013-2018**

It should be noted that there was a notable decrease of 33% in fire incidents, from 21 fire incidents in 2017 to 14 fire incidents in 2018.

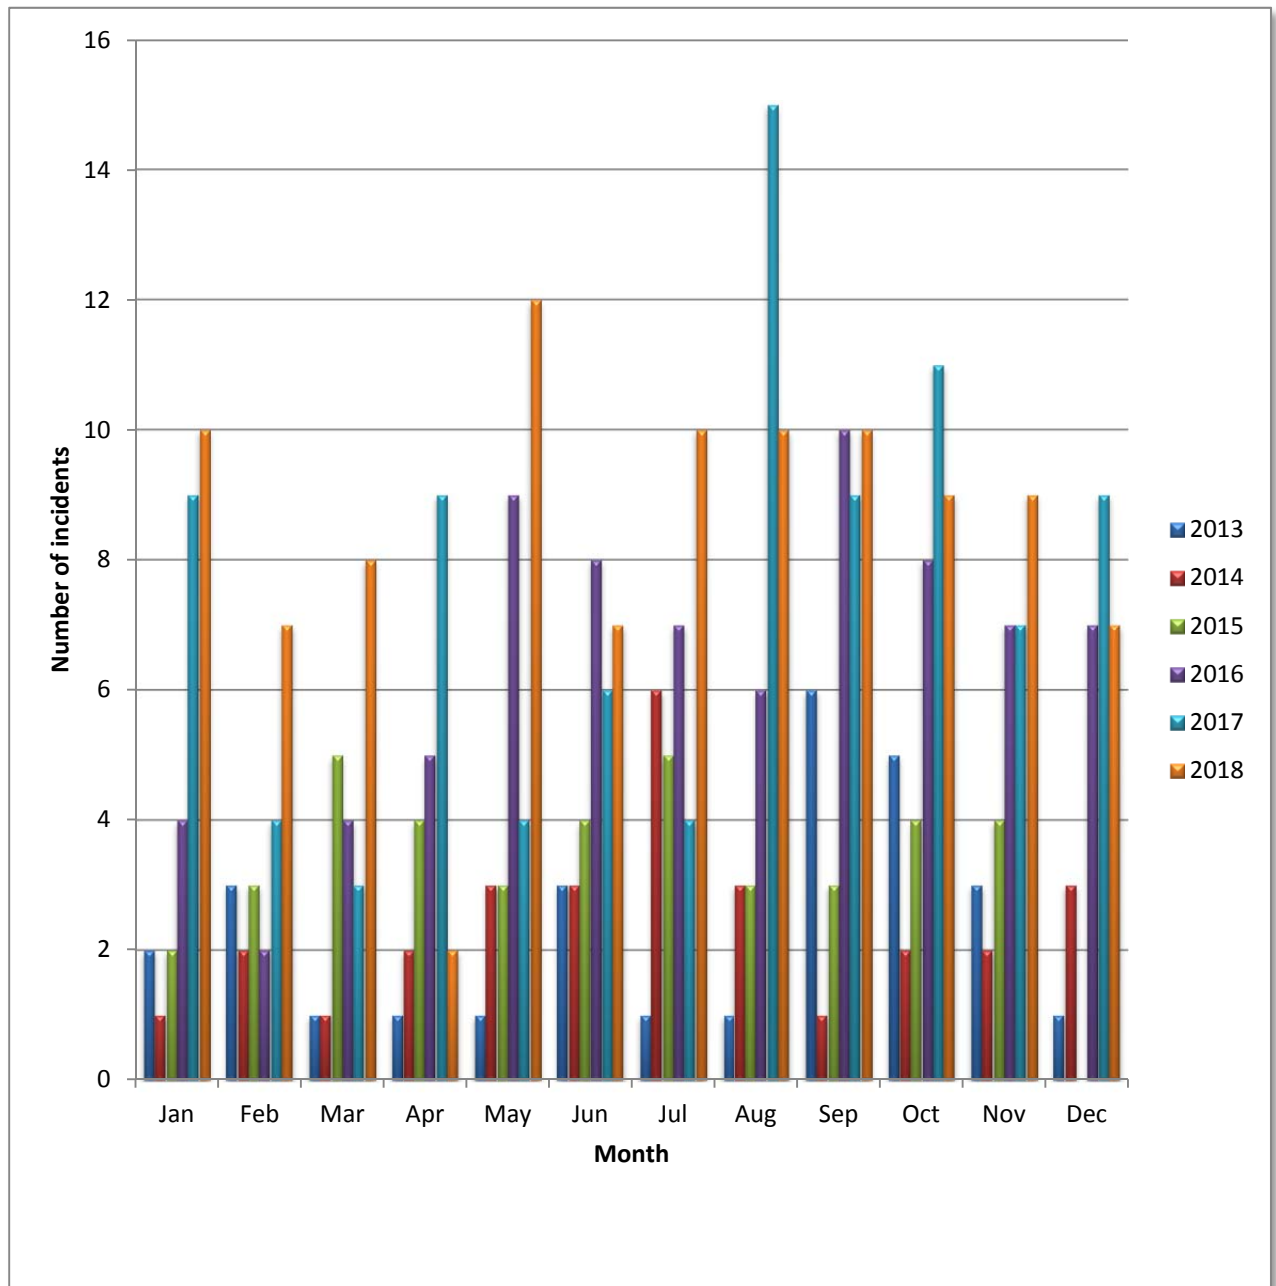
The 101 incidents reported in 2018 were distributed throughout the year, as shown in *Figure 2*. On average there was a fire or thermal incident reported every 4 days. Brief details of each incident are recorded at *Appendix A*.

**Figure 2: Incidents by month 2013-2018**

Although there was a decrease in incidents in April 2018, there was no apparent trend in the month by month incidents.

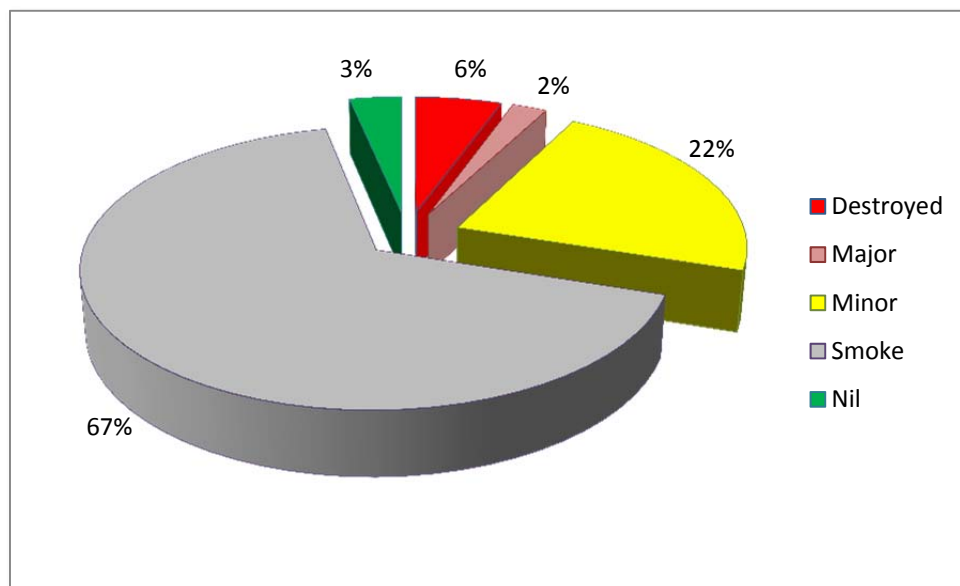
Based on OTSI assessment and operator reports, three buses were destroyed, one suffered major damage, 28 had minor damage, 63 had smoke damage and six buses had nil damage (see *Figure 3*).

**Figure 3: Severity level of incidents NSW 2018**

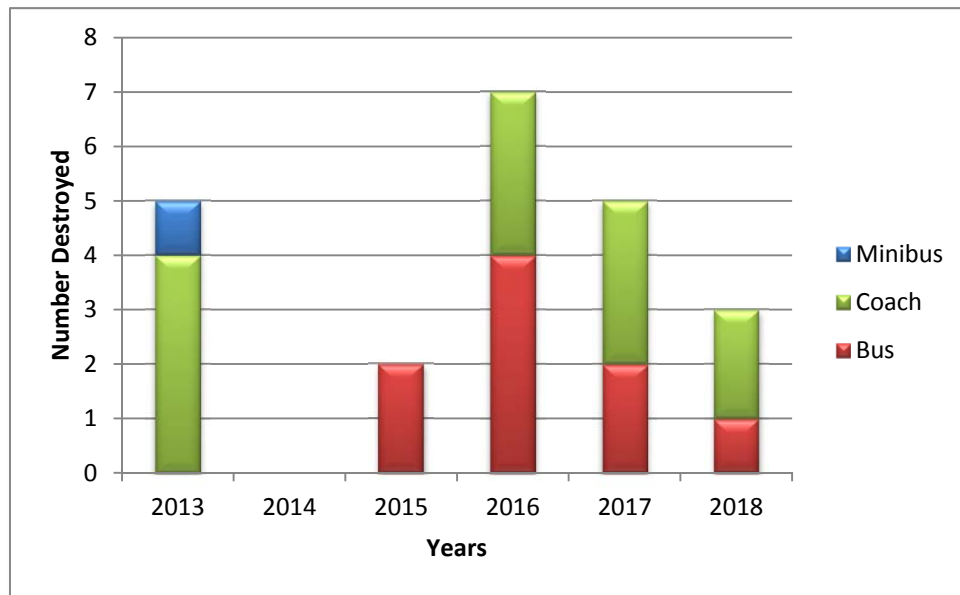
The numbers of destroyed buses have continued to decline following a peak in 2016. Figure 4 indicates that in 2018 three buses were destroyed compared to five in 2017 and seven in 2016.

**Figure 4: Destroyed 2013-2018**

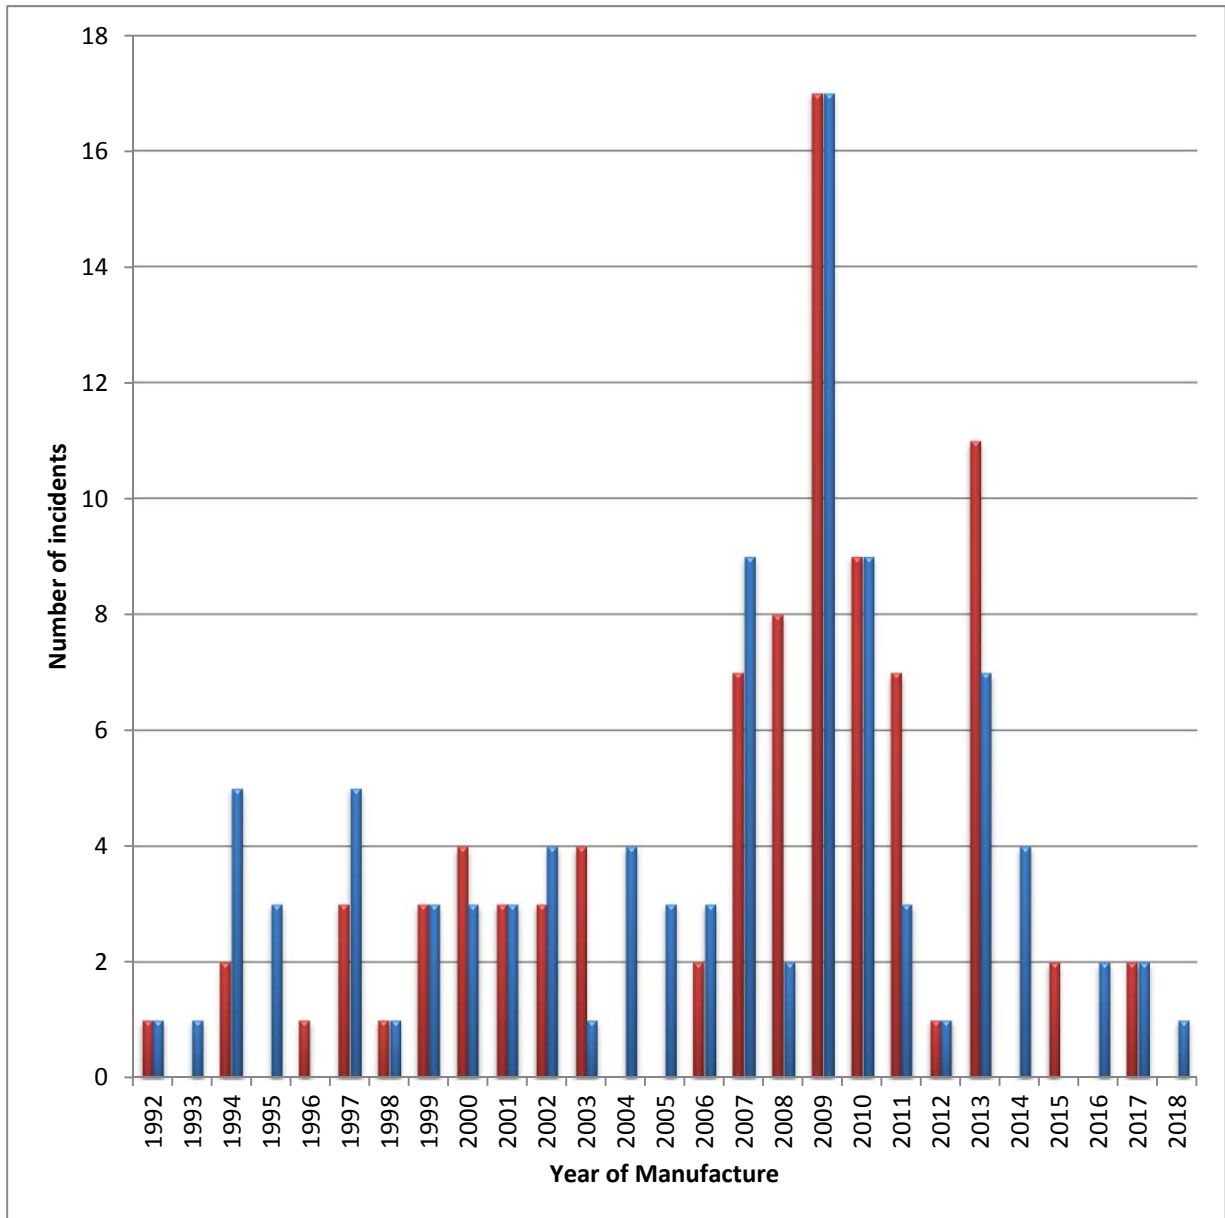
The ages of the buses involved ranged from almost new to 25 years. The majority of incidents involved buses between 5 and 11 years old (see *Figure 5*). An analysis of bus fleets in previous years showed that this age range makes up the majority of fleets. Ten different makes of bus were involved and no make or model trends were identified.

**Figure 5: Age of bus involved in 2017 (red) and 2018 (blue)**

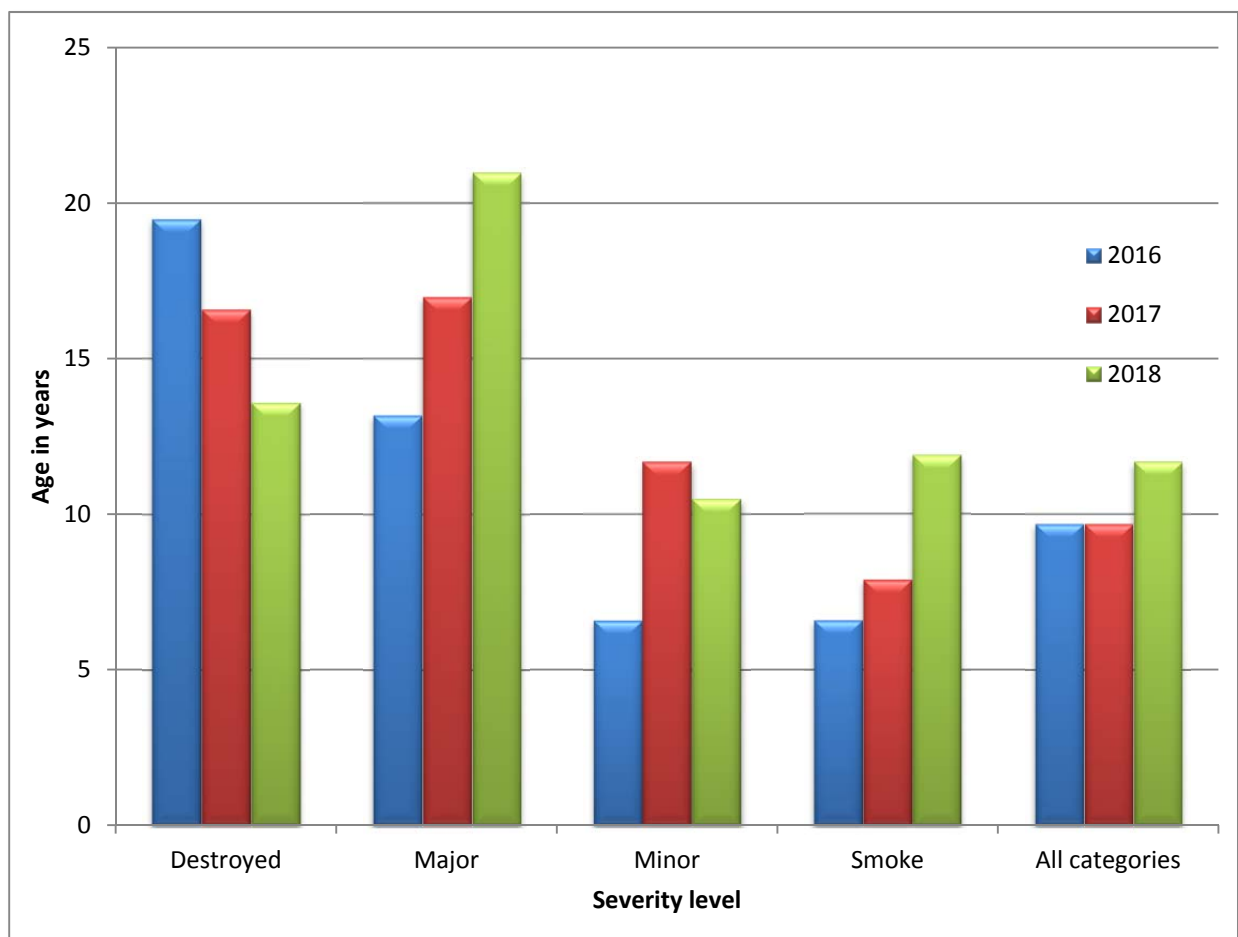
The severity level and the average age of buses involved in incidents in 2016, 2017 and 2018 are shown below in *Figure 6*.

**Figure 6: The severity level and the average age of the bus**

The three destroyed buses ranged in year of manufacture from 1992 to 2013 and the bus that sustained major damage was manufactured in 1997. The average age for buses in the destroyed category in 2016 was 19.5 years, in 2017 was 16.6 years, and in 2018 was 13.6 years. The average age for buses in the minor damage category in 2016 was 6.6 years, 2017 was 11.7 years and in 2018 was 10.5 years. The average age of buses involved in all levels of fire and thermal incidents was 11.7 years, an increase of three from previous years.

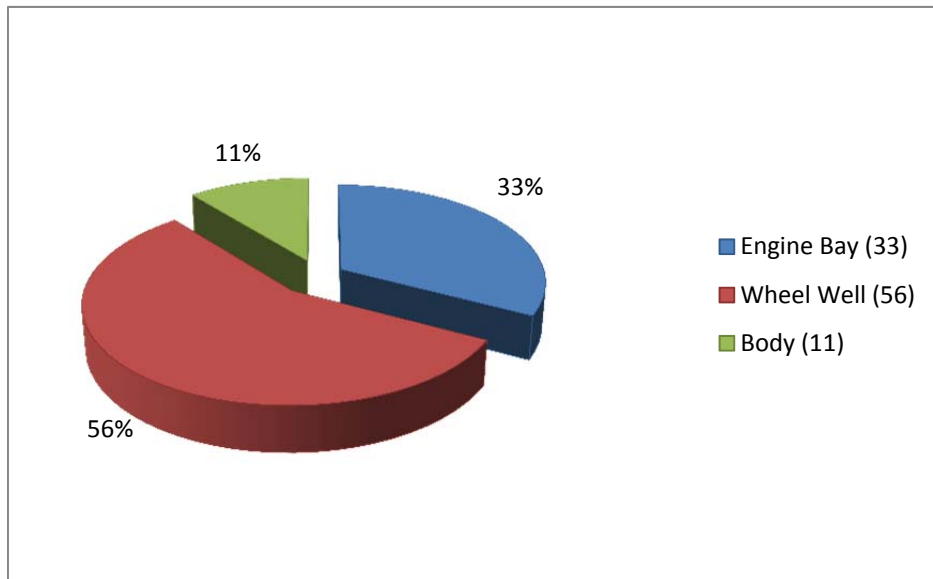
In 2018, the majority of fire and thermal incidents 56% originated in the wheel well. The engine bay had 33% and the body had 11%. *Figure 7* shows the originating area of all incidents in 2018.

**Figure 7: Location by origin 2018**

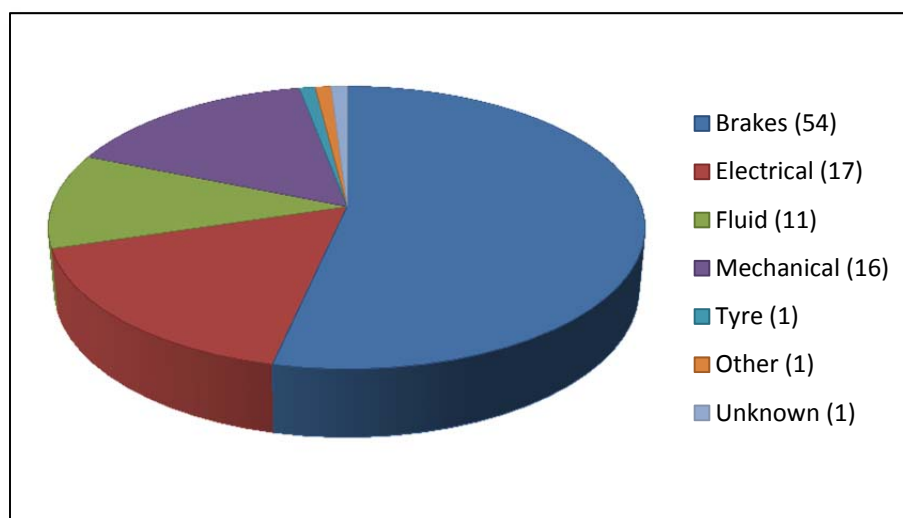
The data for the causes of fire and thermal incidents in 2018 are shown in *Figure 8*.

**Figure 8: Causes of incidents 2018**

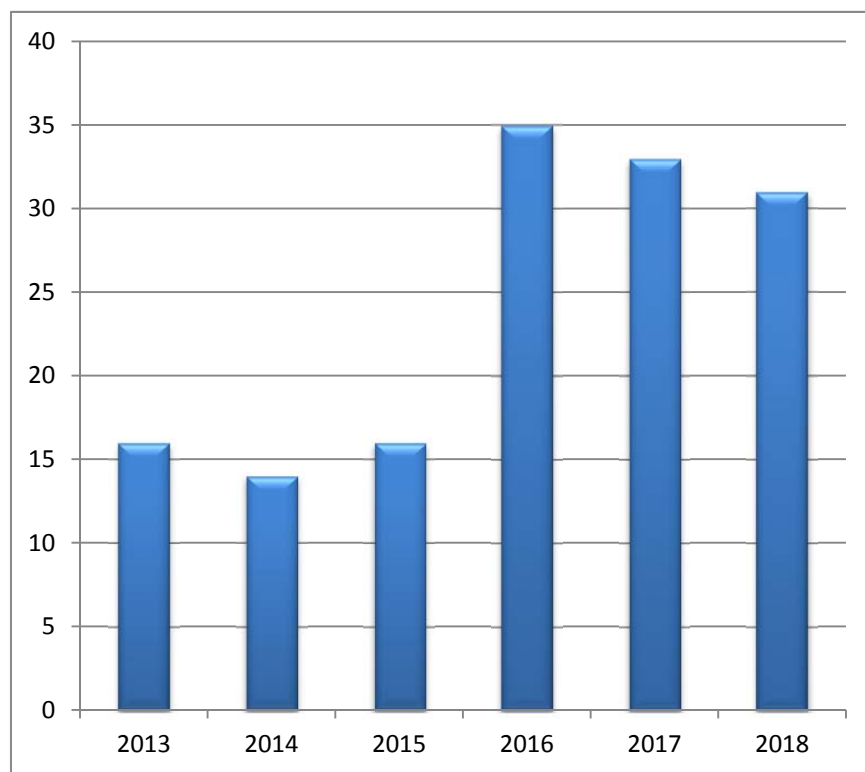
In 2018, 33 incidents (33%) originated in the engine bay. Although only minor, there has been a decline since a peak of 35 in 2016 (*Figure 9*).

**Figure 9: Number of engine bay incidents 2013-18**

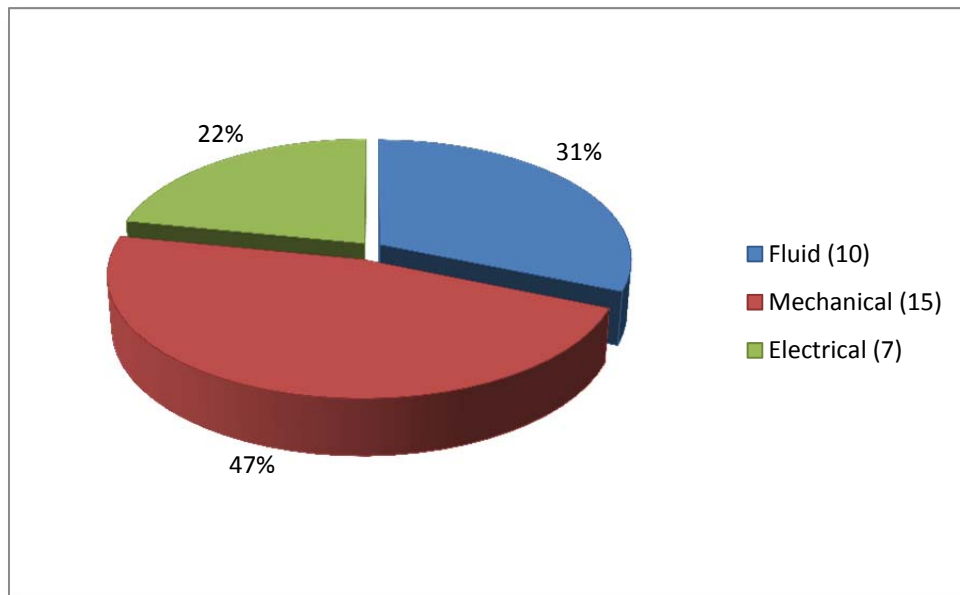
The cause of the engine bay incidents in 2018 was mechanical malfunction (46%), fluid leakage (33%), and electrical malfunction (21%) (*Figure 10*).

**Figure 10: Cause of engine bay incidents 2017**

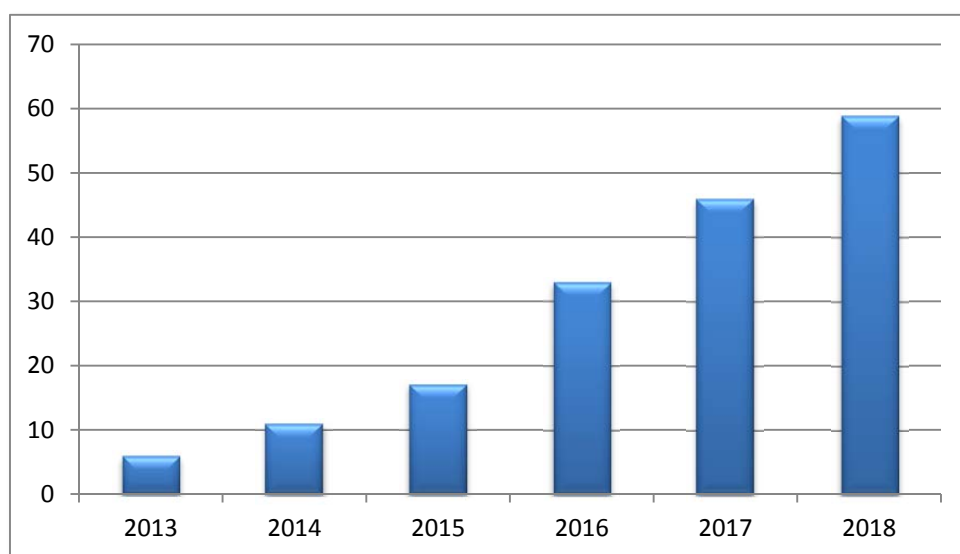
In 2018, 58 incidents (56%) were located around the wheel well. It should be noted that the majority of these incidents (88%) resulted in smoke damage only. OTSI believes that it is likely the increasing trend of wheel well thermal incidents is due in part to an increase in reporting and the increase in disc brake related incidents. However, these precursor incidents should not be ignored as one wheel well fire destroyed a bus on the Sydney Harbour Bridge in December 2018. Figures indicate that there has been a steady increase in wheel well incidents from five in 2013 to 59 in 2018 (see *Figure 11*).

**Figure 11: Number of wheel well incidents 2013-18**

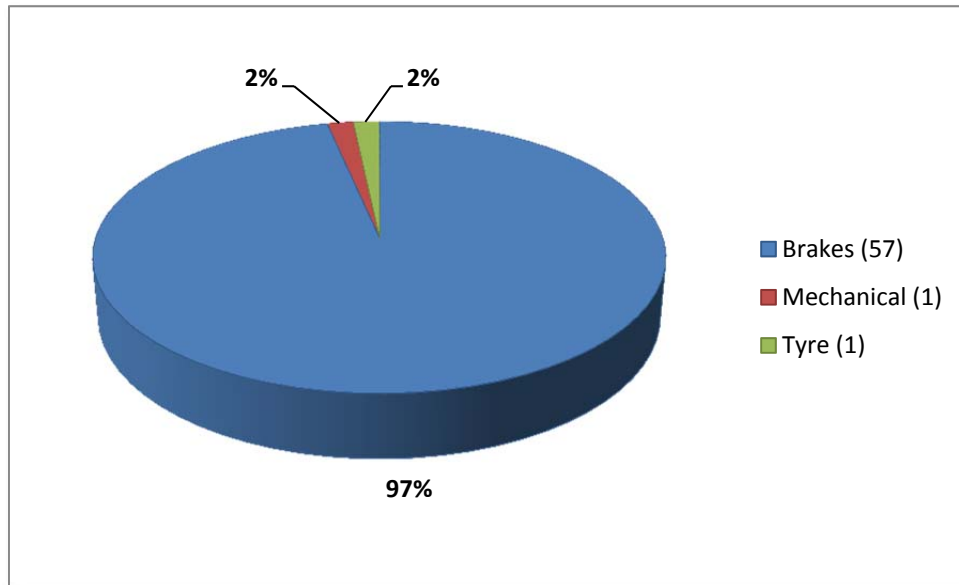
The majority of incidents 97% were a result of brake issues, which is separated into the following: faulty brake calliper (34), faulty brake booster (10), dragging drum brake (4), leaking oil onto brakes (2) and miscellaneous (7). Tyre problems occurred on one occasion (2%) and a mechanical failure on one occasion (2%). (*Figure 12*)

**Figure 12: Causes of wheel well incidents 2018**

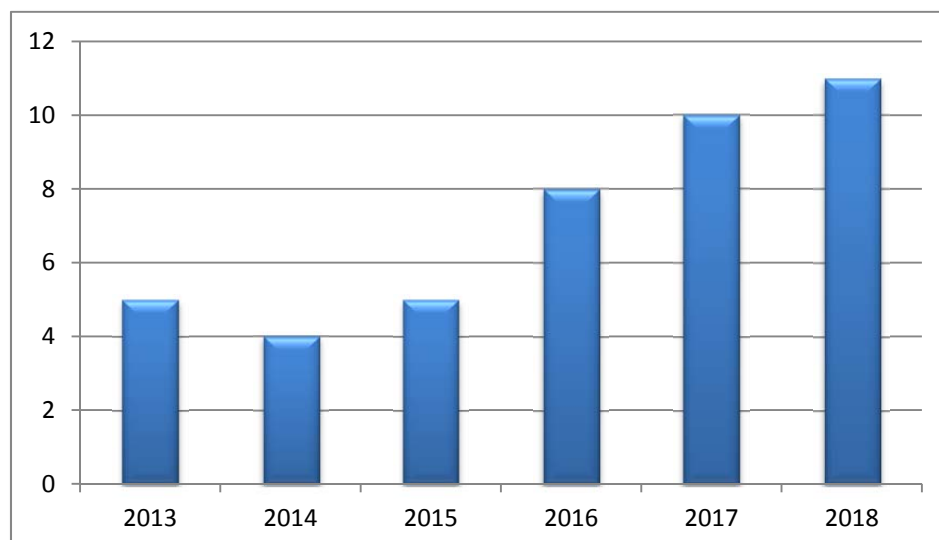
A smaller number of incidents originated both inside and outside the body of the bus or coach. There has been a steady increase in body incidents from a low in 2014 to 2018 (see *Figure 13*).

**Figure 13: Number of body incidents 2013-18**

The cause of all body incidents was due to electrical malfunction or failure (100%). The eleven electrical incidents had a wide variety of origins, faulty ignition switches, wiper motors, A/C control gear and faulty wiring; however, all were within the confines of the passenger saloon area.

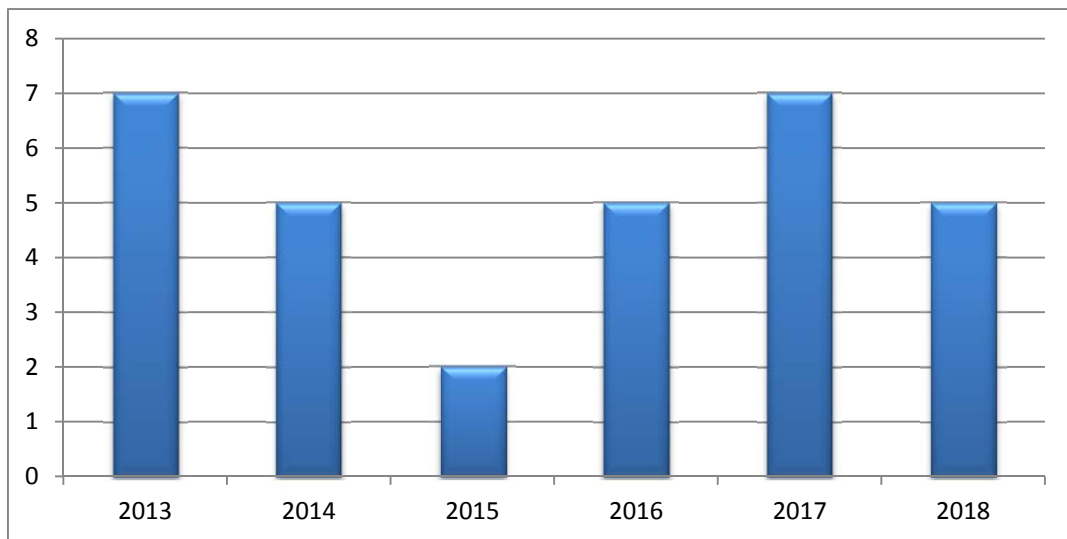
The number and causes of fire and thermal incidents involving CNG-fuelled buses is shown below (see *Figures 14 and 15*).

**Figure 14: Number of CNG bus incidents 2013-18**

In 2018, there were five incidents involving CNG fuelled buses.

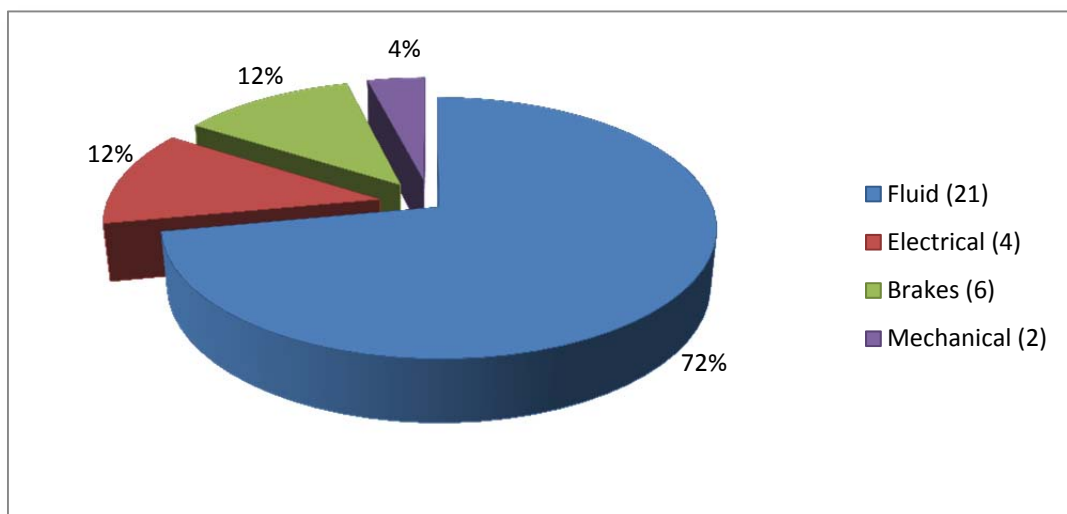
**Figure 15: Causes of CNG bus incidents 2013-18**

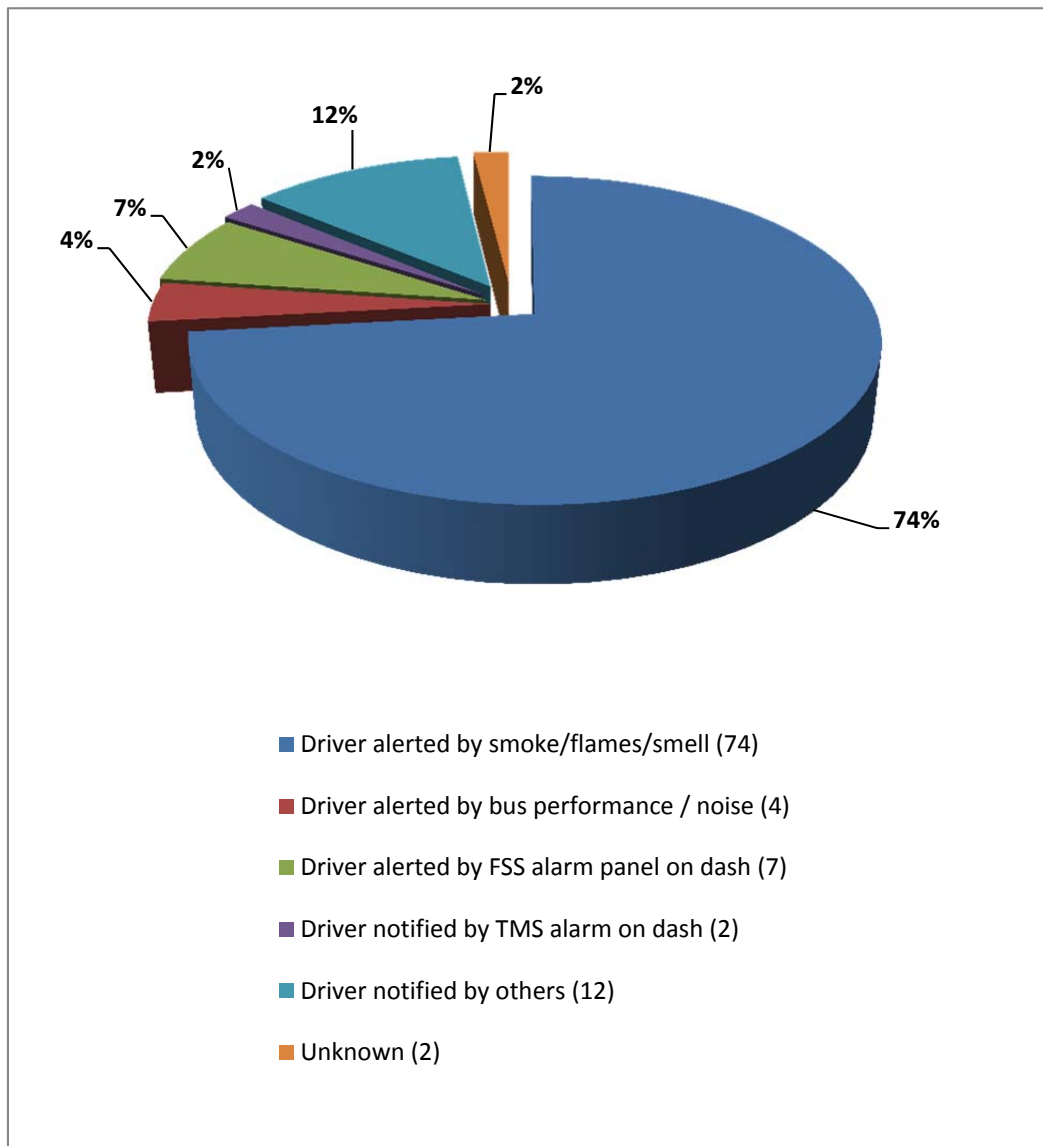
The data for the detection of incidents in 2018 are shown in Figure 17.

**Figure 17: Detection of incidents 2018**

In 2018, bus drivers were the first to either see or smell smoke or see flames on 74% of occasions. They also played a role in detecting a problem on nine other occasions. This highlights the importance of the driver's role in detecting the fire and acting accordingly.

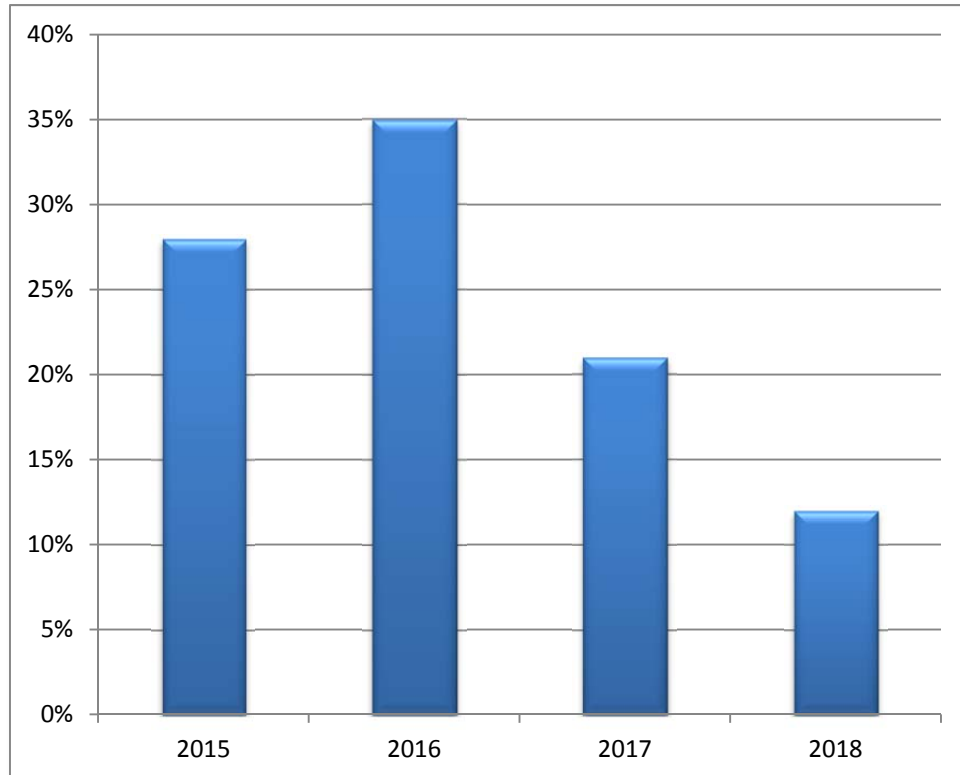
In 2018, NSW Fire and Rescue was called upon to attend on 12 occasions (12%). The percentage of occasions that NSW Fire and Rescue attended for the past four years is shown below (*Figure 18*).

**Figure 18: NSW Fire and Rescue: percentage attended 2015-2018**

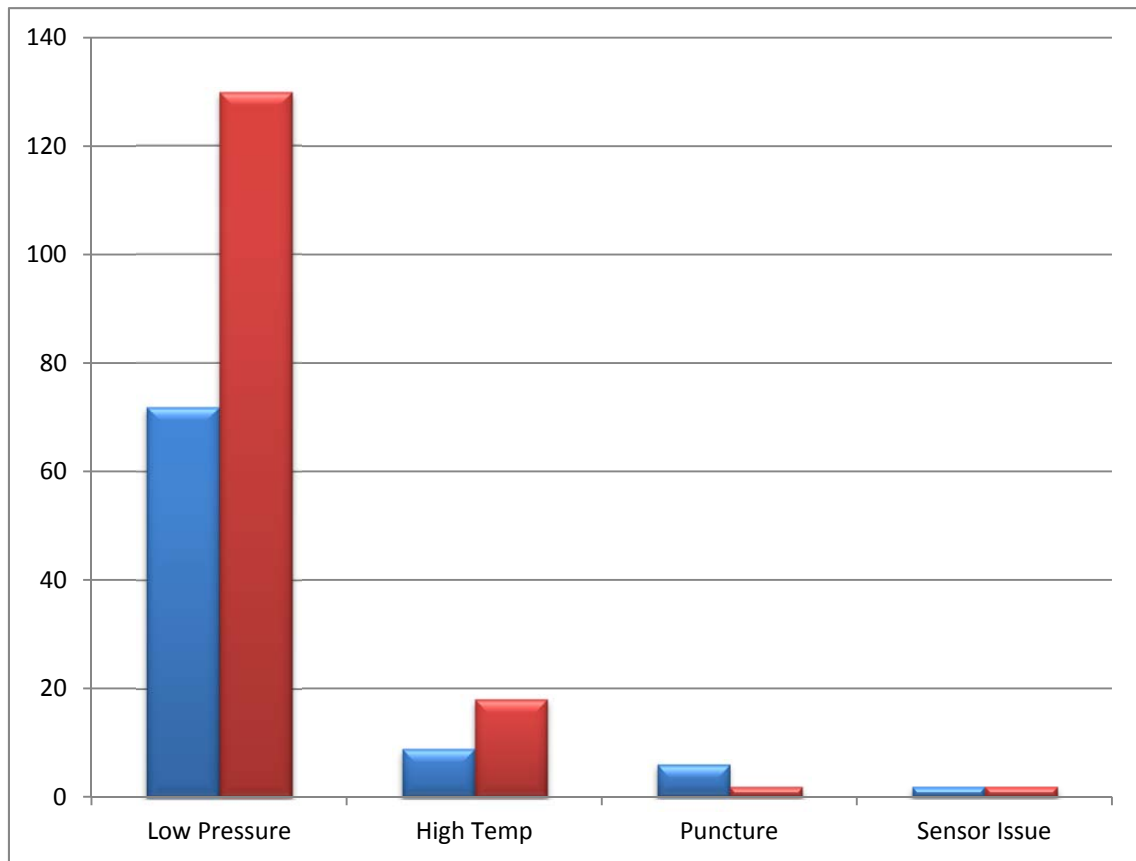
The 19 operators reported having a total of 1211 buses fitted with TMS. The numbers of the activations are provided in Figure 20 below. It should be noted that this number does not reflect all activations as many operators did not keep records of activation numbers. It is hoped that improved record keeping by operators will make the data more comprehensive in future years.

**Figure 20: TMS activations 2018**

Many bus operators now have tyre monitoring systems fitted<sup>7</sup>. A large number were fitted as part of the EBFS system installation and are now fitted as standard equipment on all TfNSW contract buses. These systems continuously monitor tyre pressure and temperature data which is transmitted from wireless, valve-stem mounted tyre sensors. A dash-mounted screen provides a visual and audible alert for rapid deflation, under inflation, high pressure and excessive heat conditions.
