**Office of  
Transport Safety  
Investigations**

**Bus Fires in New South Wales in 2021**

Investigation Reference 04594 (9)

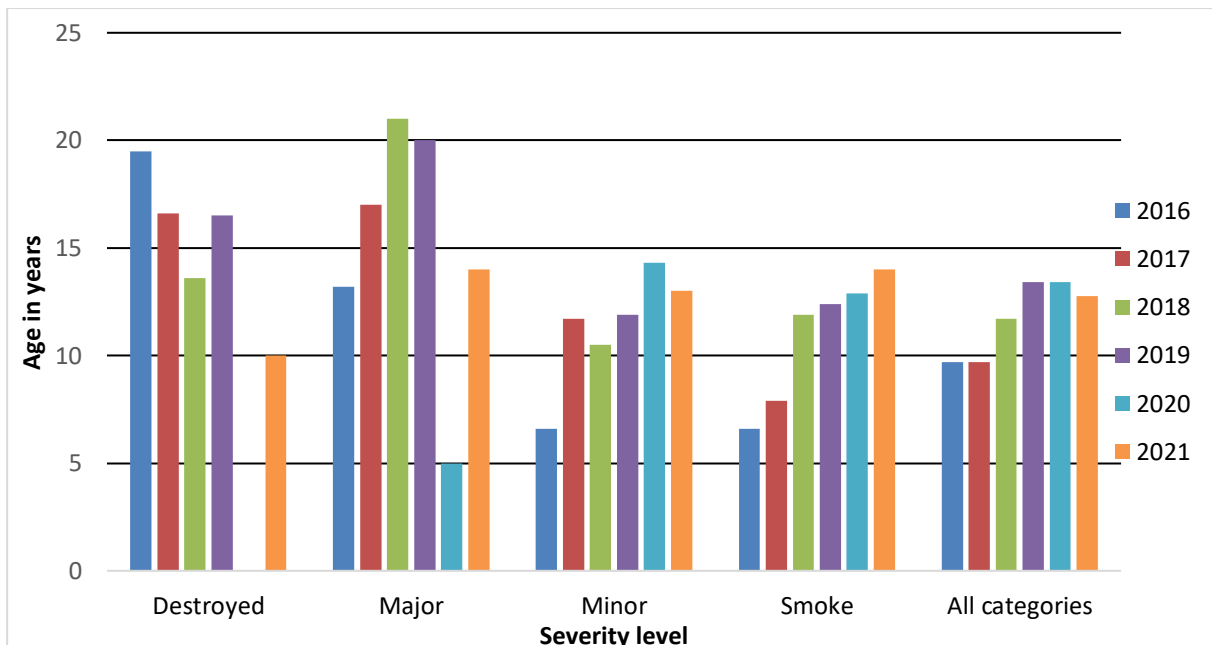
From 2016 to 2021 the average age of destroyed buses was 15.2 years, major damage 15.0 years, minor damage 11.3 years and smoke damage 10.9 years. The damage level and the average age of buses involved in incidents between 2016 and 2021 are shown below in Figure 11.

Figure 11: Damage level and age of bus 2016-2021
