FERRY SAFETY INVESTIGATION REPORT

**SYSTEMIC INVESTIGATION INTO TRAINING OF FERRY CREWS
OPERATIONAL PROCEDURES AND EMERGENCY DRILLS
SYDNEY FERRIES**

NOVEMBER 2007 - MAY 2009

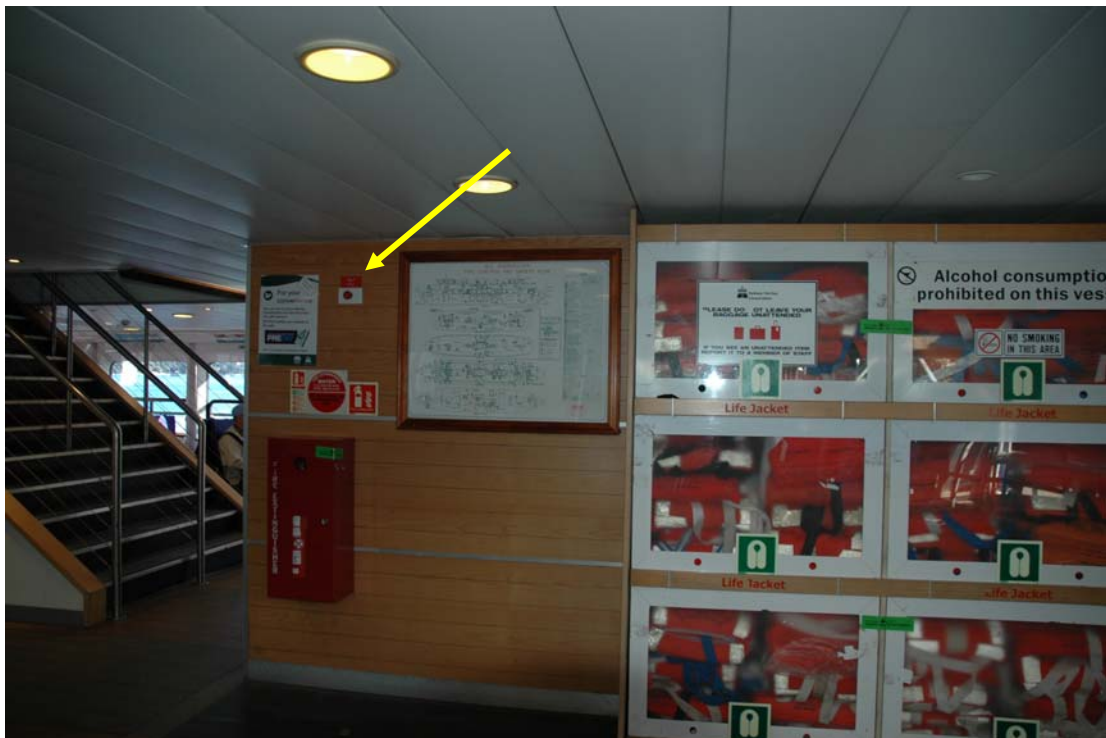
Photograph 2: Crew assistance button

- 1.84 On the Freshwater Class ferries there is an alarm button available for passengers to contact crew on each deck and in the two toilets for people with a disability should the passenger become ill or wish to report a safety incident. This crew contact button on the two decks is badly signed and requires considerable searching to locate it (see *Photograph 2*).
