## Commissioning and servicing of bus and coach fire suppression systems

### The incident

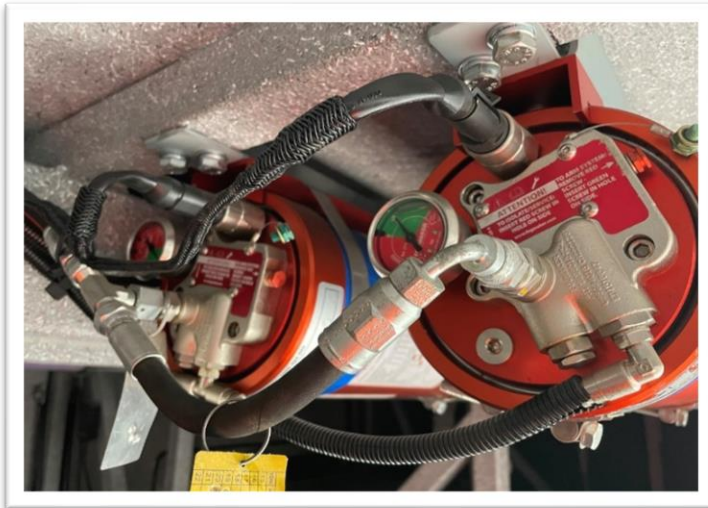
Left image:  
Fire suppression system installed on the vehicle involved in the detailed thermal event. Red isolation screw observed in the right-hand side of the valve body on both agent tanks which impeded the system's automatic discharge operation.

- Ensure that a vehicle equipped with EBFSS does not enter service unless the EBFSS is fully operational as evidenced by applicable commissioning and service documentation.

- Undertake a visual check of all vehicles as soon as possible to confirm the EBFSS has been commissioned correctly and is in an operational state.
- Ensure that EBFSS servicing and pressure testing is carried out in accordance with Australian Standard AS5062 - 2016 (*Fire protection for mobile and transportable equipment*) and OEM guidelines.

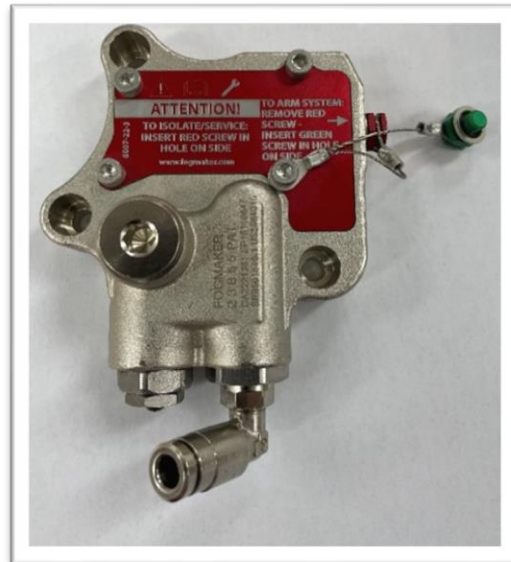
Right image:  
Agent cylinder valve body shown with the red system isolation screw inserted. The operational green screw hanging by the OEM tether is ready for system commission or system use. Red screw used for system service and decommissioning activities.

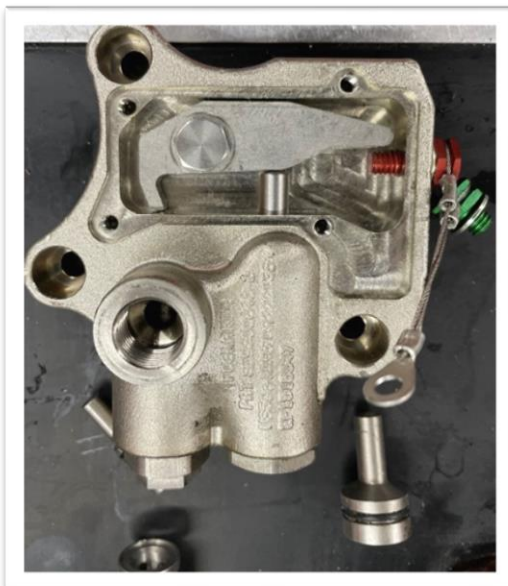
Left image:  
Picture of disassembled valve body showing the internal function of the red isolation screw.
